Anmore Gate Limited Partnership
Unit #301 – 370 Esplanade East
North Vancouver, BC
V7L 1A4

December 15, 2023
File: 23403-B
R0

**Re: Geotechnical Investigation Report – Proposed Subdivision Development – Anmore Gate
Pinnacle Ridge, Anmore, BC
Lot 8 Sec 16 & 21 TP 39 New Westminster District PL BCP38521 &
Lot 71 Sec 16 & 21 TP 39 New Westminster District PL 61510**

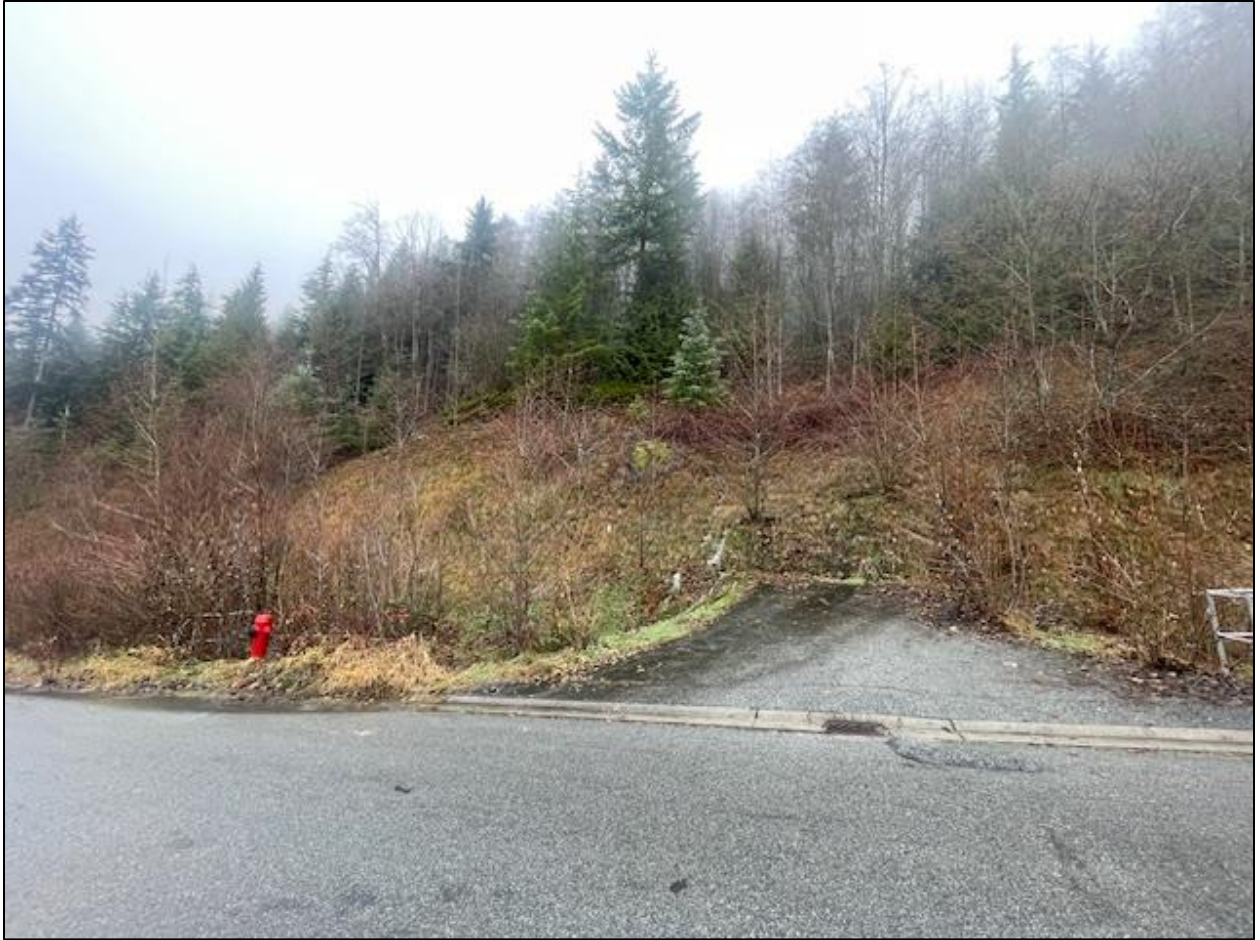
Photo 5: Transient stream flow north of Ridge Mountain Drive flowing into Minor Drainage System #1 ditch along upslope side of road (December 11, 2023)

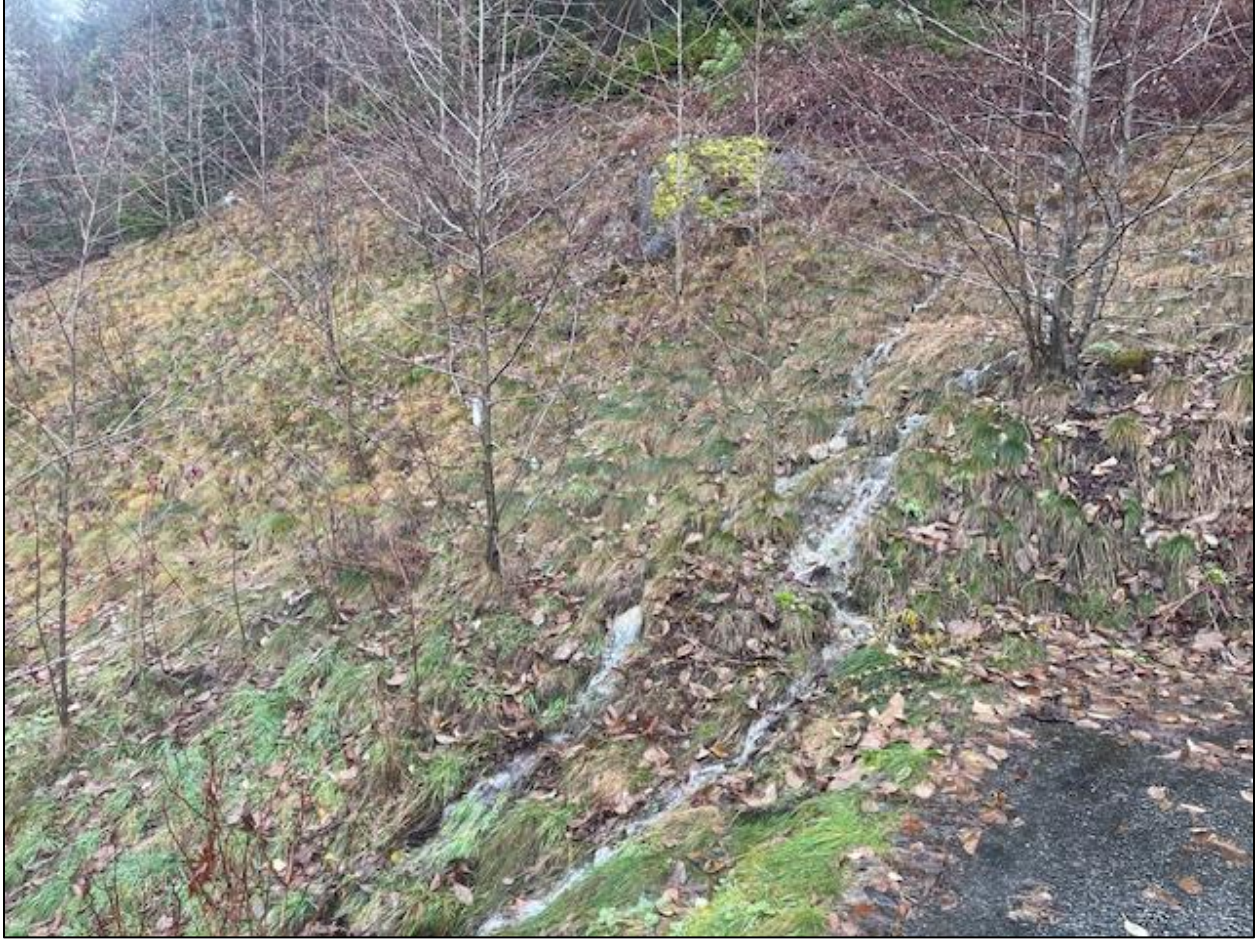
Photo 6: Transient stream flow north of Ridge Mountain Drive (December 11, 2023)

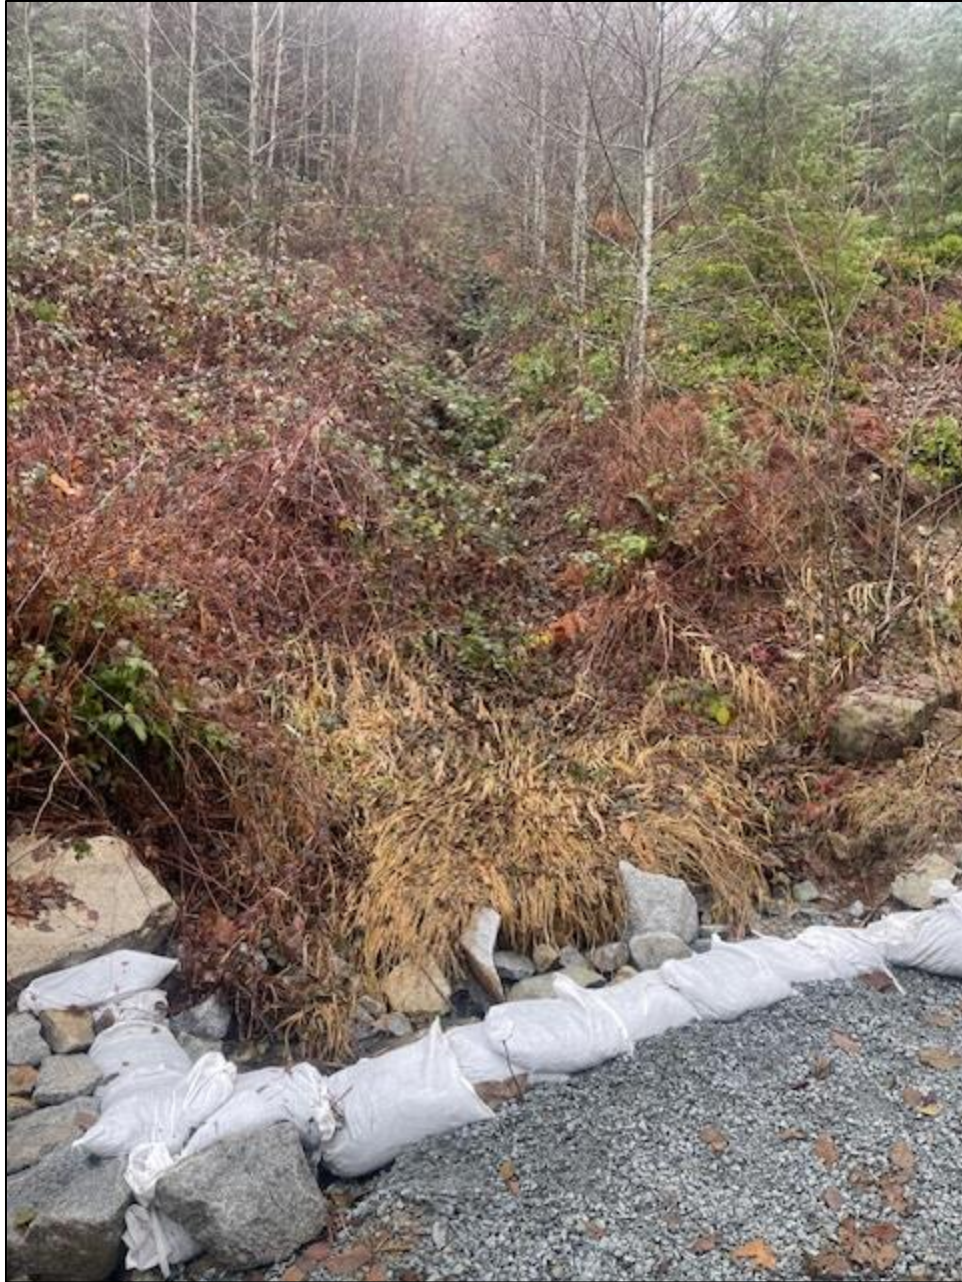
- Minor Drainage System #2 originates from the cross-slope swale of the TREZ development site and drains downslope east to west through a portion of the TREZ development area, at the southwest extent of the property. The swale is observed to be constructed of non-woven filter fabric lined with a woven fabric, and includes Deltalok™ Geo-Modular Bag system at surface through the swale alignment, as shown in our site reconnaissance photographs. The swale drains into a stormwater pipe at the upslope extent of the Ridge Mountain Drive extension and drains downslope further conveyed by stormwater pipe through proposed lots 22-24 of the TREZ development, south of the residential development at 1923 North Charlotte Drive. The system drains into Major Drainage System #2 at Wyndham Crescent.

Photo 7: Minor Drainage System # 2, drainage swale at south extent of asphalt paved Ridge Mountain Drive, collecting drainage from the cross-slope swale within TREZ development area, looking upslope/east (December 11, 2023)

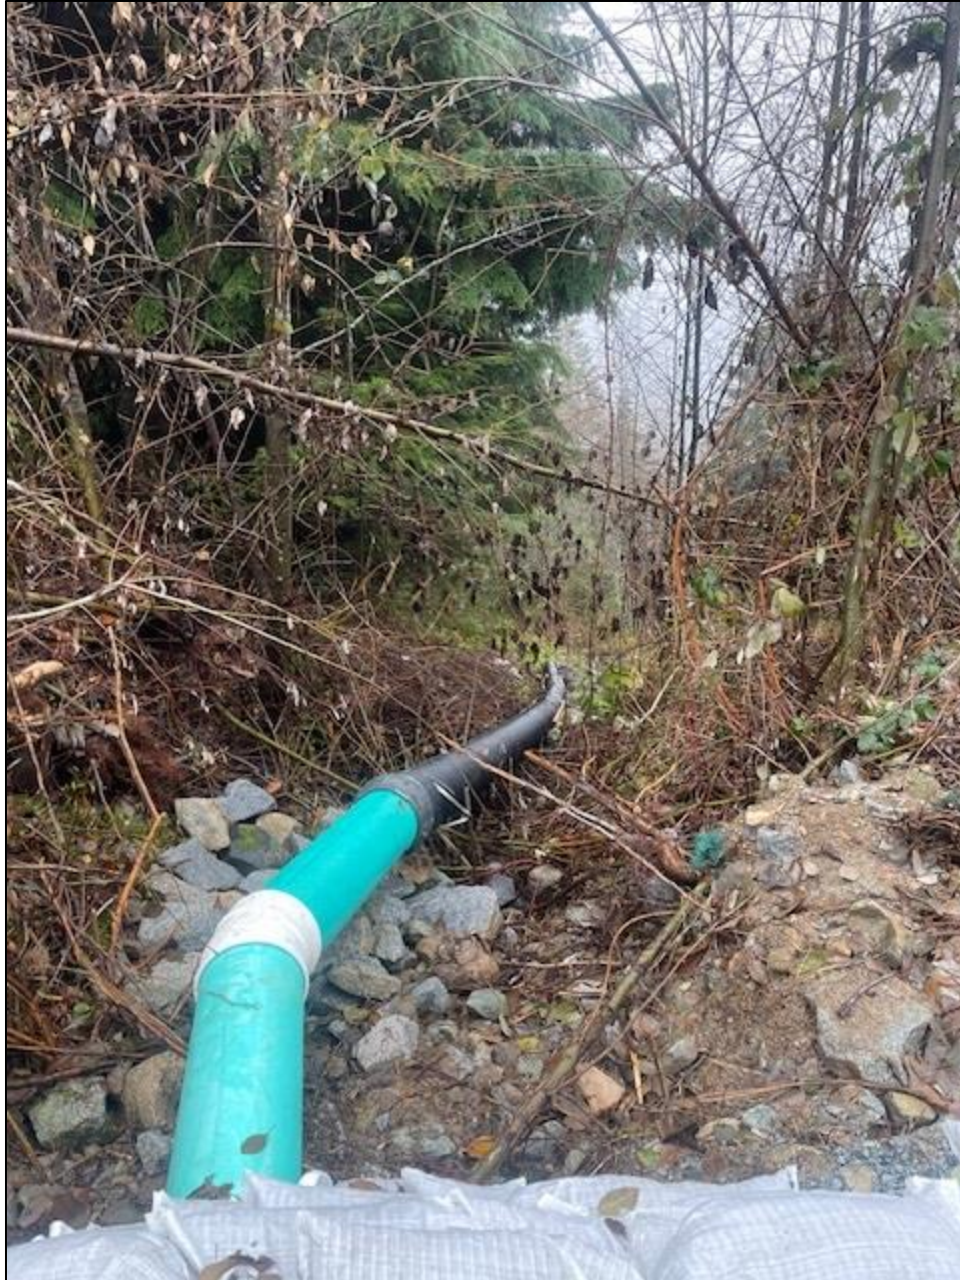
Photo 8: Minor Drainage System # 2, stormwater drainage pipe at south extent of asphalt paved Ridge Mountain Drive, collecting drainage from the swale shown in Photo 7, looking downslope/west (December 11, 2023)

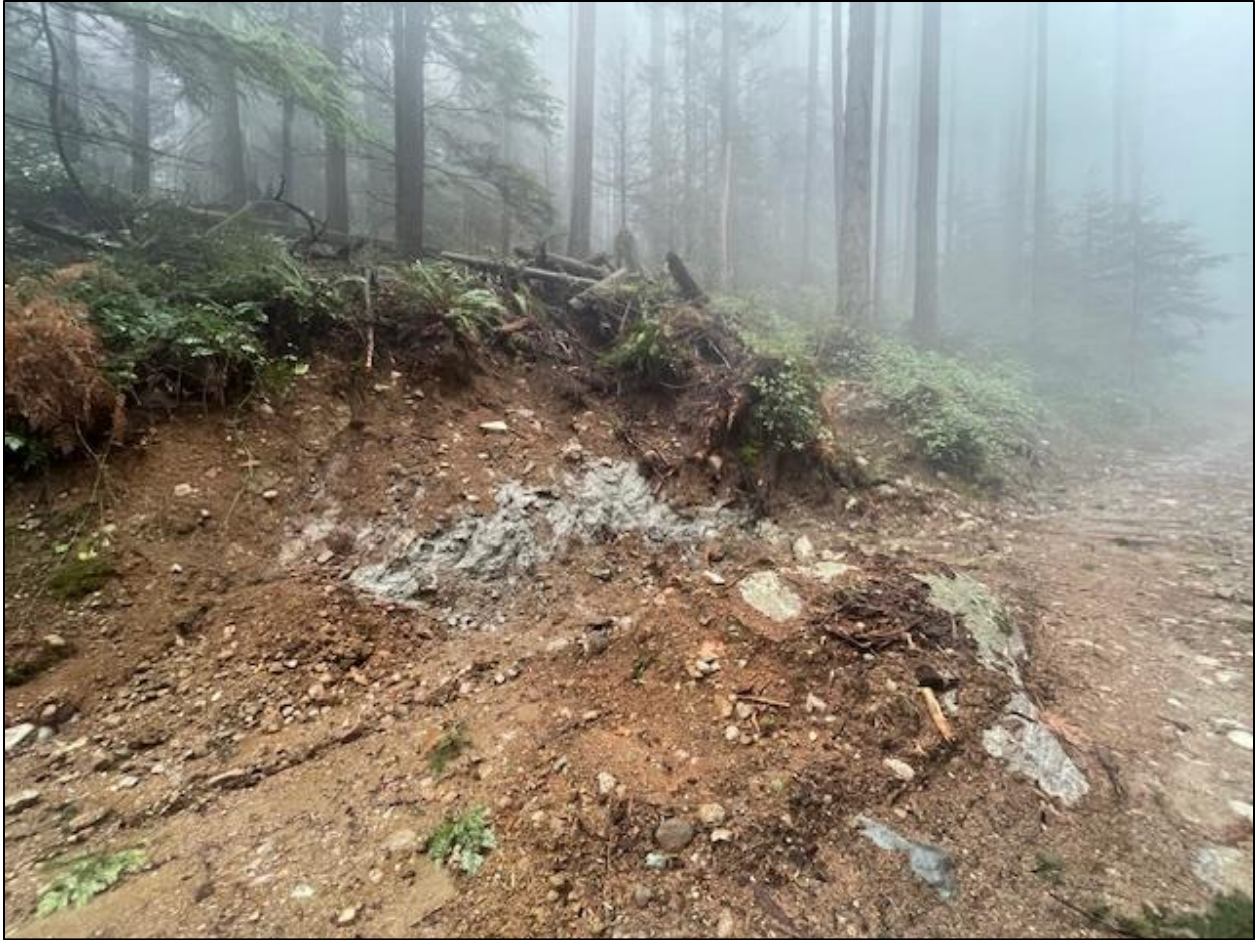
As described in Section 4.2, we observed bedrock outcrops nearby at the northwest corner of Ridge Mountain Drive and North Charlotte Road, potential bedrock outcrop or large boulder along the Ridge Mountain Drive alignment within the Anmore Gate property, and observed a bedrock outcrop at the Meridian Cell Tower area to the east during our geotechnical consulting for a new communication tower foundation support at this location in 2018. Exposed bedrock was noted to be granitic. Our experience at the nearby Meridian Cell Tower area indicates that the bedrock may have localized zones of weathered rock and fractures at the surface.

Photo 9: Exposed very dense glacial till and large boulder/bedrock outcrop along the Ridge Mountain Drive extension (December 11, 2023)

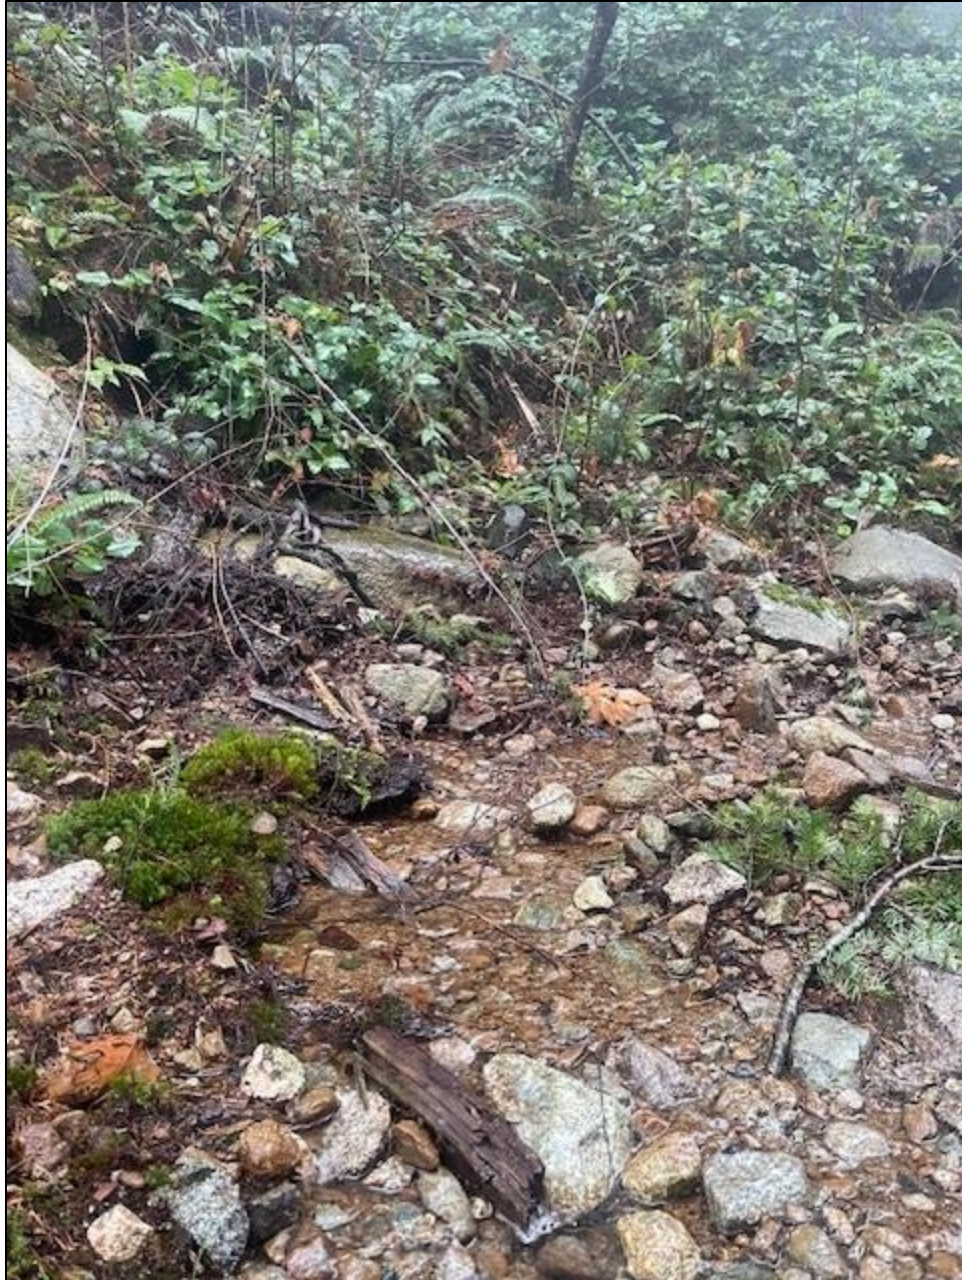
Photo 10: Transient stream along the Ridge Mountain Drive extension (December 11, 2023)

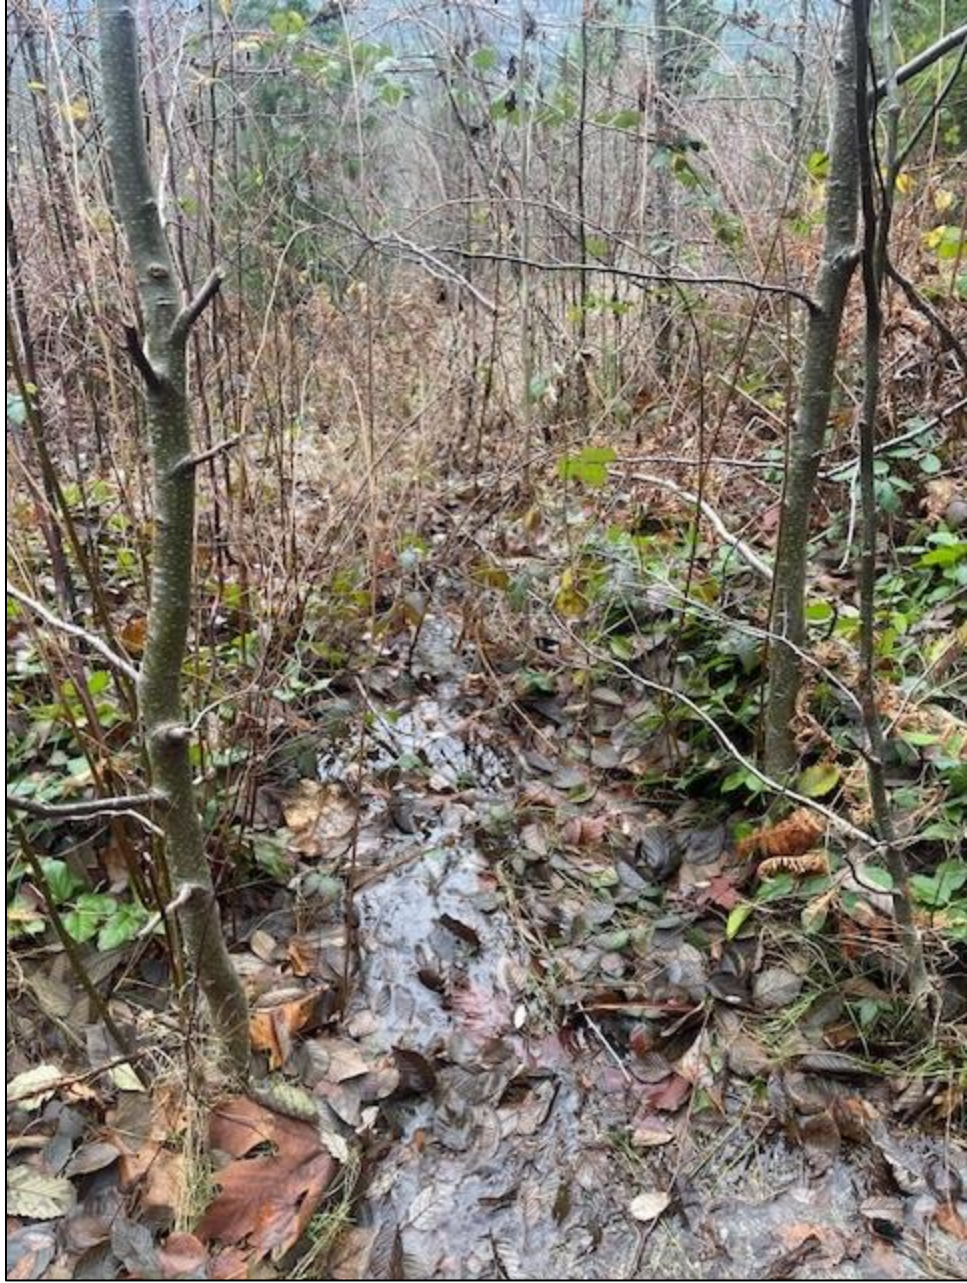
Photo 11: Transient stream along at upper access road extensions (December 13, 2023)

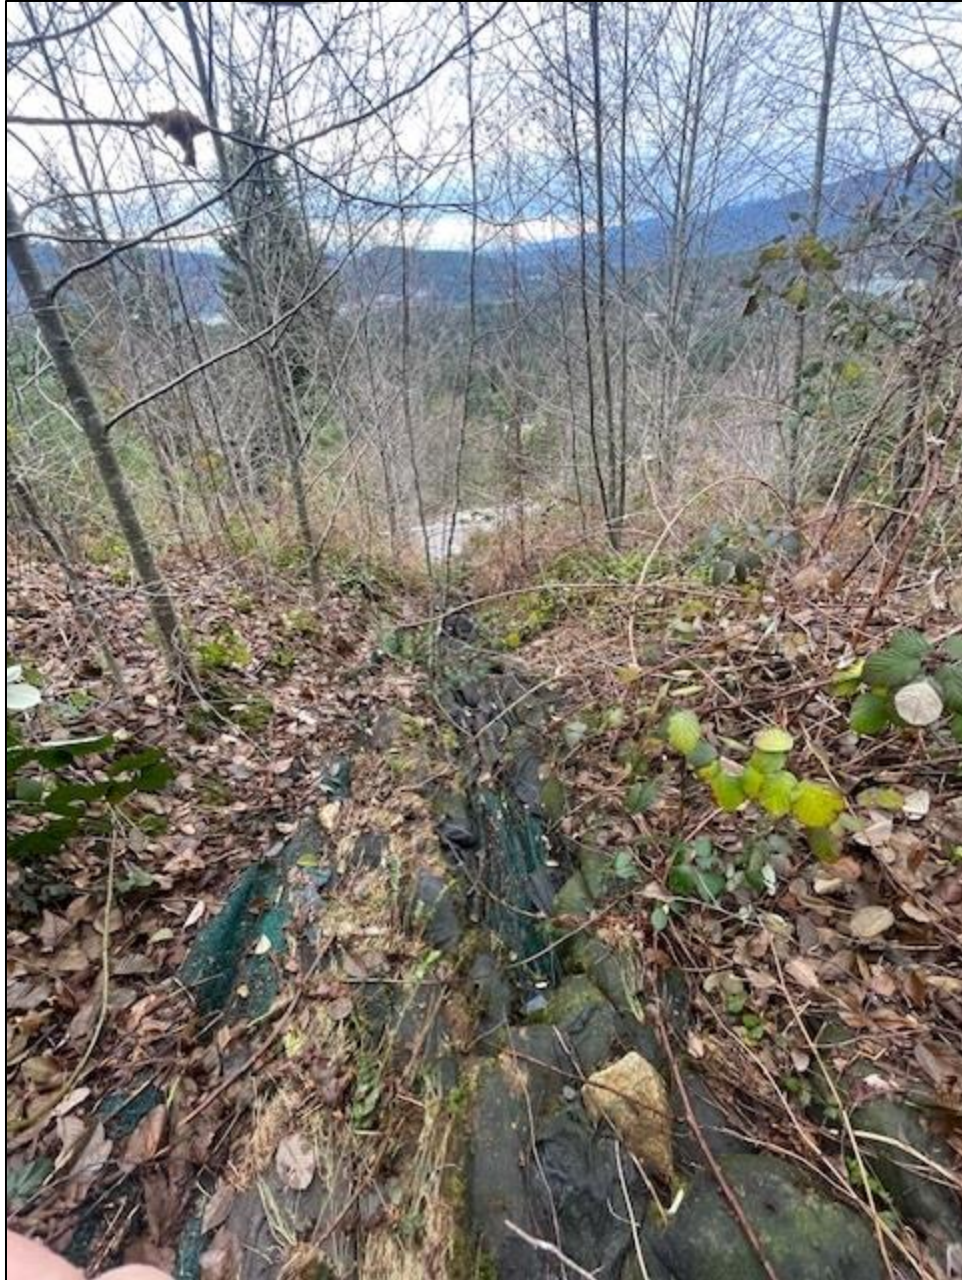
Photo 13: Upper extent of Minor Drainage System #2, downslope drainage swale at southern portion of TREZ development (December 13, 2023)

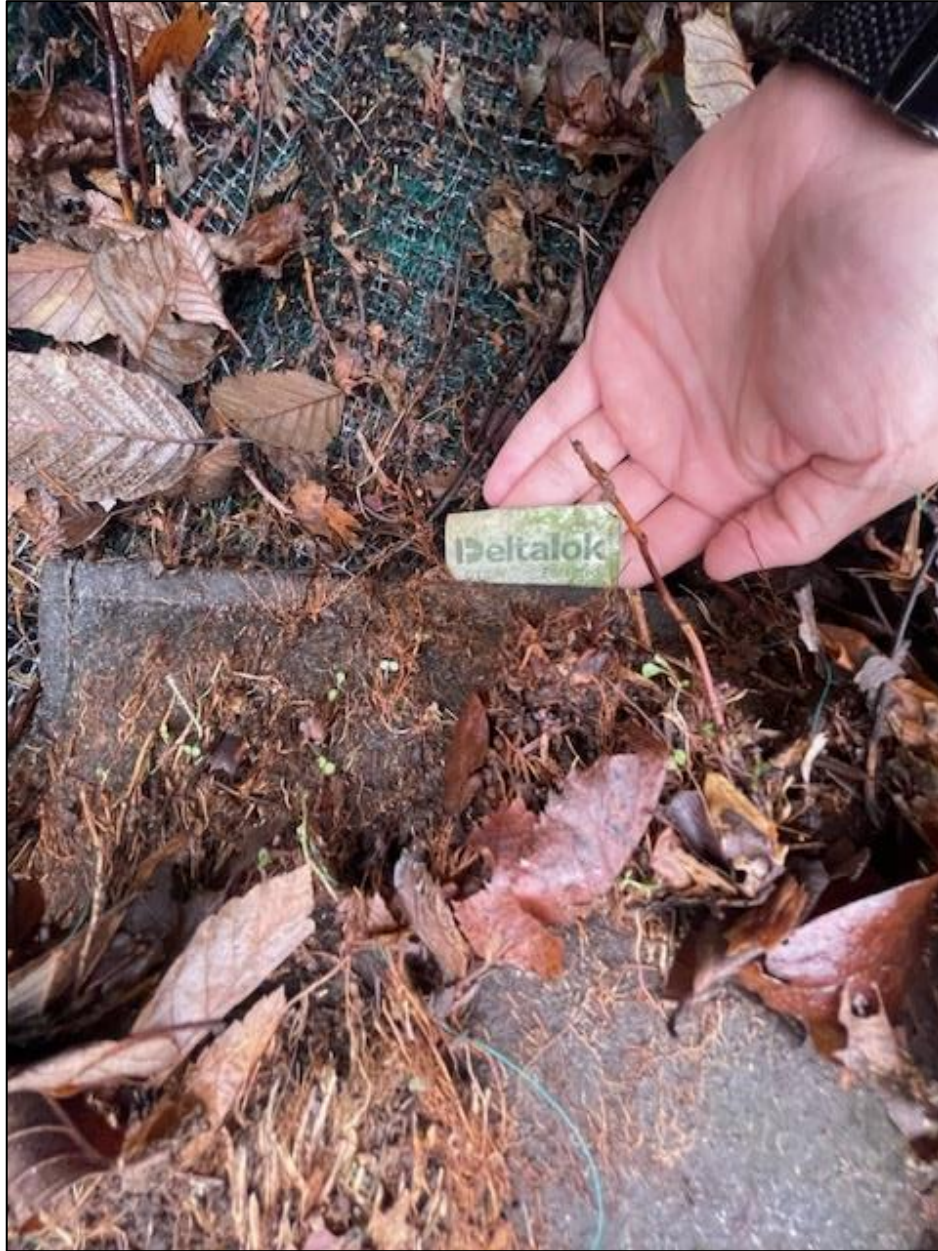
Photo 14: Downslope drainage swale at southern portion of TREZ development showing Deltalok™ Geo-Modular Bags (December 13, 2023)

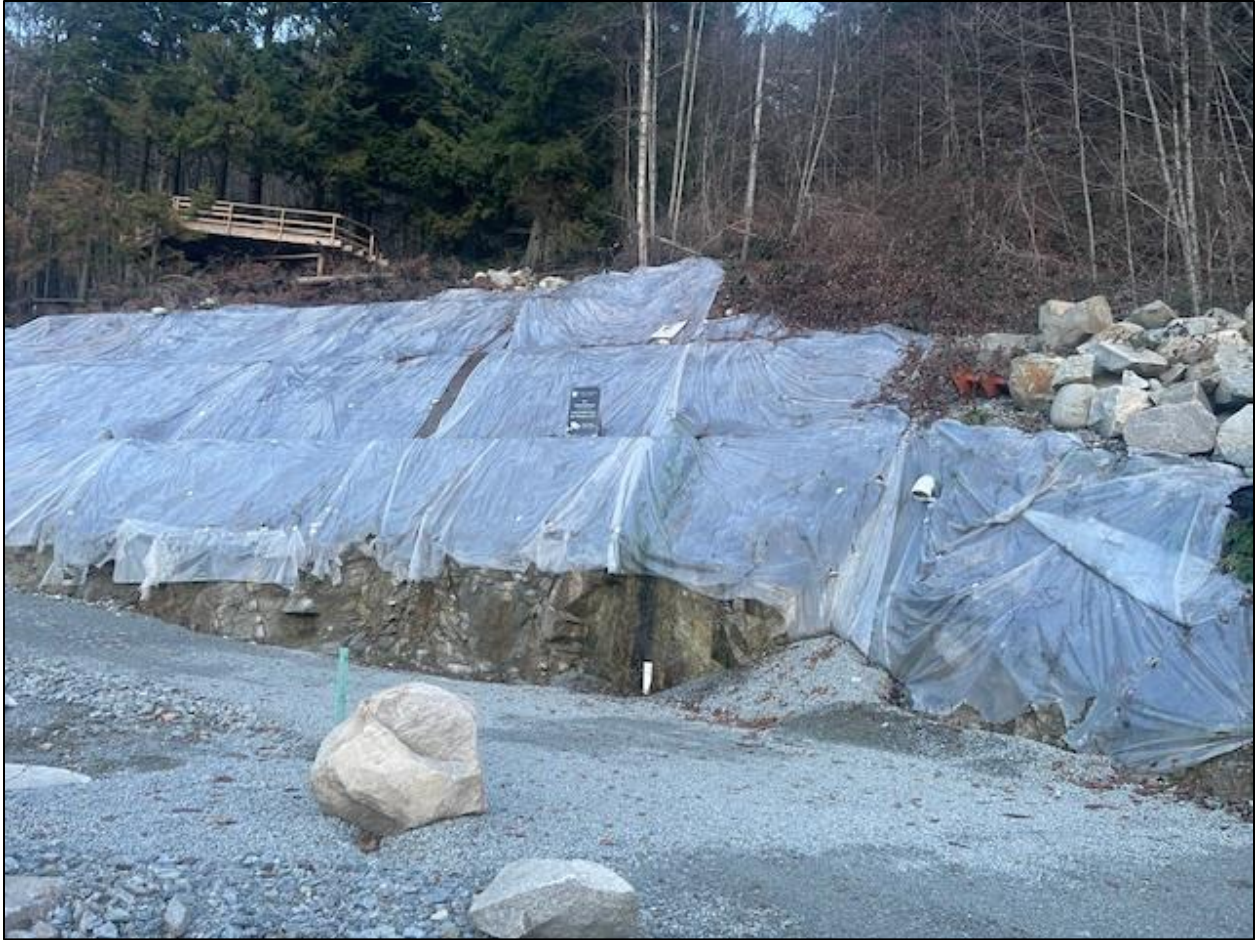
Photo 17: Bedrock outcrop at NE corner of intersection of Ridge Mountain Drive and North Charlotte Way (December 13, 2023)

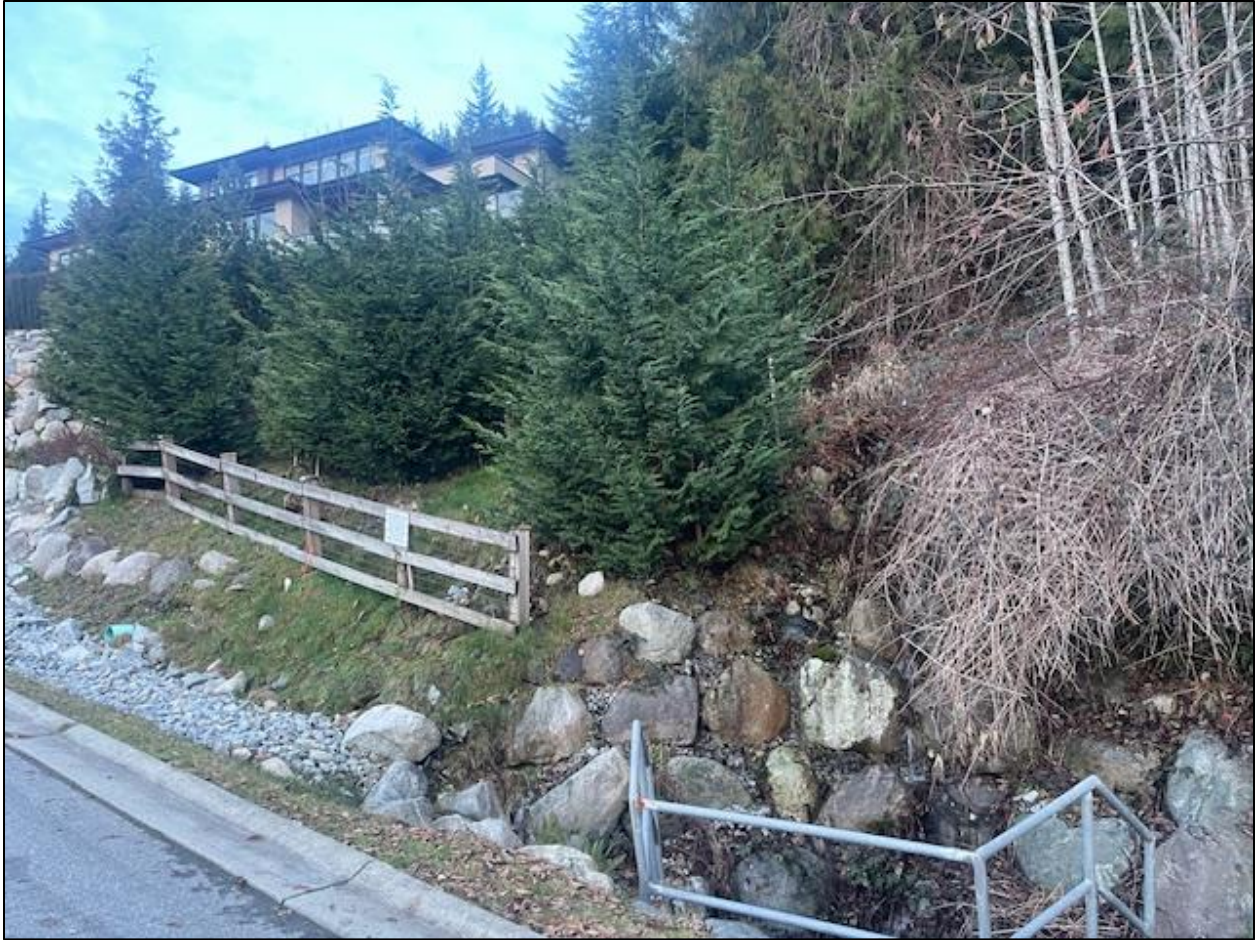
Photo 18: Minor System #1 draining into culvert at east side of North Charlotte Drive at south portion of 1983 North Charlotte Drive (December 13, 2023)

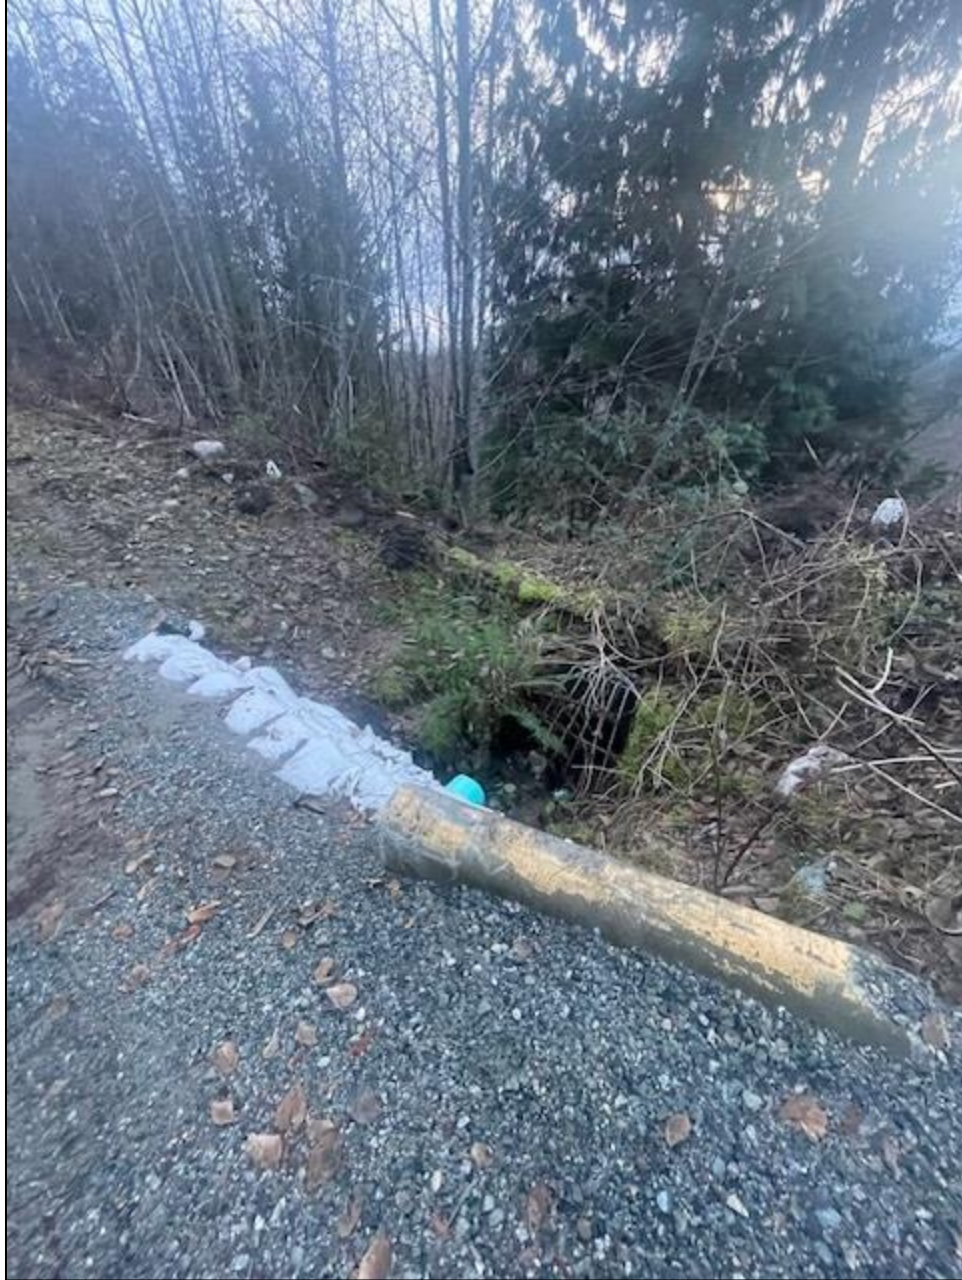
Photo 20: Minor Drainage System #2, stormwater drainage pipe intake at west side of North Charlotte Drive extension (December 13, 2023)

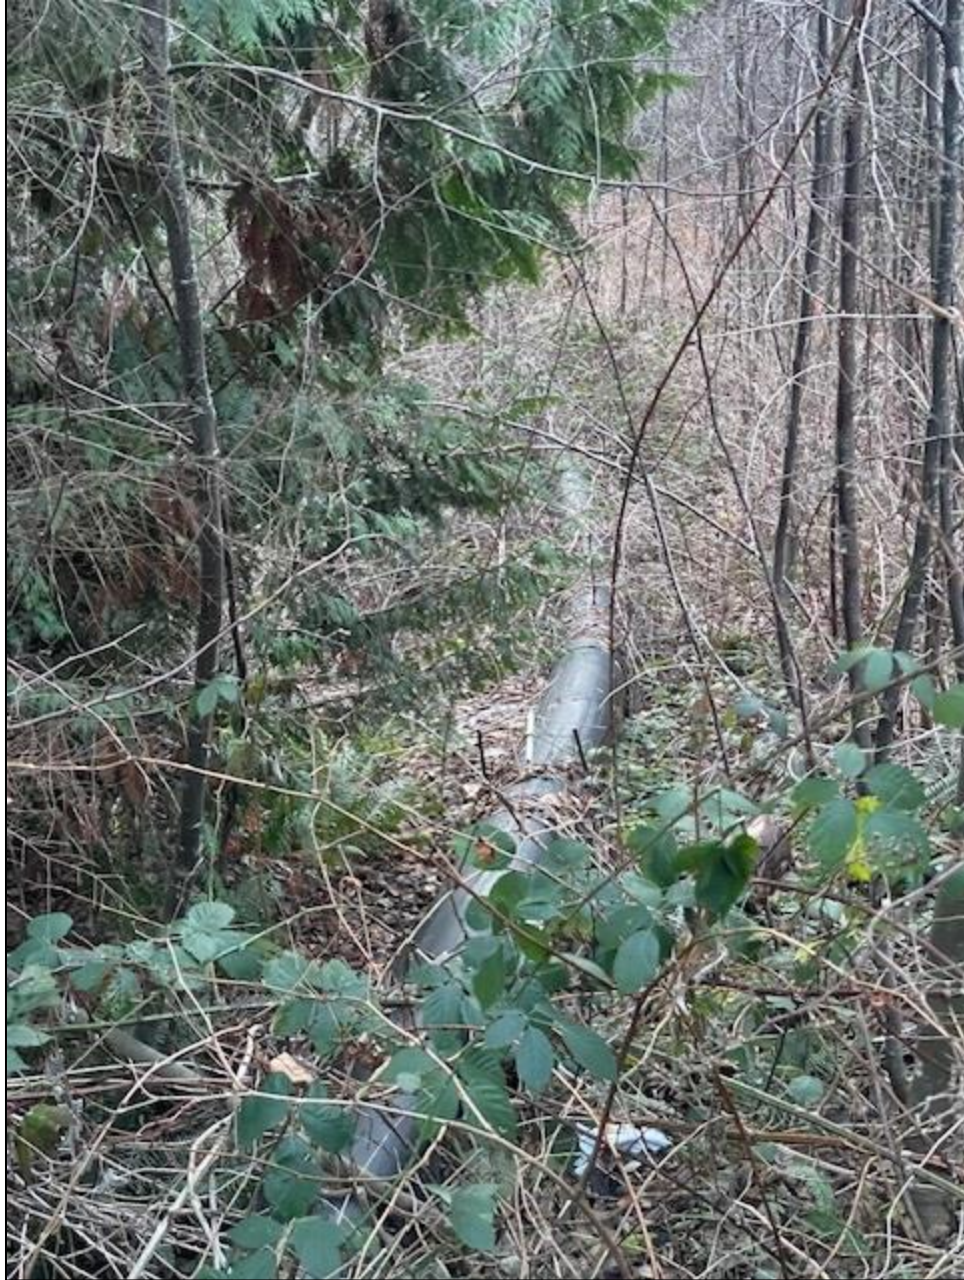
Photo 21: Minor Drainage System #2, stormwater drainage pipe at west side of North Charlotte Drive extension (December 13, 2023)

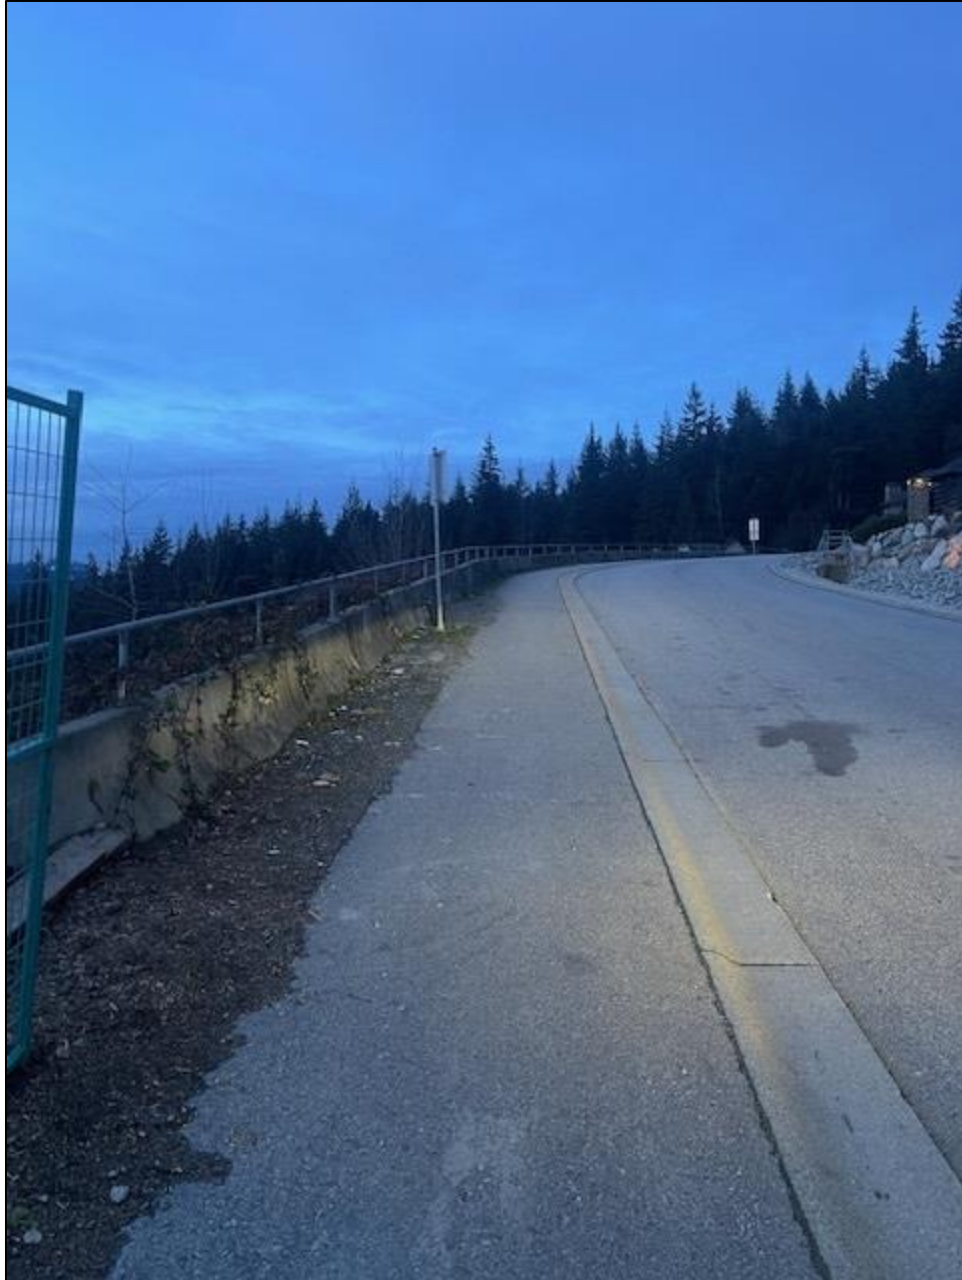
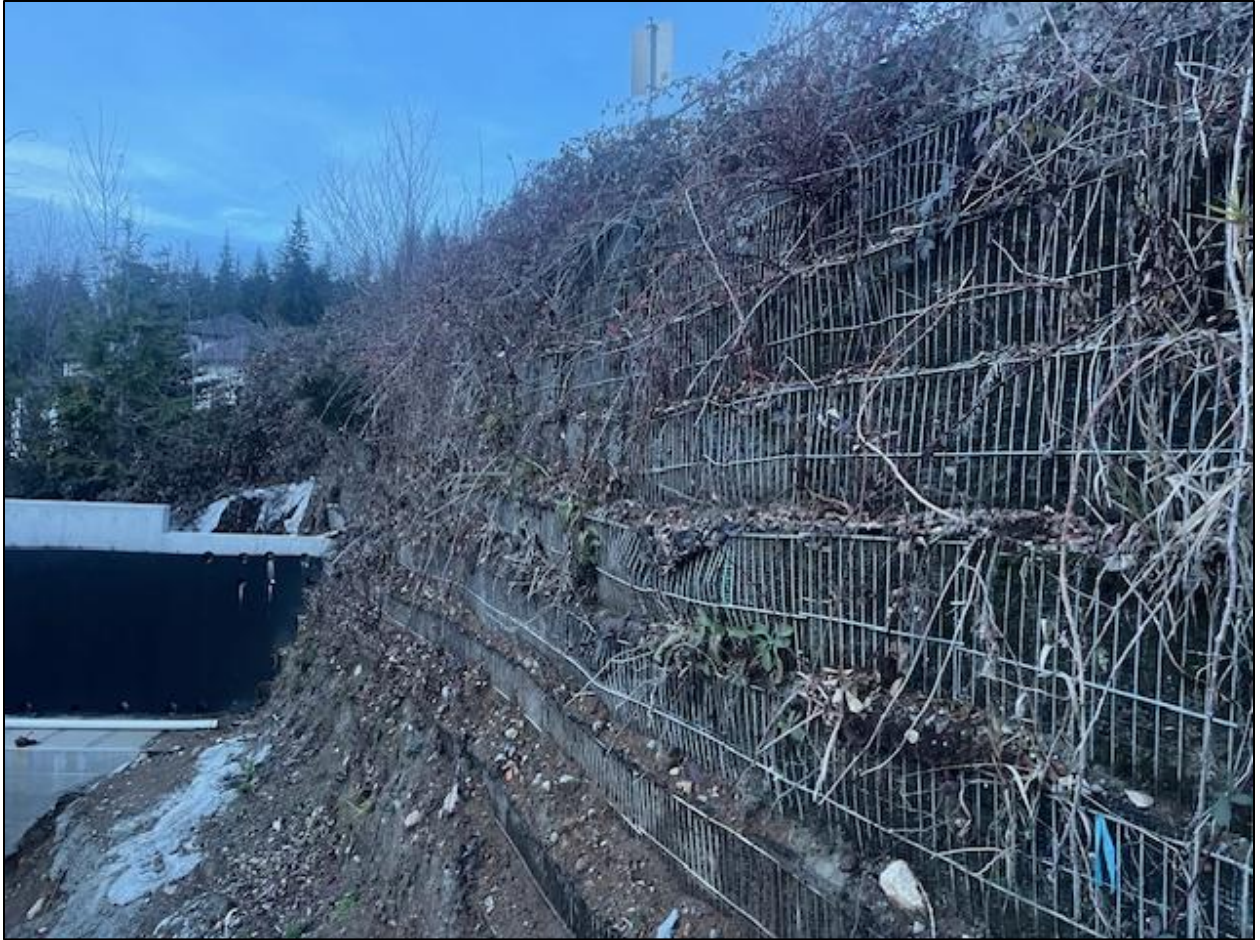
Photo 24: MSE Retaining wall along west/downslope side of North Charlotte Drive (December 13, 2023)

Photo 25: MSE Retaining wall along west/downslope side of North Charlotte Drive (December 13, 2023)

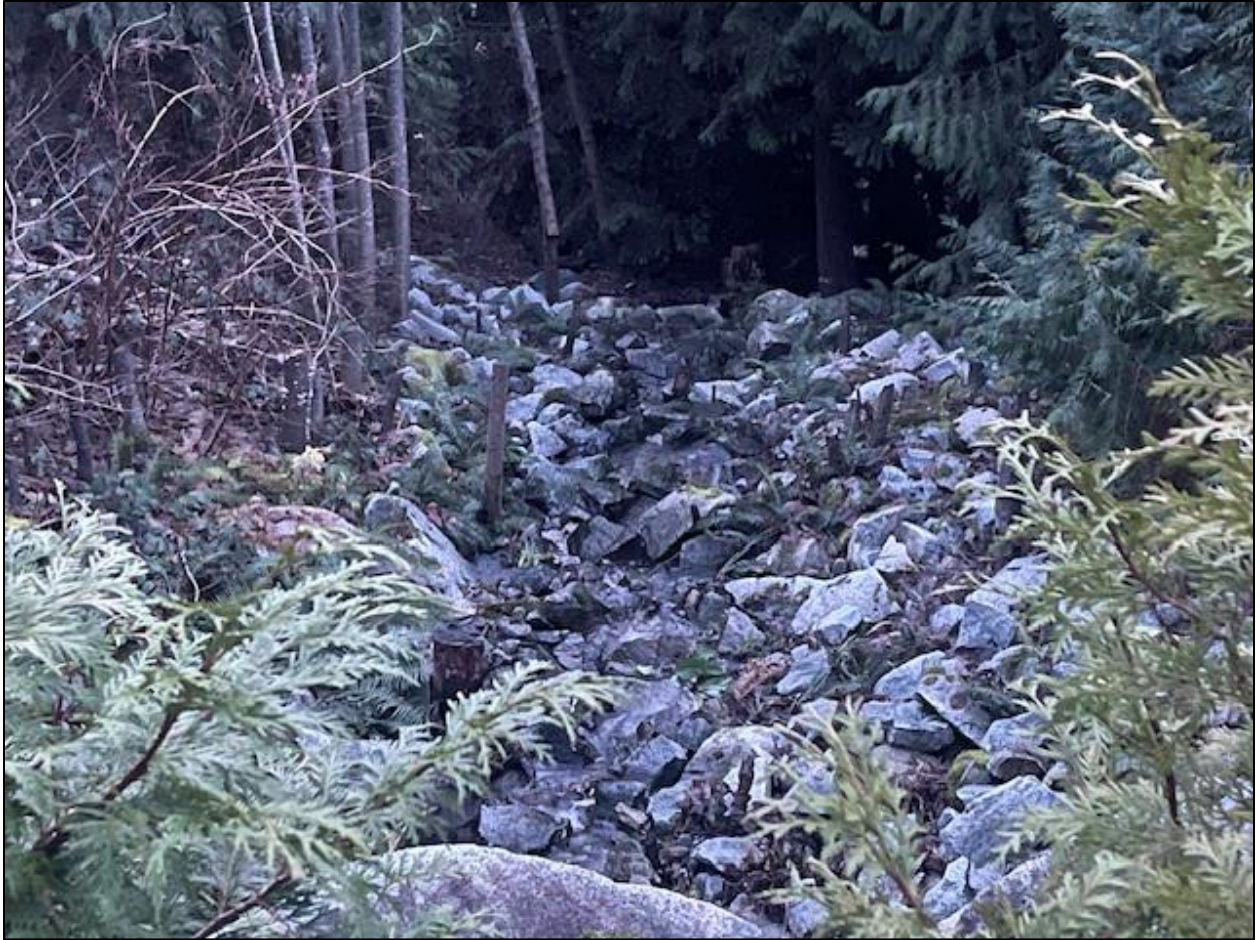
*Photo 26: Minor Drainage System #1 downslope of culvert at Ridge Mountain Drive
(December 13, 2023)*

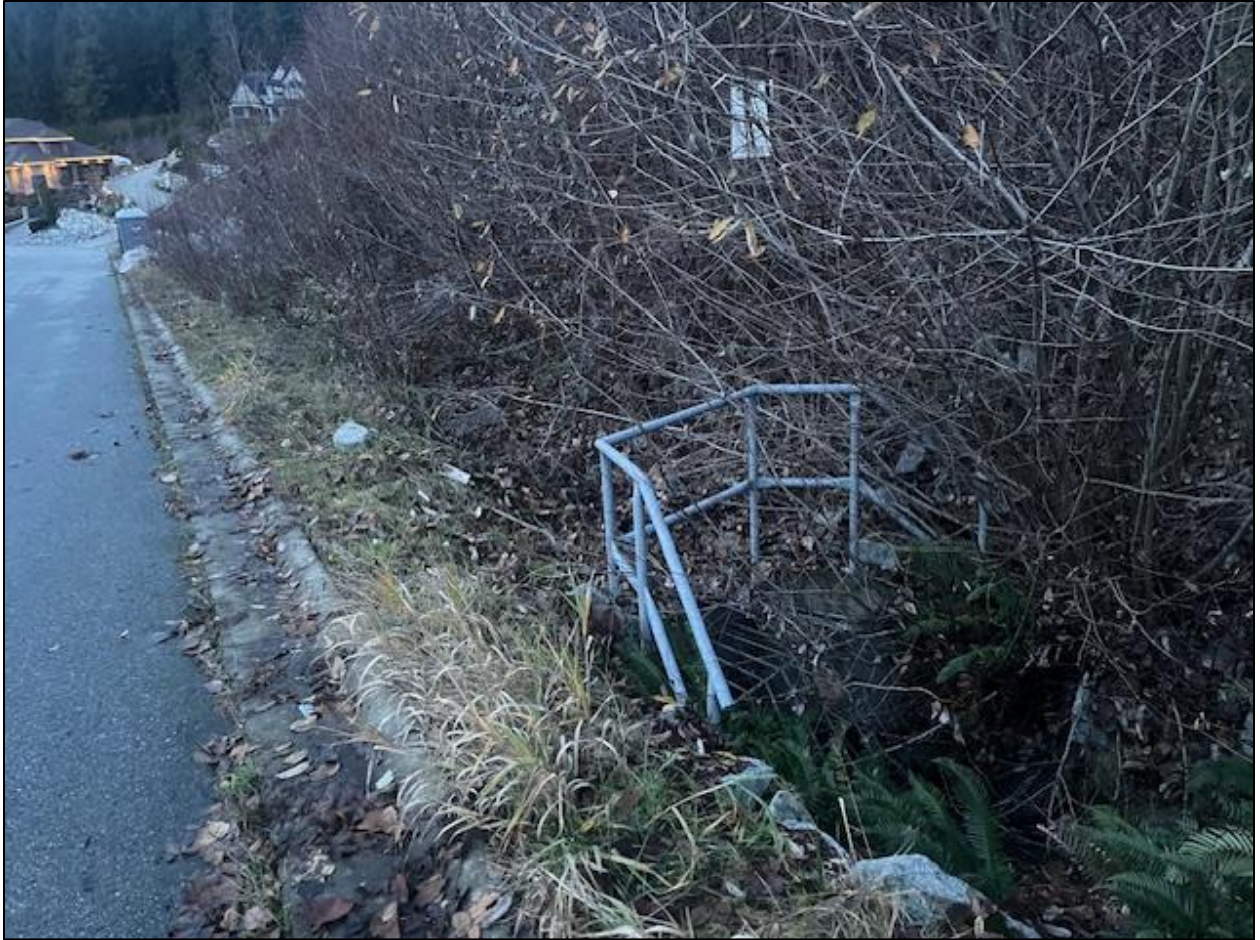
*Photo 27: Minor Drainage System #1 upslope of culvert at Ridge Mountain Drive
(December 13, 2023)*
