Anmore Gate Limited Partnership
Unit #301 – 370 Esplanade East
North Vancouver, BC
V7L 1A4

December 15, 2023
File: 23403-B
R0

**Re: Geotechnical Investigation Report – Proposed Subdivision Development – Anmore Gate
Pinnacle Ridge, Anmore, BC
Lot 8 Sec 16 & 21 TP 39 New Westminster District PL BCP38521 &
Lot 71 Sec 16 & 21 TP 39 New Westminster District PL 61510**

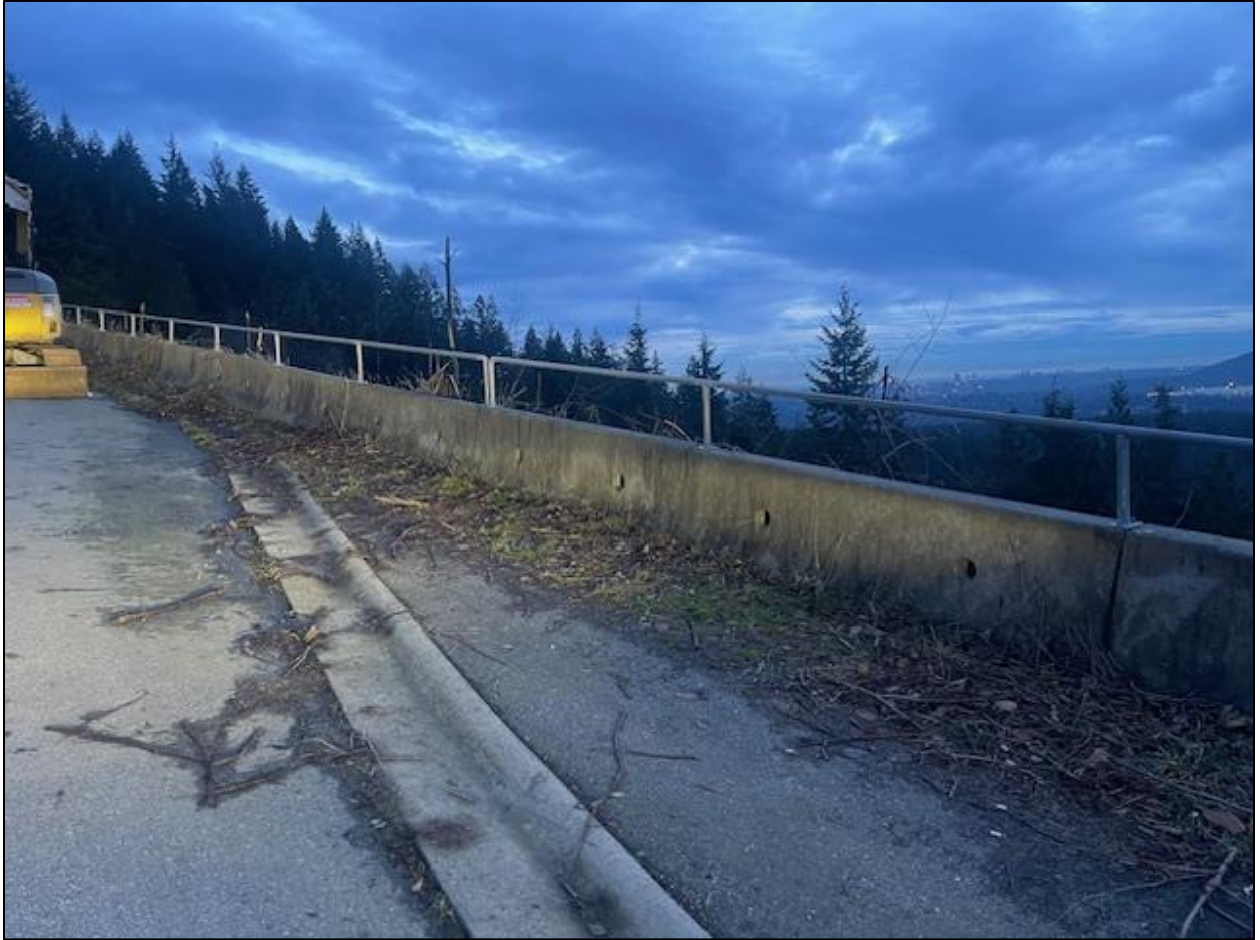
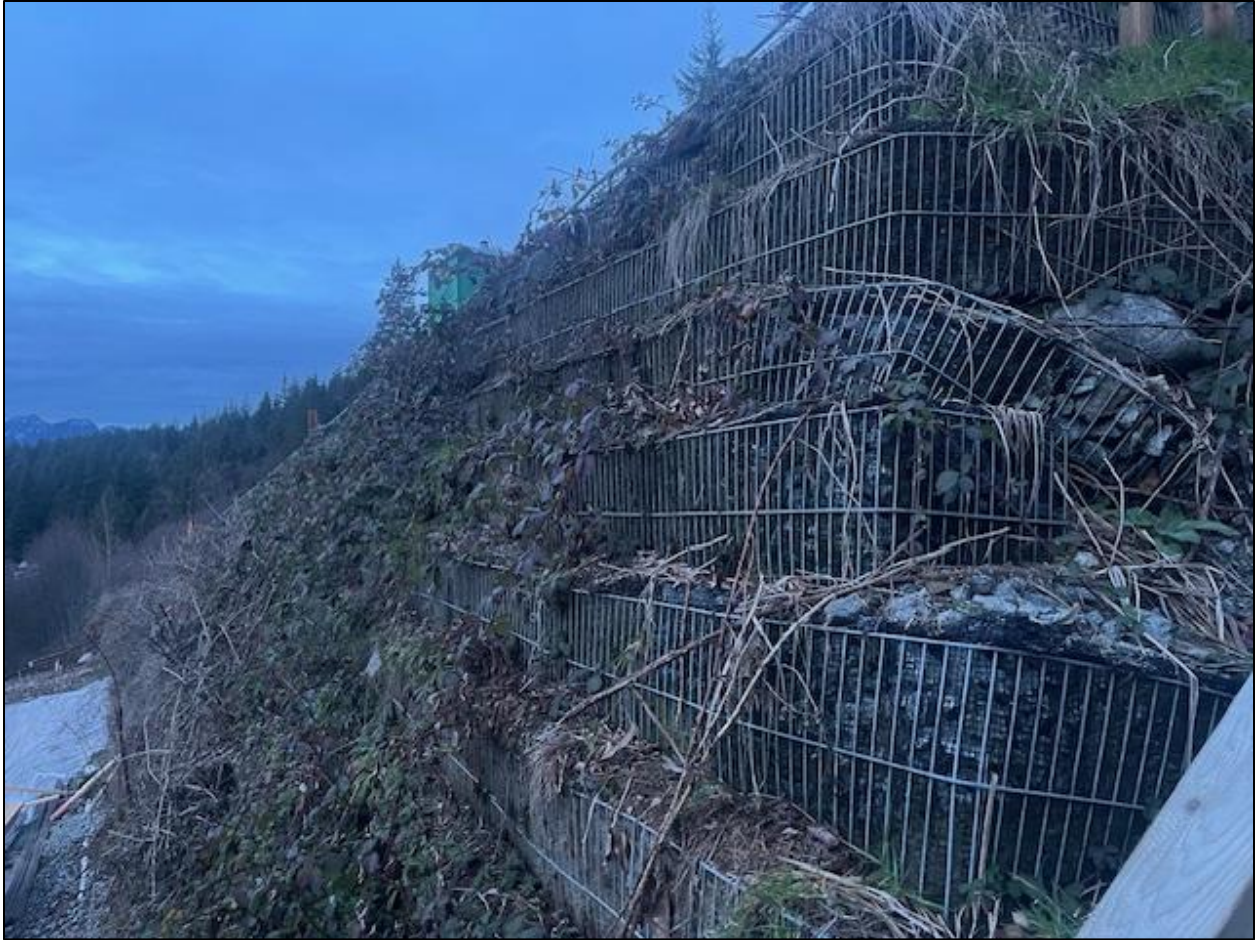
Photo 28: MSE Retaining wall along west/downslope side of Ridge Mountain Drive (December 13, 2023)

Photo 29: MSE Retaining wall along west/downslope side of Ridge Mountain Drive (December 13, 2023)
