December 15, 2023
File: 23403-C
R0

**Re: Geotechnical Investigation Report – Proposed Subdivision Development – Bella Terra
Pinnacle Ridge, Anmore, BC
Lot 2 Sec 16 TP 39 New Westminster District PL BCP50903**

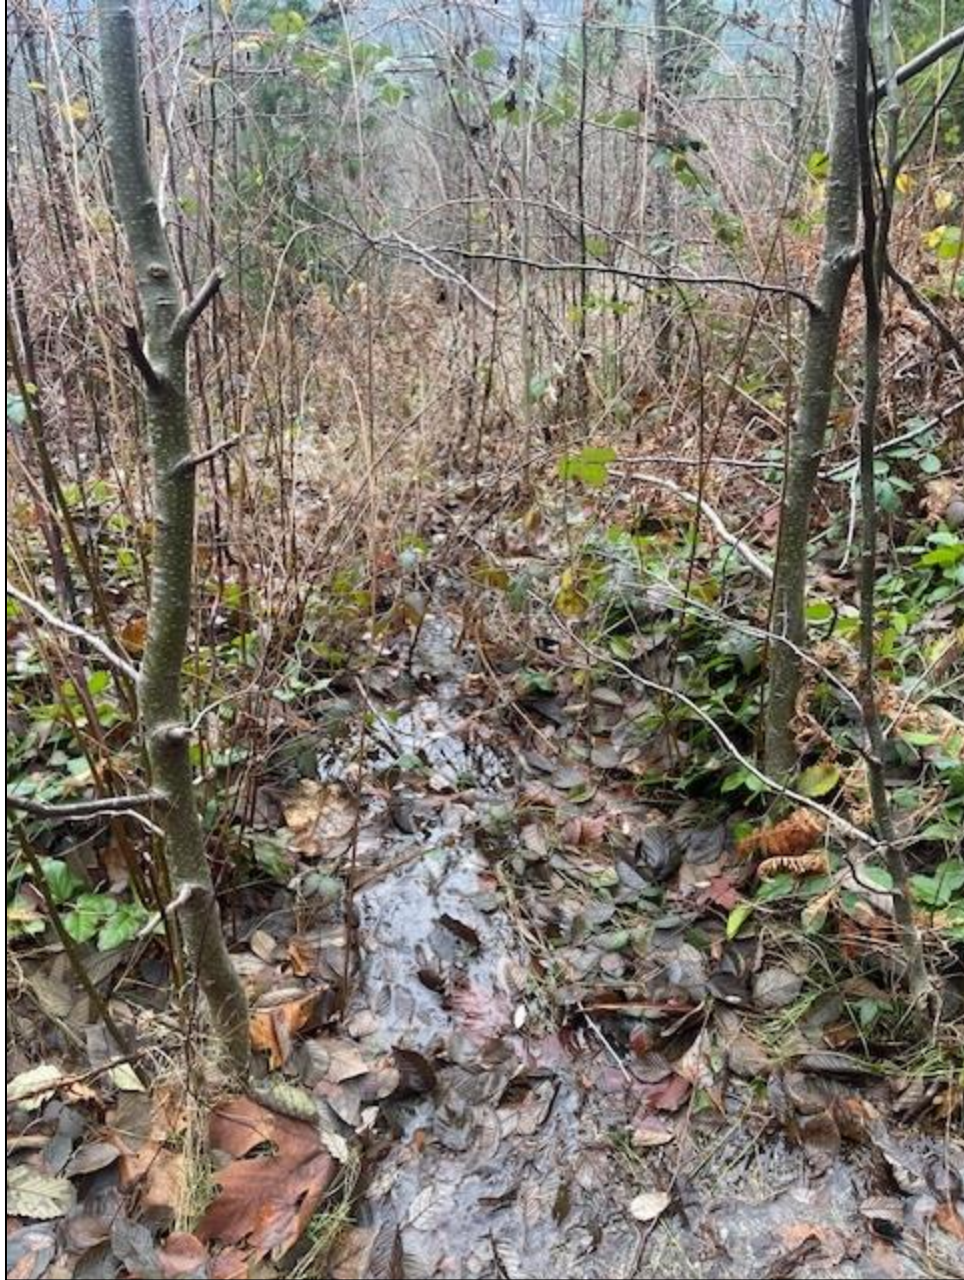
Photo 11: Transient stream along at upper access road extensions (December 13, 2023)

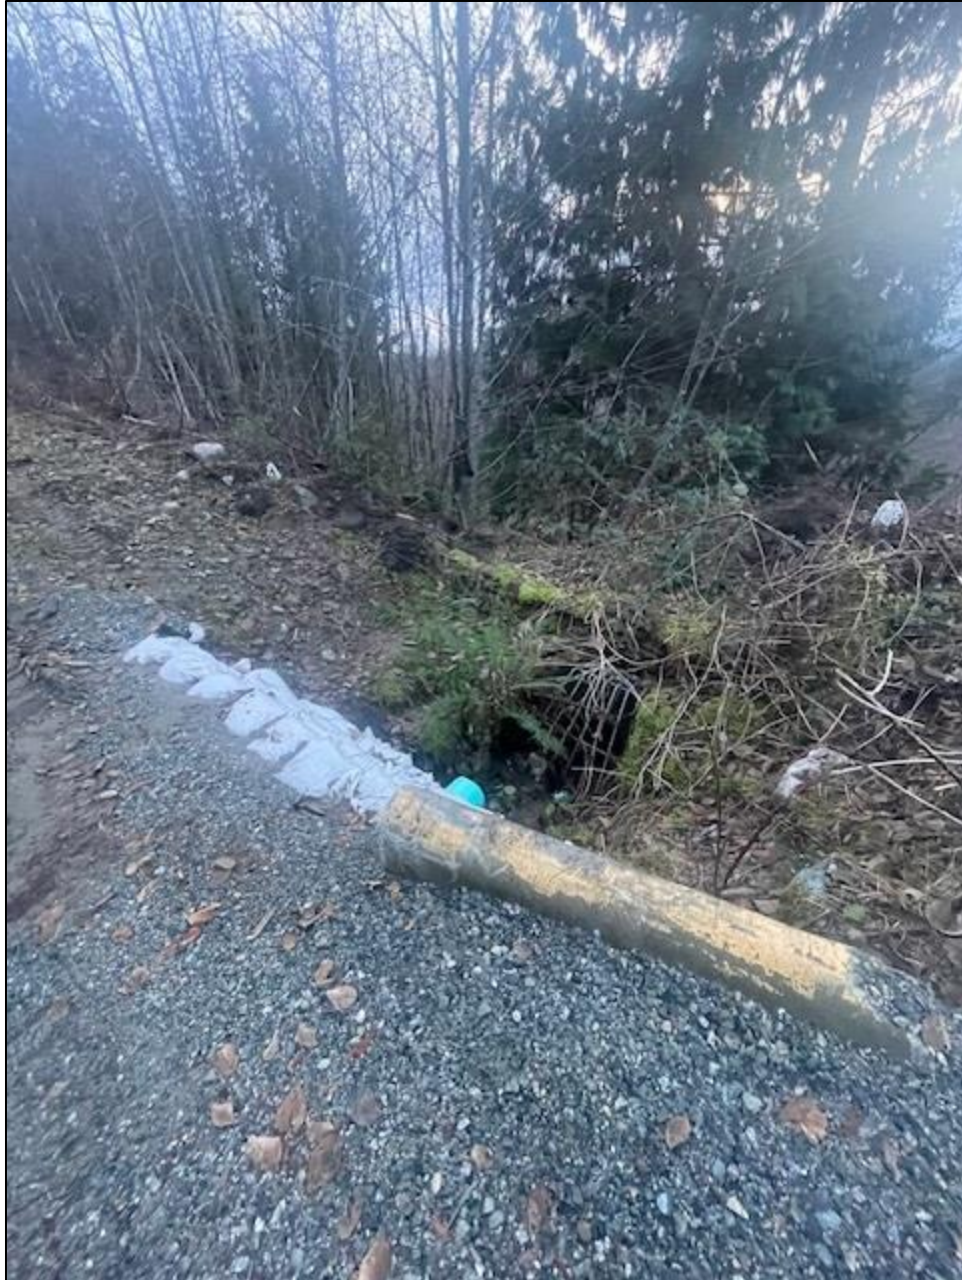
Photo 20: Minor Drainage System #2, stormwater drainage pipe intake at west side of North Charlotte Drive extension (December 13, 2023)
