2017 ANNUAL WATER QUALITY REPORT

Public Works Department
Village of Anmore
Prepared by: Luke Guerin, Operations Superintendent

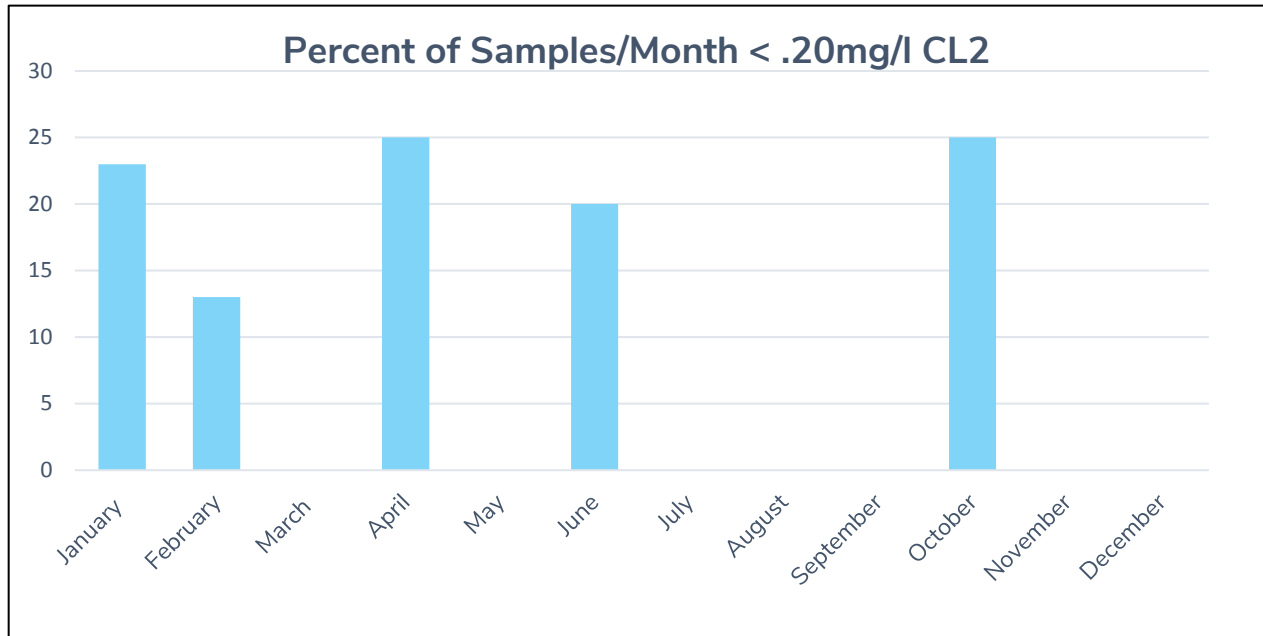
Figure #4: Percentage of Samples / Month with < 0.20 mg/l Free Chlorine

Tables #11, #12 and Figure #4 provide a summary of the number of samples collected from each sample station that were found to have free chlorine concentrations less than 0.20 mg/l. A map of all water quality sample collection points regularly sampled by the Village can be found in Appendix #4.

Free residual chlorine concentrations in water received by the Village from Port Moody generally varies and is not at concentrations high enough to provide adequate disinfection throughout the Village. Reduced concentrations of disinfectant have historically been a challenge for the Village's water system. Prior to the commissioning of the permanent Chlorine Booster Station in December of 2013, Anmore's Water System had little to no chlorine residual.
