2018 ANNUAL WATER QUALITY REPORT

Public Works Department
Village of Anmore
Prepared by: Luke Guerin, Operations Superintendent

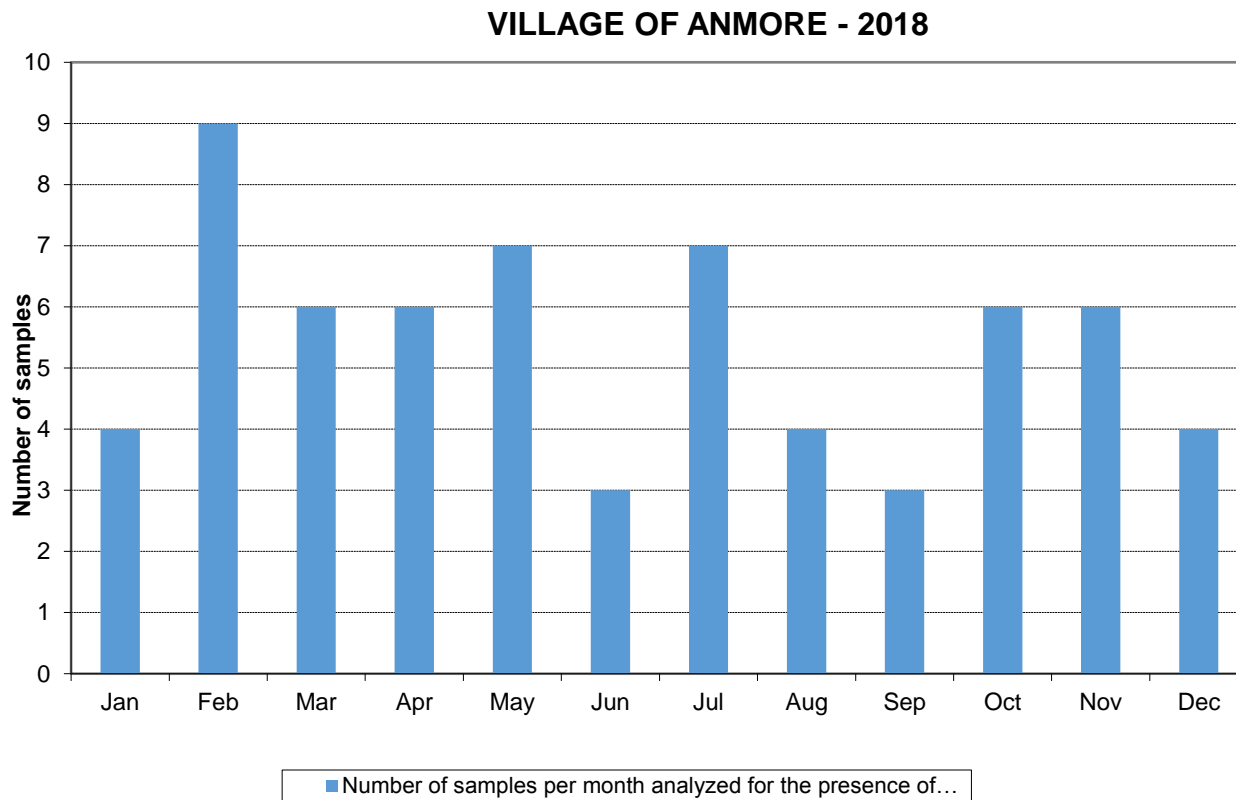
Figure #1: Number of Bacterial Samples Analyzed / Month

The quantity of bacterial samples collected from municipal water distribution systems is based on the population served. Under the BCDWPR the Village is required to collect a minimum of 4 bacteriological samples from the water distribution system per month based on population (under 5000). Figures #1 and #2 display the number of bacteriological samples collected from the Village's water distribution system

and the percentage of samples collected that returned HPC results greater than 500 CFU/ml each month. It should be noted that the statistical analysis of a small number of samples per month is subject to skewing of results due to the limited number of samples. For example, if less than 10 samples were submitted in a month and one sample was positive, the percentage of samples containing coliforms would exceed the standard of 10%.

A complete record of 2018 bacteriological water quality sampling results can be found in Appendix #1. The Village of Anmore's results were all within regulatory limits for 2018.

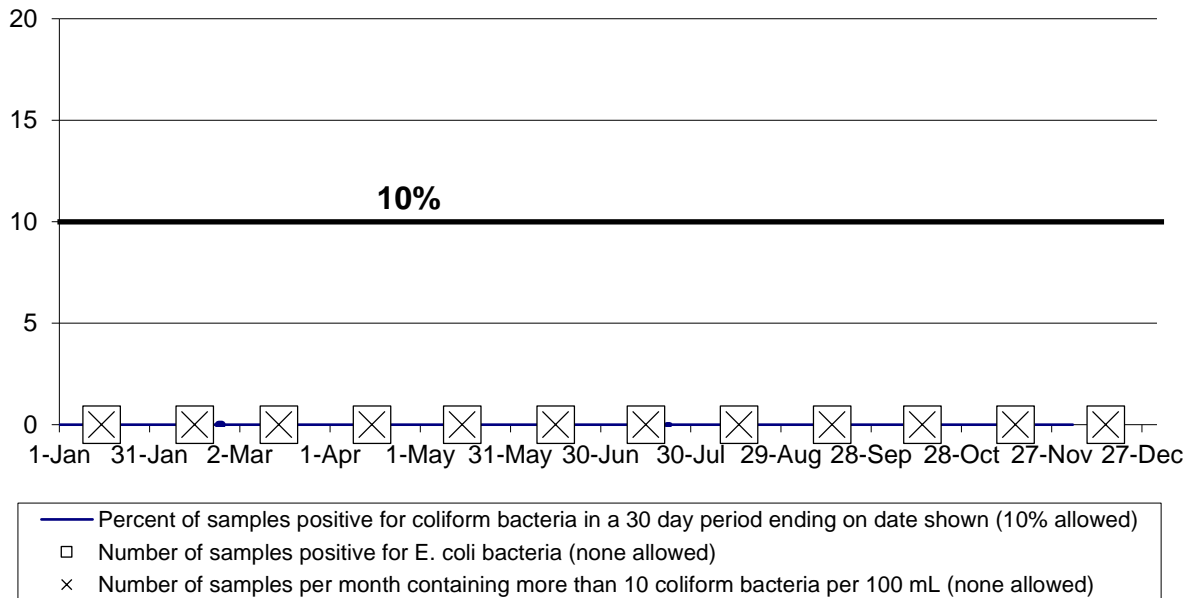
Figure #3: Results of Bacteriological Analysis of Potable Water Samples and Compliance with BCDWPR

VILLAGE OF ANMORE - 2018

Results of Bacteriological Analyses of Potable Water Samples Compliance With BC Drinking Water Protection Regulation
