ENVIRONMENTAL ASSESSMENT

Anmore Lands Environmental Assessment

AquaTerra Project No. 20221035

Date: 07 February 2024

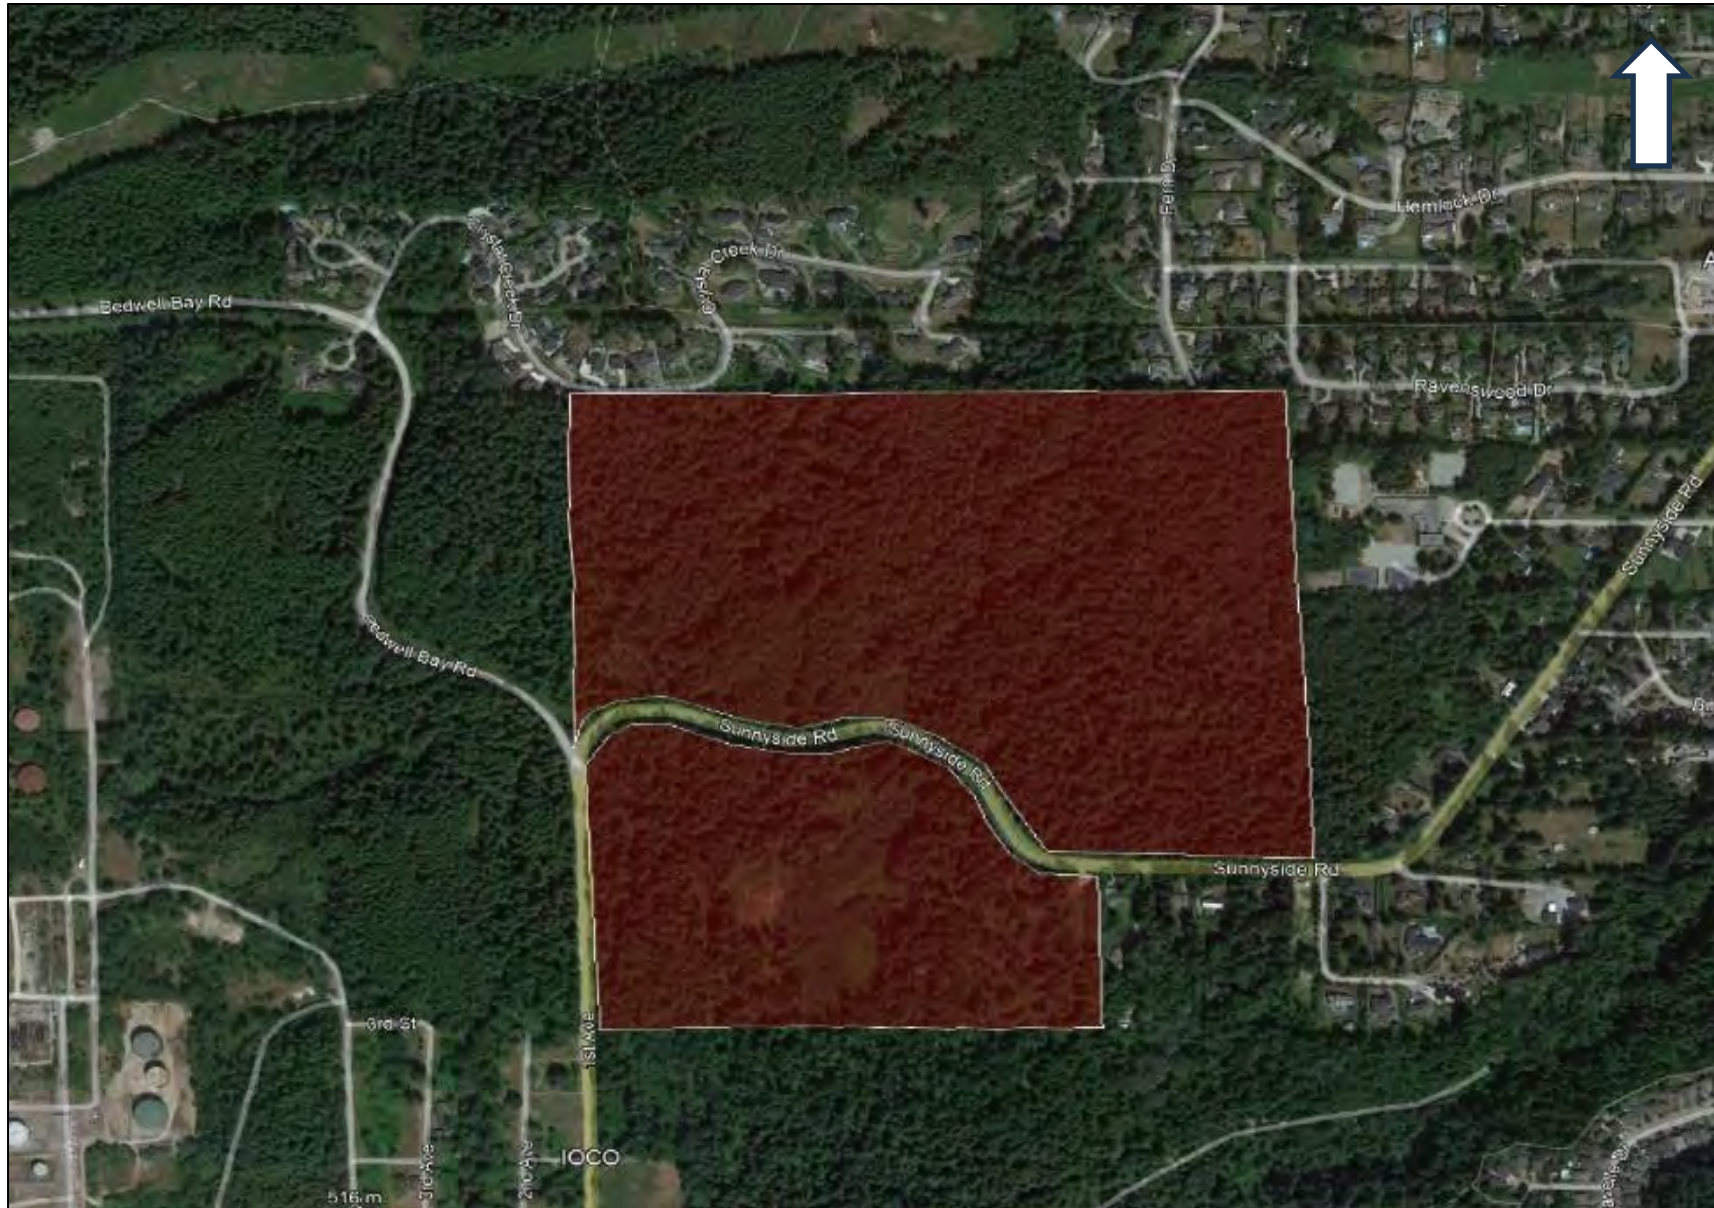
Figure 1. Icona Properties – Anmore Lands, approximate site boundary (Red Polygon) and surrounding area.

The Anmore Lands (the 'site'), as illustrated in **Figure 1**, consists of undeveloped areas situated to the north and south of Sunnyside Road within the Village of Anmore and is currently owned by Icona Properties ('Icona'; the 'client'). Icona retained AquaTerra Environmental Ltd. ('AquaTerra') to evaluate aquatic and terrestrial habitats, environmentally sensitive areas, unique habitat features, sensitive species, and to evaluate potential development opportunities and constraints associated with the proposed preliminary development plan (**Figure 2**) for the site. Environmental assessments and monitoring have been on-going by AquaTerra personnel since 2014, as discussed in Section 2.

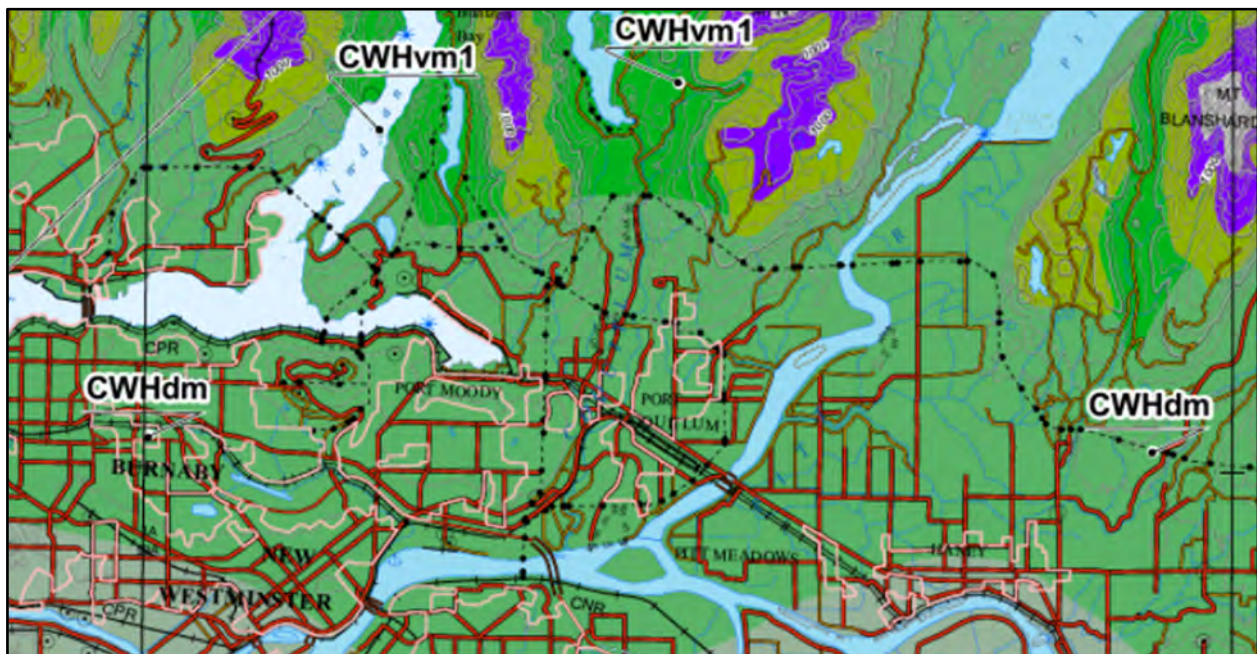
Figure 2. Biogeoclimatic Zone (CWHdm) for the Site and Surrounding Area.

The site is situated within the Coastal Western Hemlock (CWH) biogeoclimatic zone (**Figure 2**), which occurs at low to middle elevations mostly to the west of the coastal mountains, along the entire British Columbia Coast and on into both Alaska and Washington/Oregon. The CWH consists of 10 subcategories of continentality (hypermaritime, maritime, and submaritime subzones) and precipitation (very dry, dry, moist, wet, and very wet). Applicable to the site is the Coastal Western Hemlock Dry Maritime Subzone (CWHdm), occurring at low elevations on the mainland and immediately adjacent islands. Elevational limits range from sea level to approximately 650 m. The CWHdm has warm, relatively dry summers and moist, mild winters with little snowfall. Growing seasons are long and feature only minor water deficits on zonal sites. Mean annual temperature is approximately 8°C and ranges from 5.2 °C to 10.5 °C among the CHW subzones. The mean annual precipitation for the zone is 2228 mm (ranging from 1000 to 4400 mm) (MOF, 1991).

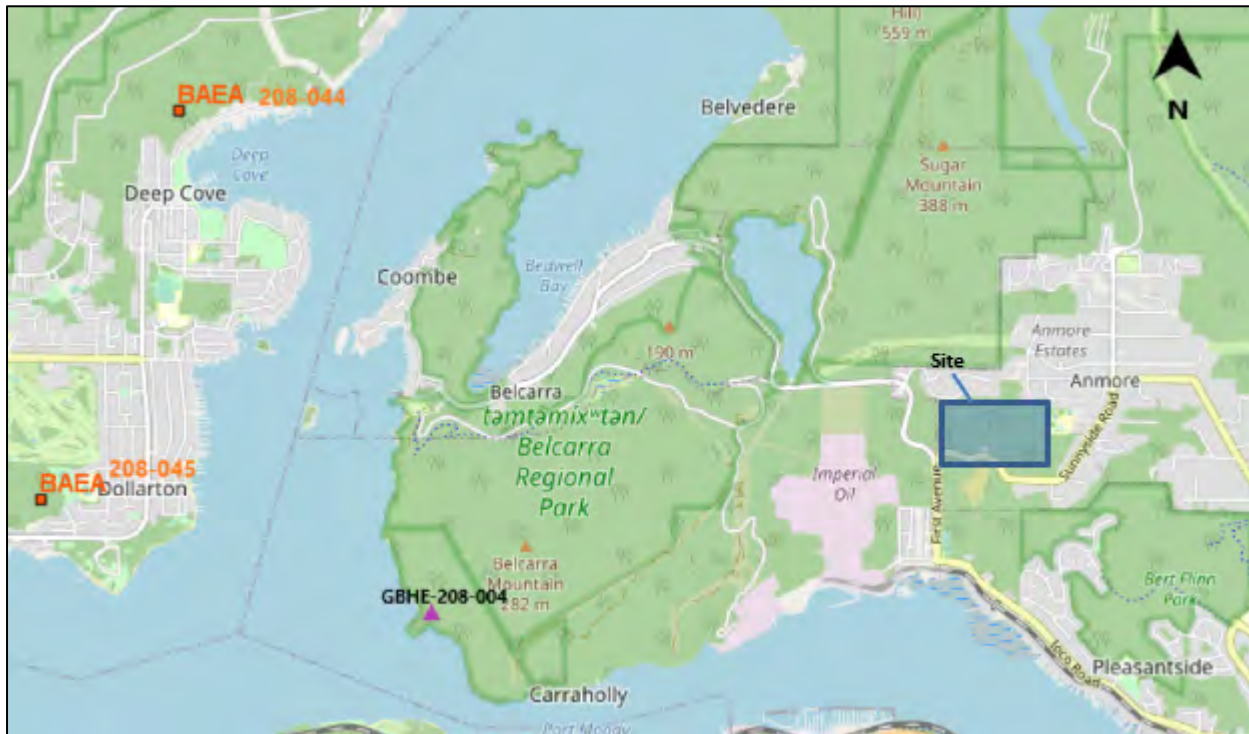
Figure 3. Map view of GBHE Management Team and Wildlife Tree Stewardship database results.

The review of the Great Blue Heron (GBHE) Management Team database and Wildlife Trees Stewardship (WiTs) database did not identify any existing or historic raptor or heron nests within the site boundaries. Two (2) Bald Eagle (*Haliaeetus leucocephalus*) nests and one (1) Great Blue Heron (*Ardea herodias fannini*) nesting locations were mapped within approximately seven (7) km from the site as illustrated in **Figure 3** and **Table 2**. The status of the identified colony is unknown.

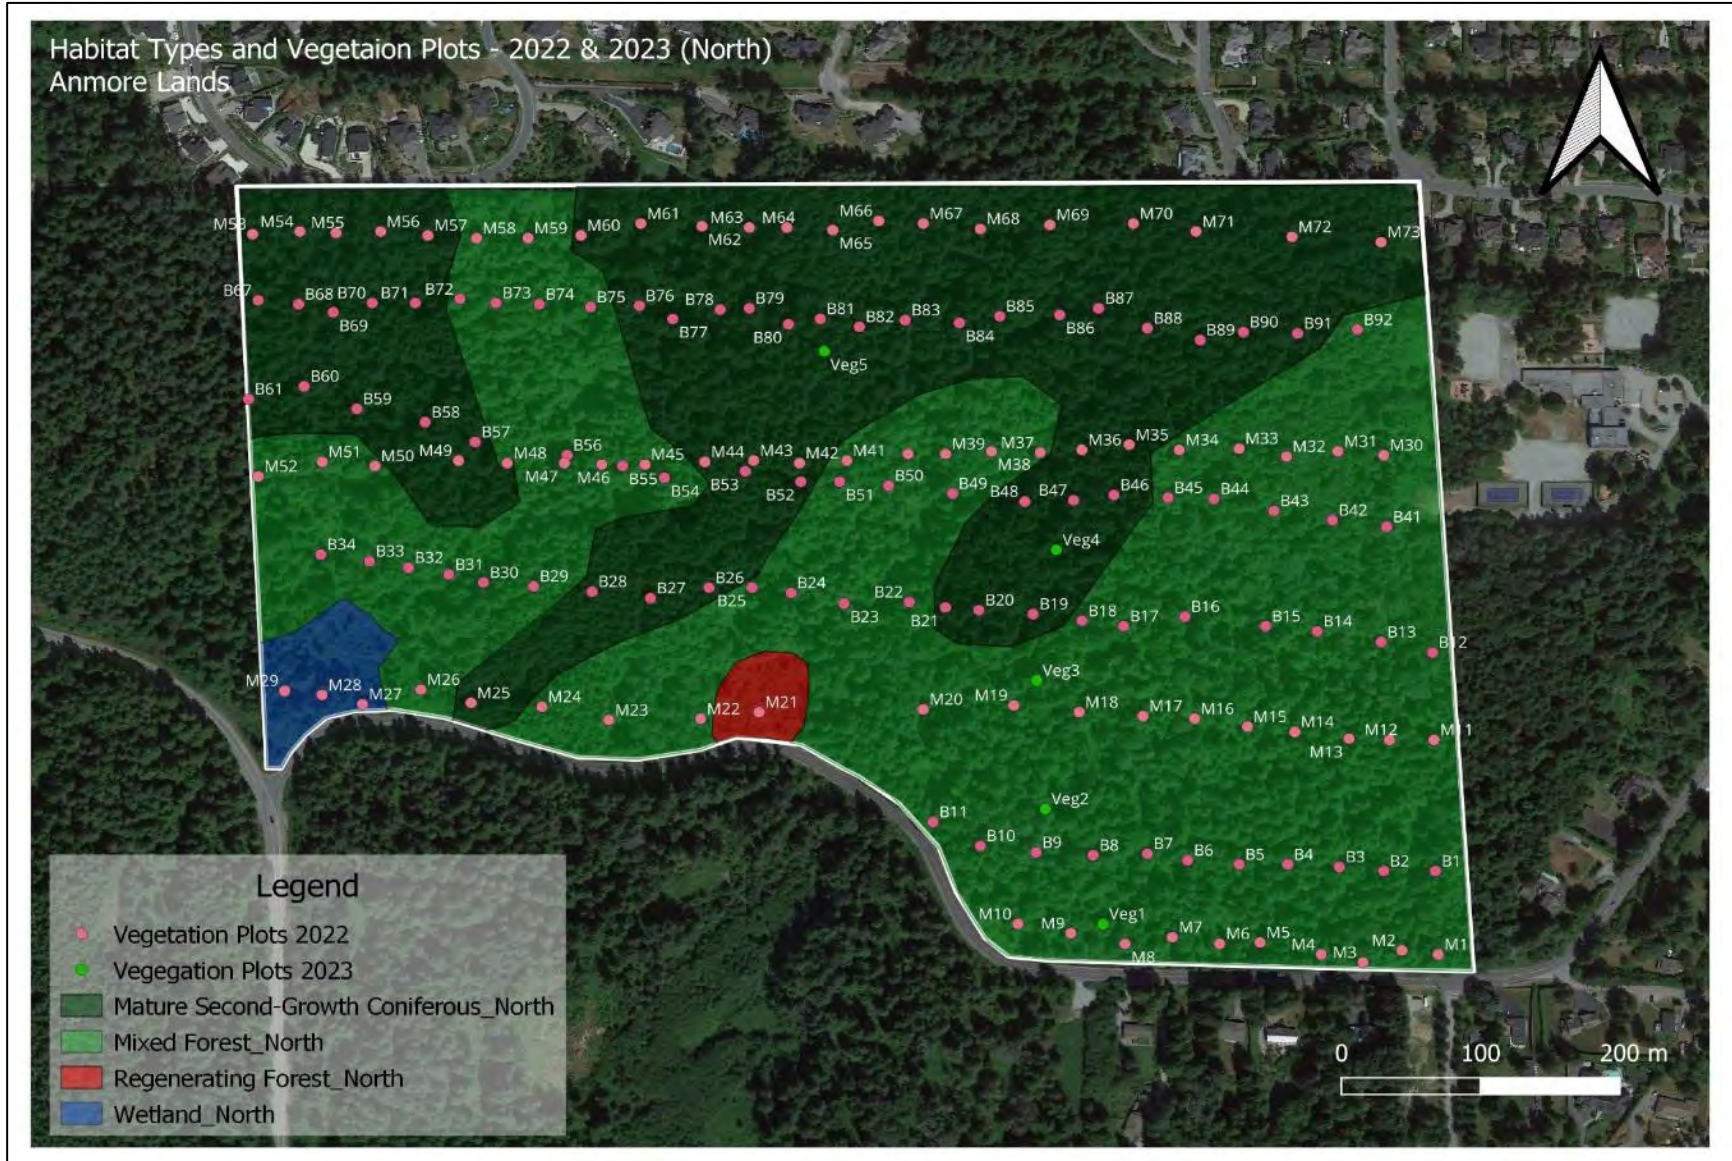
Figure 8. Mapped Habitat Types and Vegetation Plots north of Sunnyside Road (2022 & 2023).

Vegetation plots and various habitat types based on vegetation assessment details are illustrated in **Figure 8**, which is in general agreement with the preliminary habitat mapping completed by AquaTerra in 2014. An abundance of wildlife trees being actively utilized by wildlife and other potential wildlife trees were also documented. Unique terrestrial habitat features including wildlife trees, rocky outcroppings and encountered tributaries are provided in **Figure 9**.

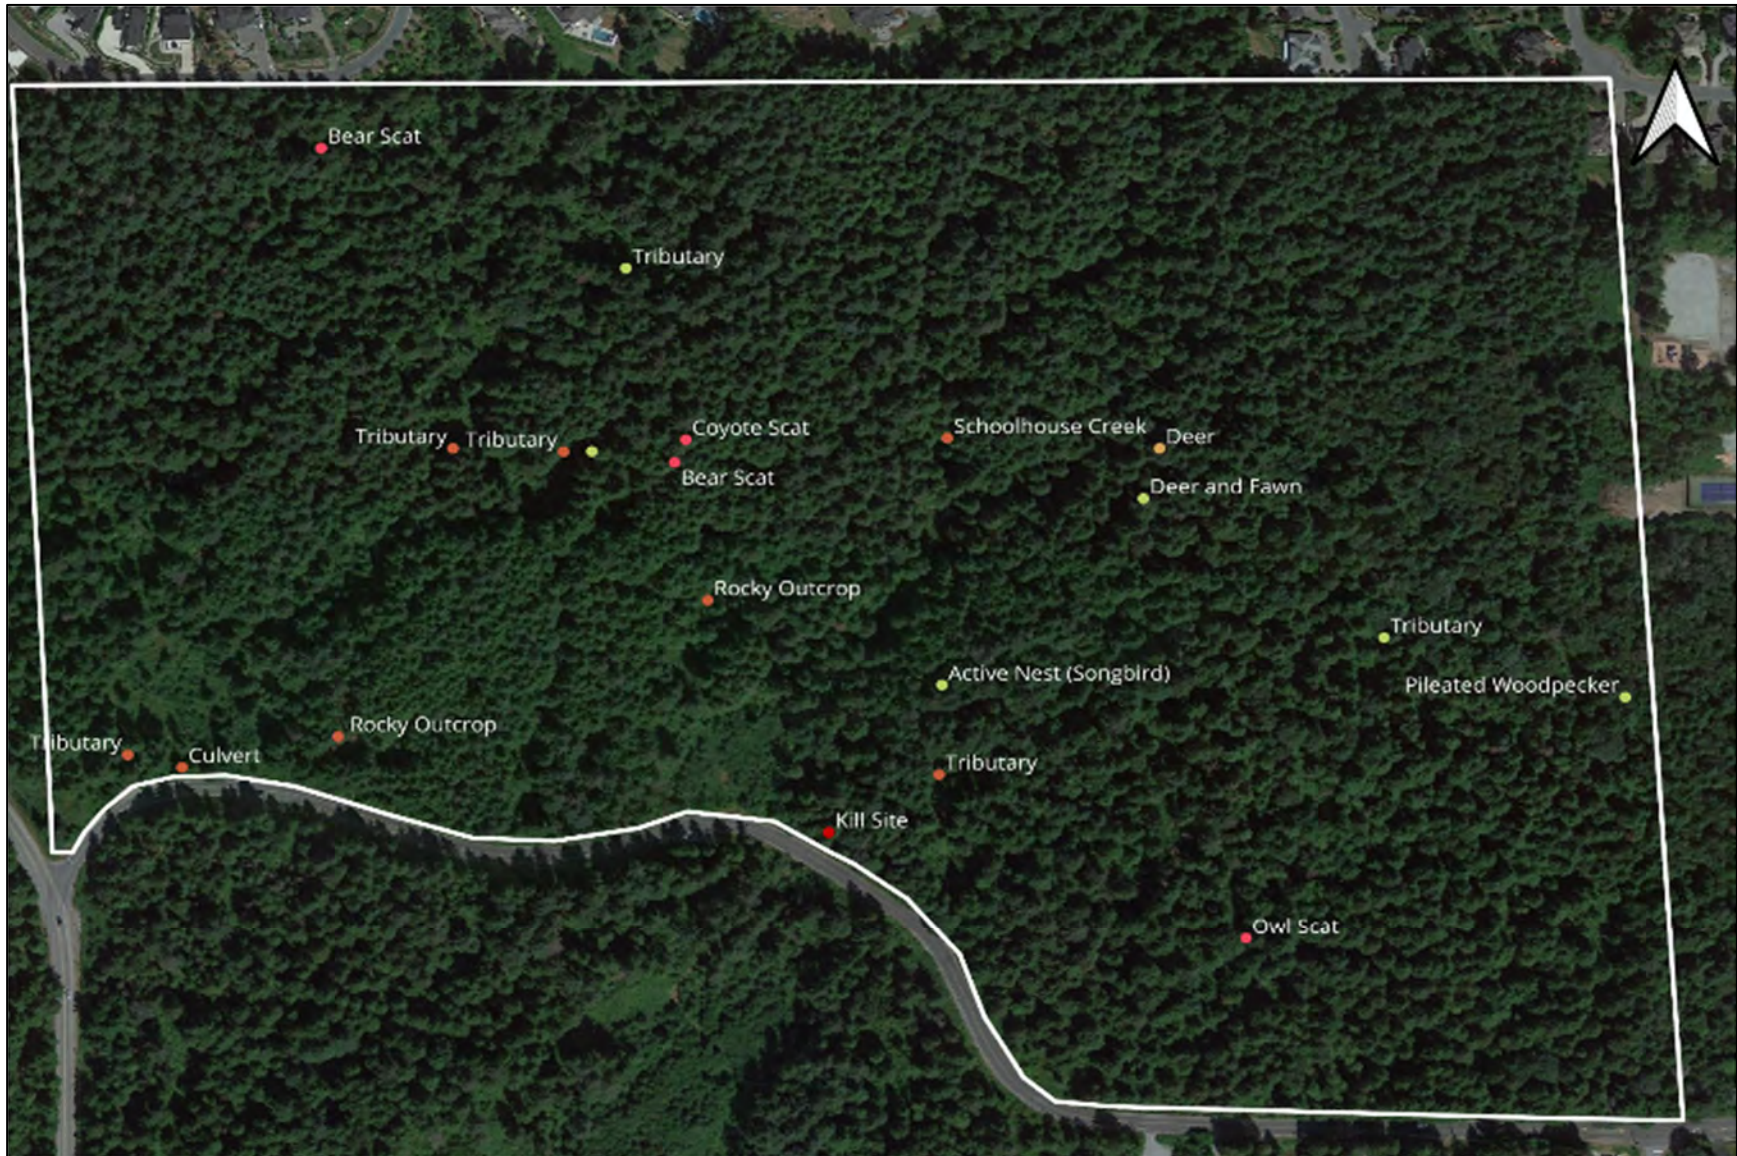
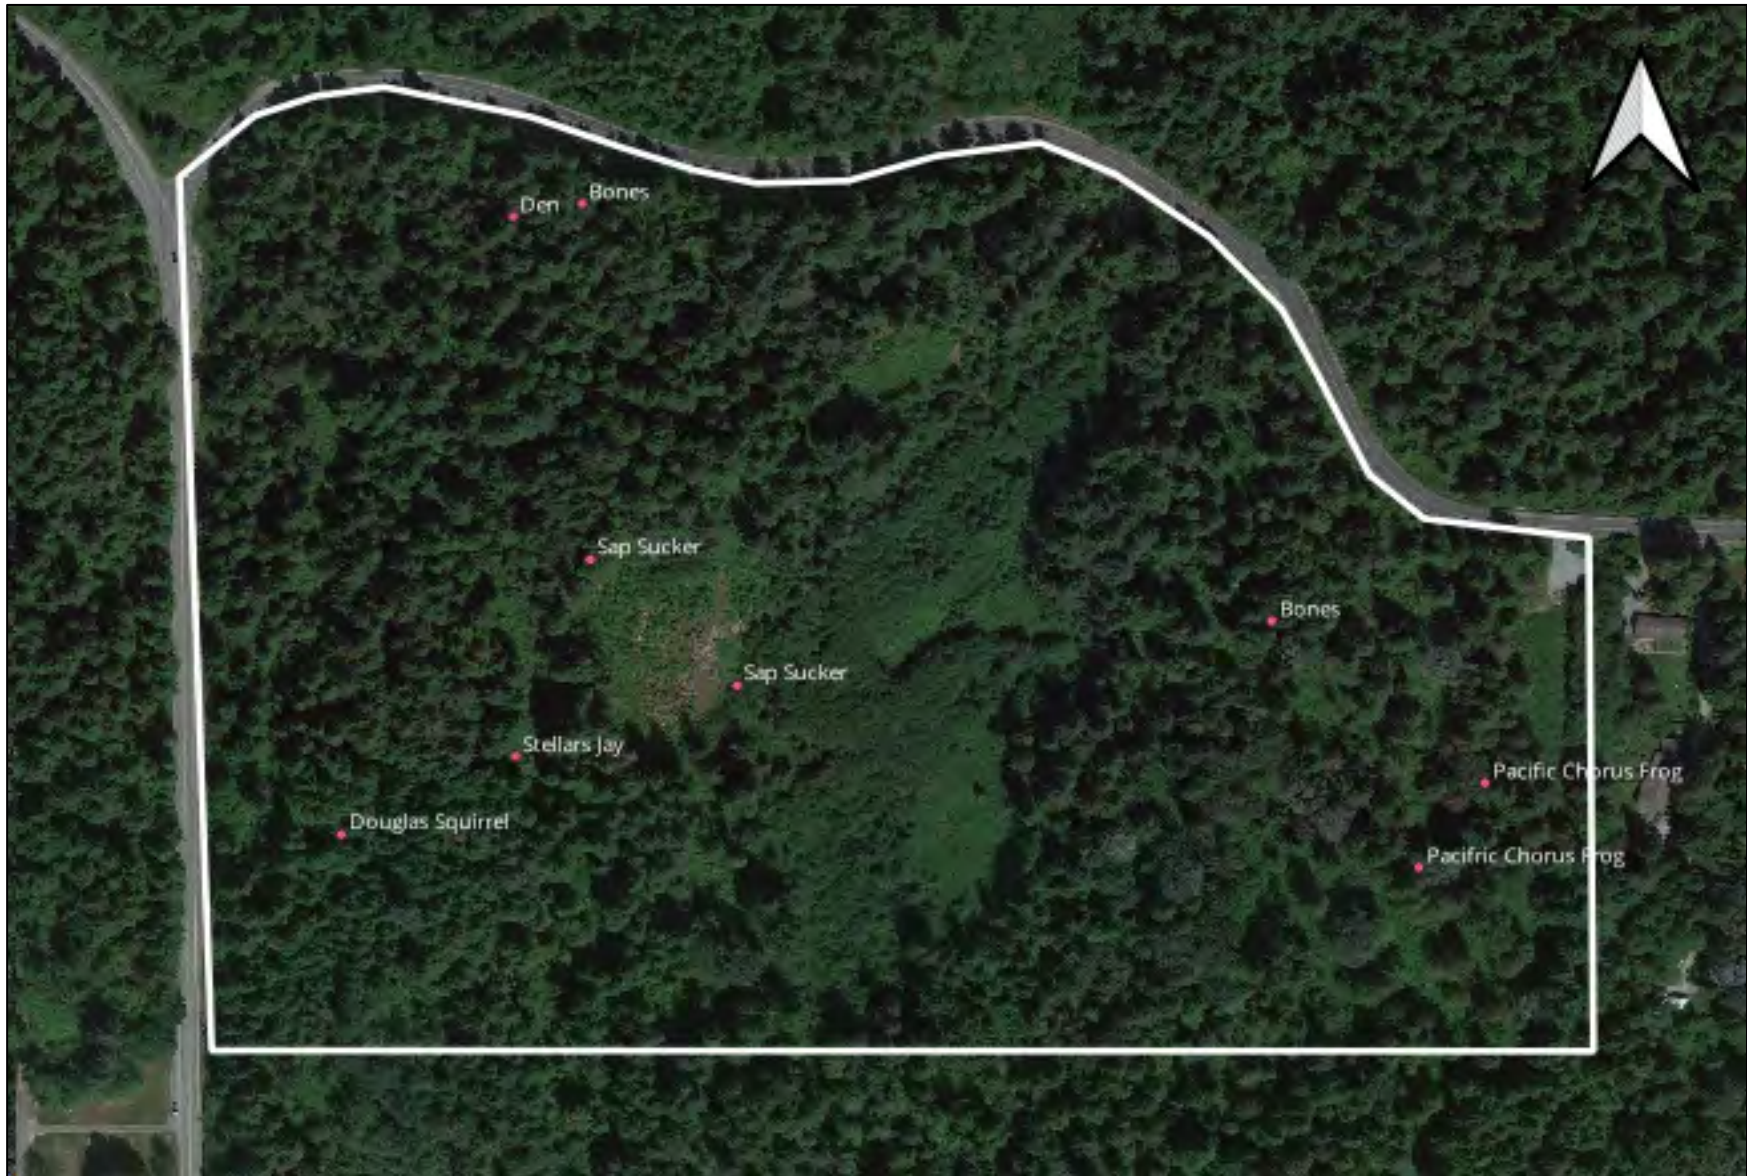
From 2014 to 2023, direct mammal observations were limited to the Douglas Squirrel (*Tamiasciurus douglasii*) and Black-tailed Deer (*Odocoileus hemionus* ssp. *columbianus*). Indirect mammal observations included Raccoon (*Procyon lotor*) scat and tracks, Coyote (*Canis latrans*) scat, Black-tailed Deer pellets, and tracks, and Black-bear (*Ursus americanus*) scat and tracks. Multiple kill sites with feathers and bones were observed indicating the presence of a carnivorous mammal(s). Observations are illustrated in **Figure 12 & Figure 13**.

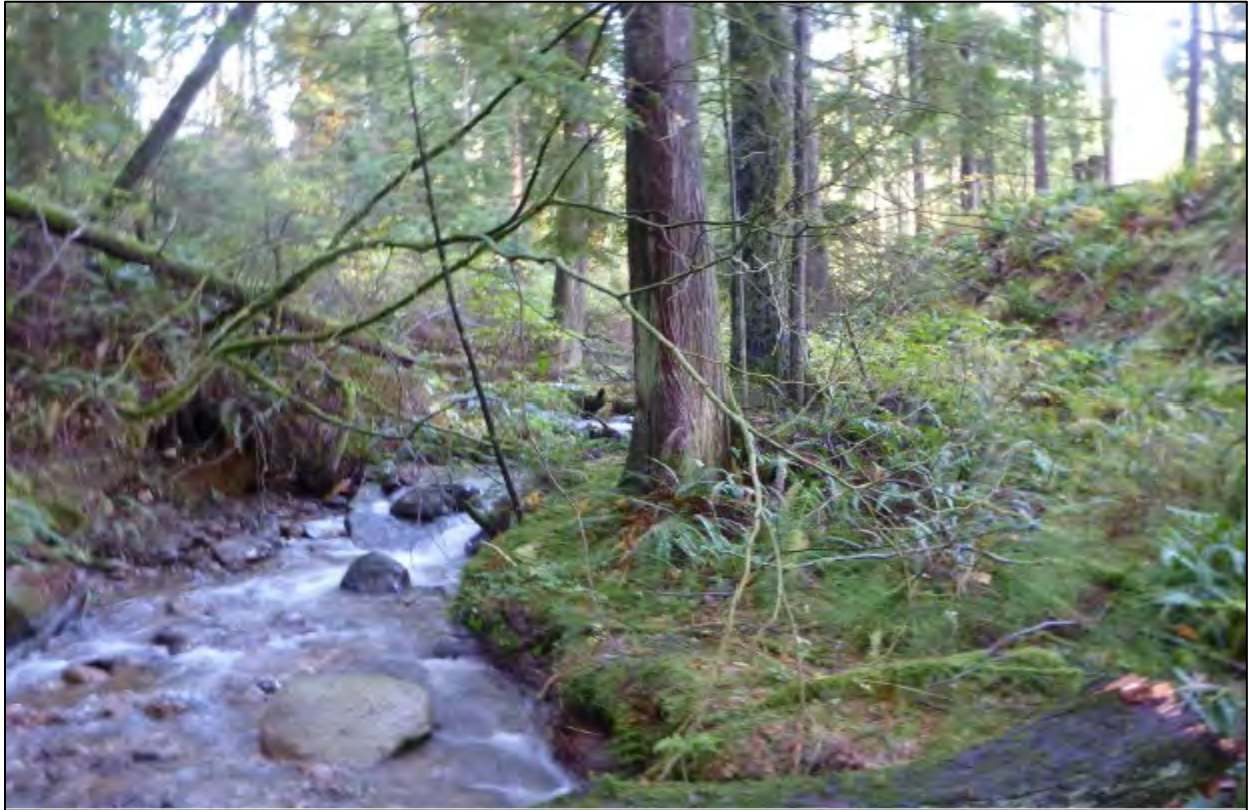
November 2014 – Middle reach of Schoolhouse Creek North of Sunnyside Road.

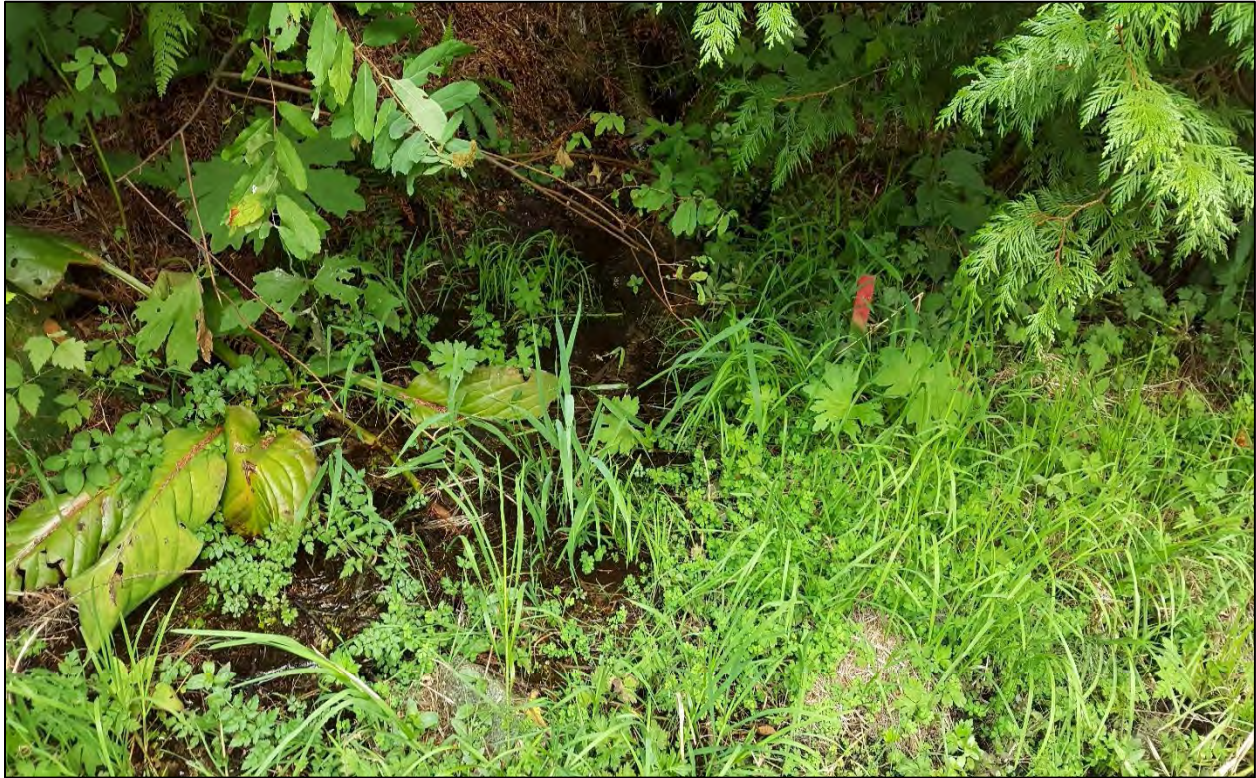
September 2017 – Lower reach of S-Trib 5-4 during low flow conditions.

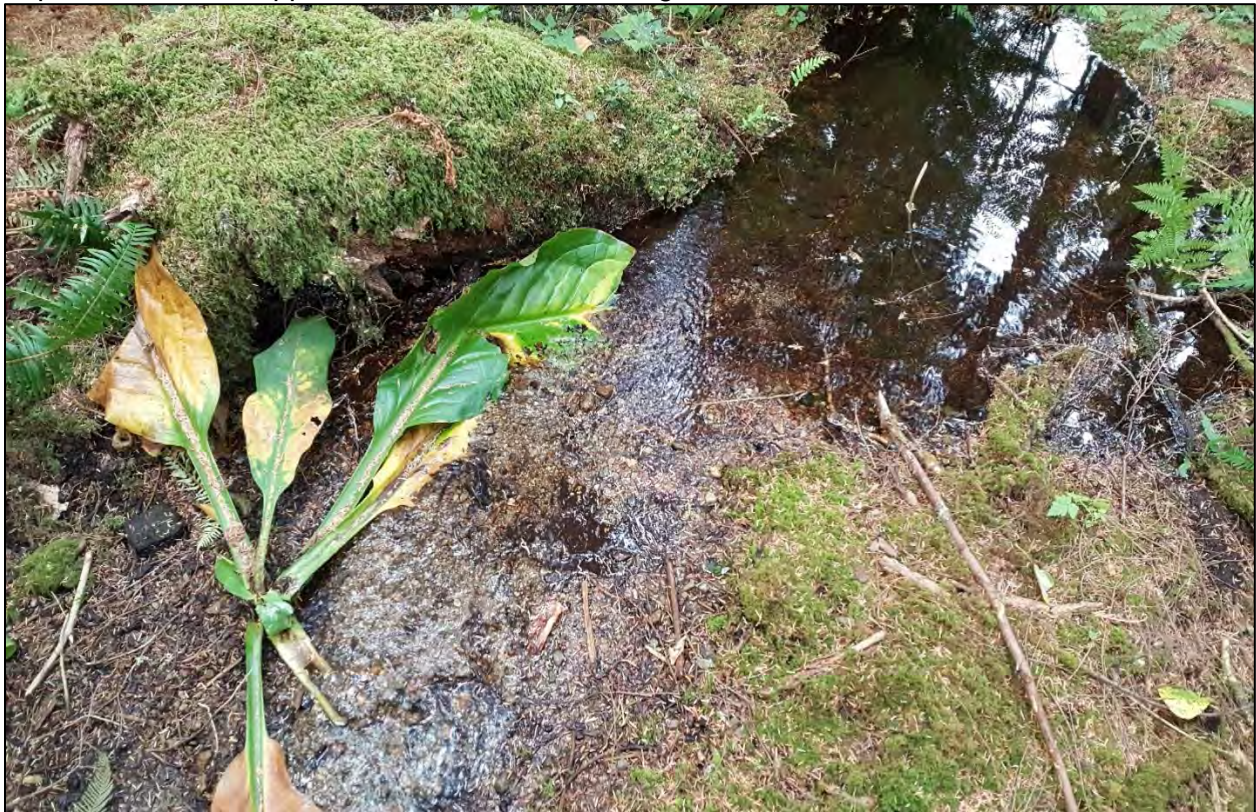
September 2017 – Upper reach of S-Trib 5-4 during low flow conditions.

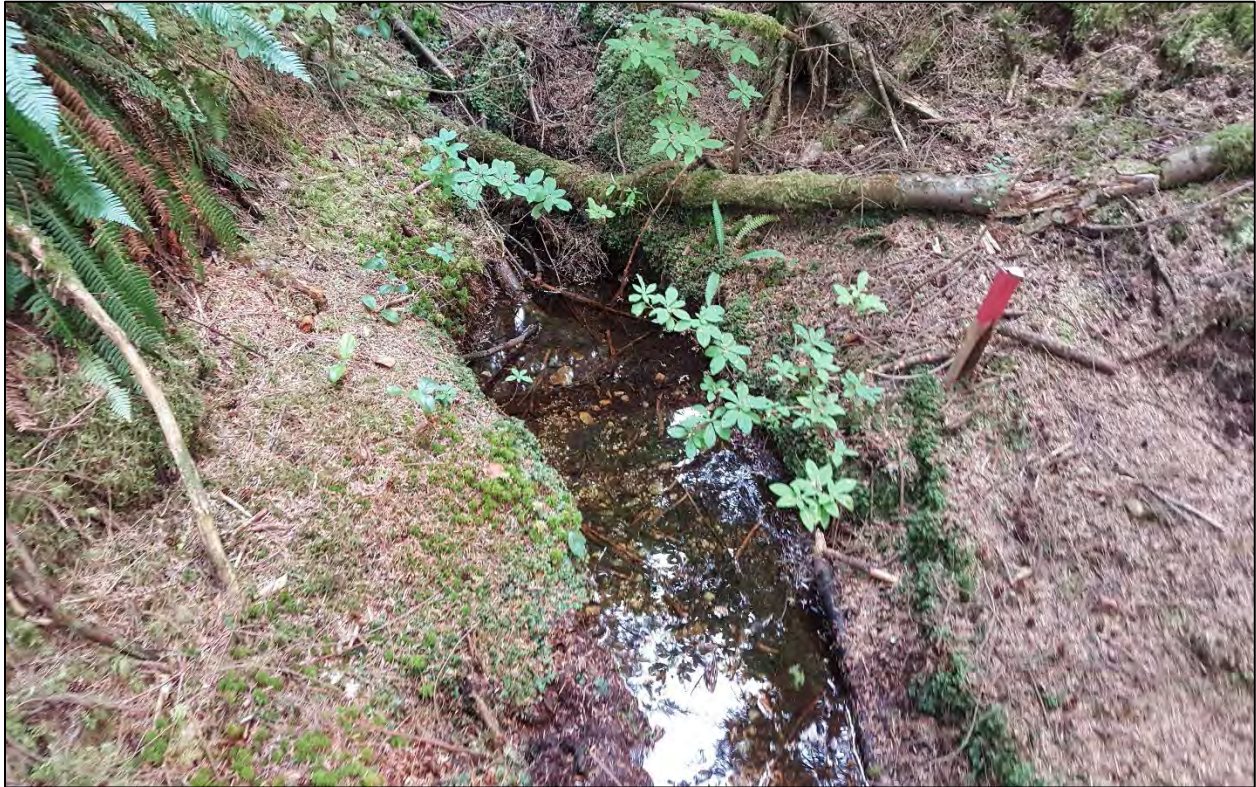
September 2017 – Upper reach of D-Trib 2 during low flow conditions.

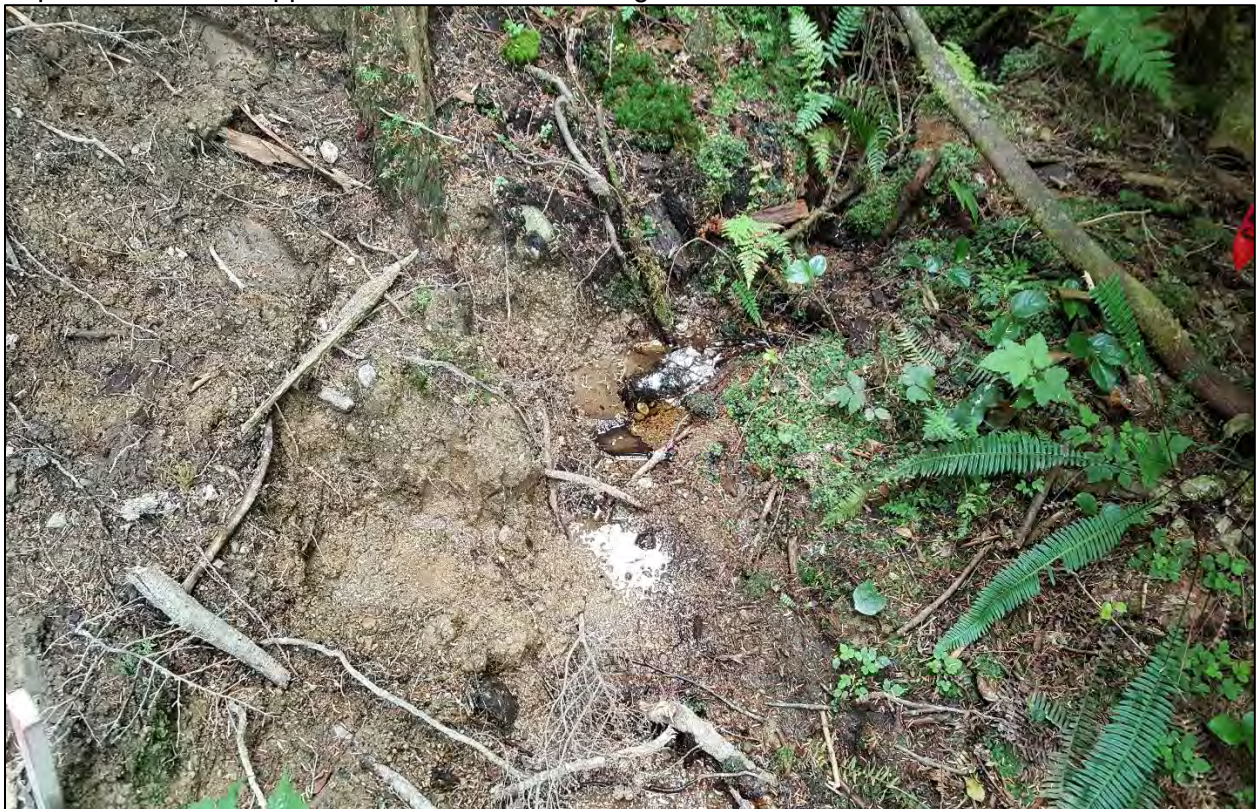
September 2017 – Upper reach of D-Trib 4 during low flow conditions.

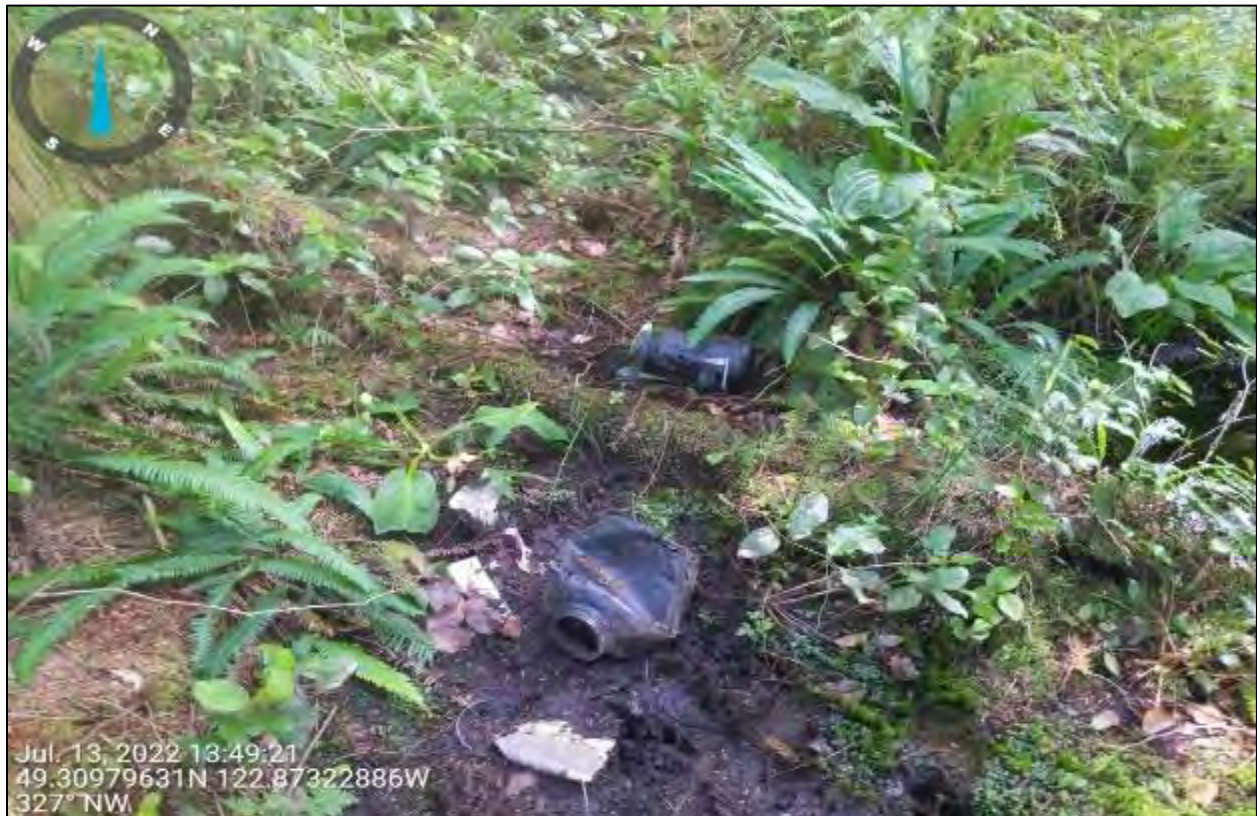
June 2022 - Wetland area on the southwestern corner of the site with high volume of garbage.
