# OVERVIEW ENVIRONMENTAL ASSESSMENT

Vacant Lots  
PIDs: 027-687-309, 002-811-626, and 028-856-589,  
Anmore, B.C.

Prepared for:  
Anmore Gate & Bella Terra Investments 2 Inc.

March 2024

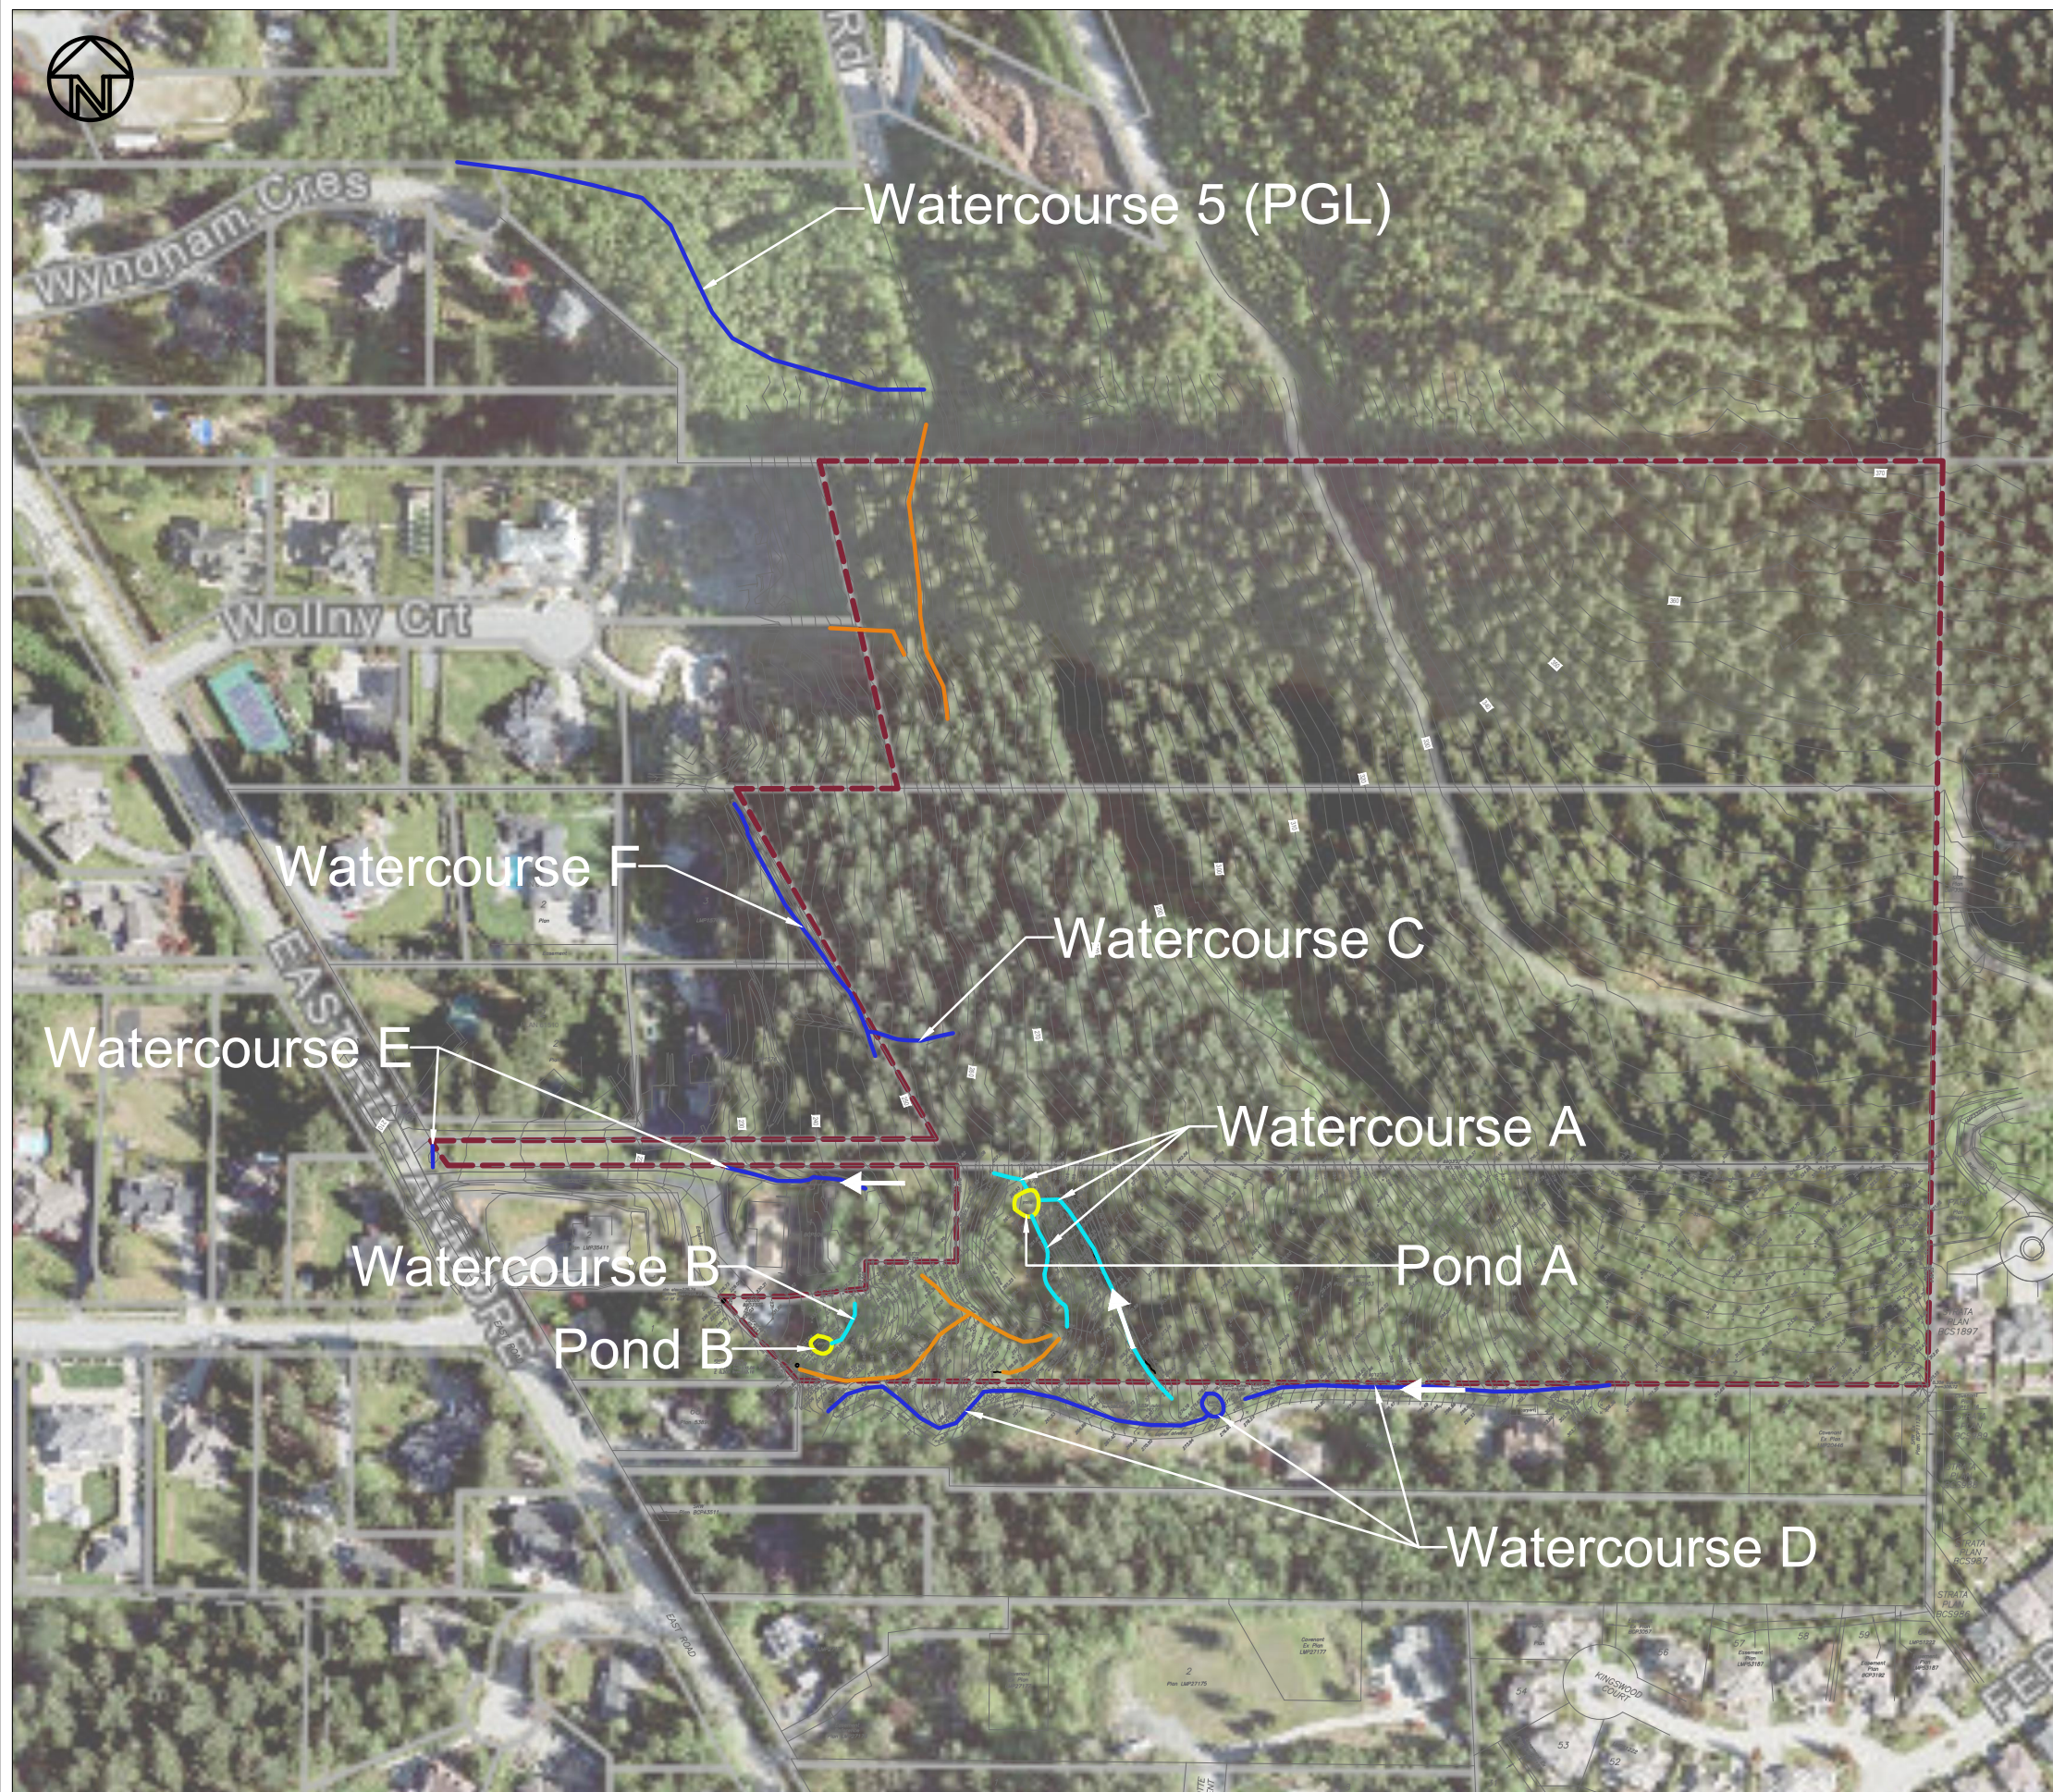
Refer to the Watercourse Location Map in Appendix A for details. Streams, channelized streams, and ditches regulated under the RAPR are shown in dark blue. Ditches coloured light blue on the Watercourse Location Map have been observed to be flowing during the field assessments but infiltrating and terminating to ground or draining to ponds that are unconnected and isolated. There are ditches coloured orange (Appendix A) that have been previously mapped on topographic surveys of the Site but have been observed to be dry during all field assessments.

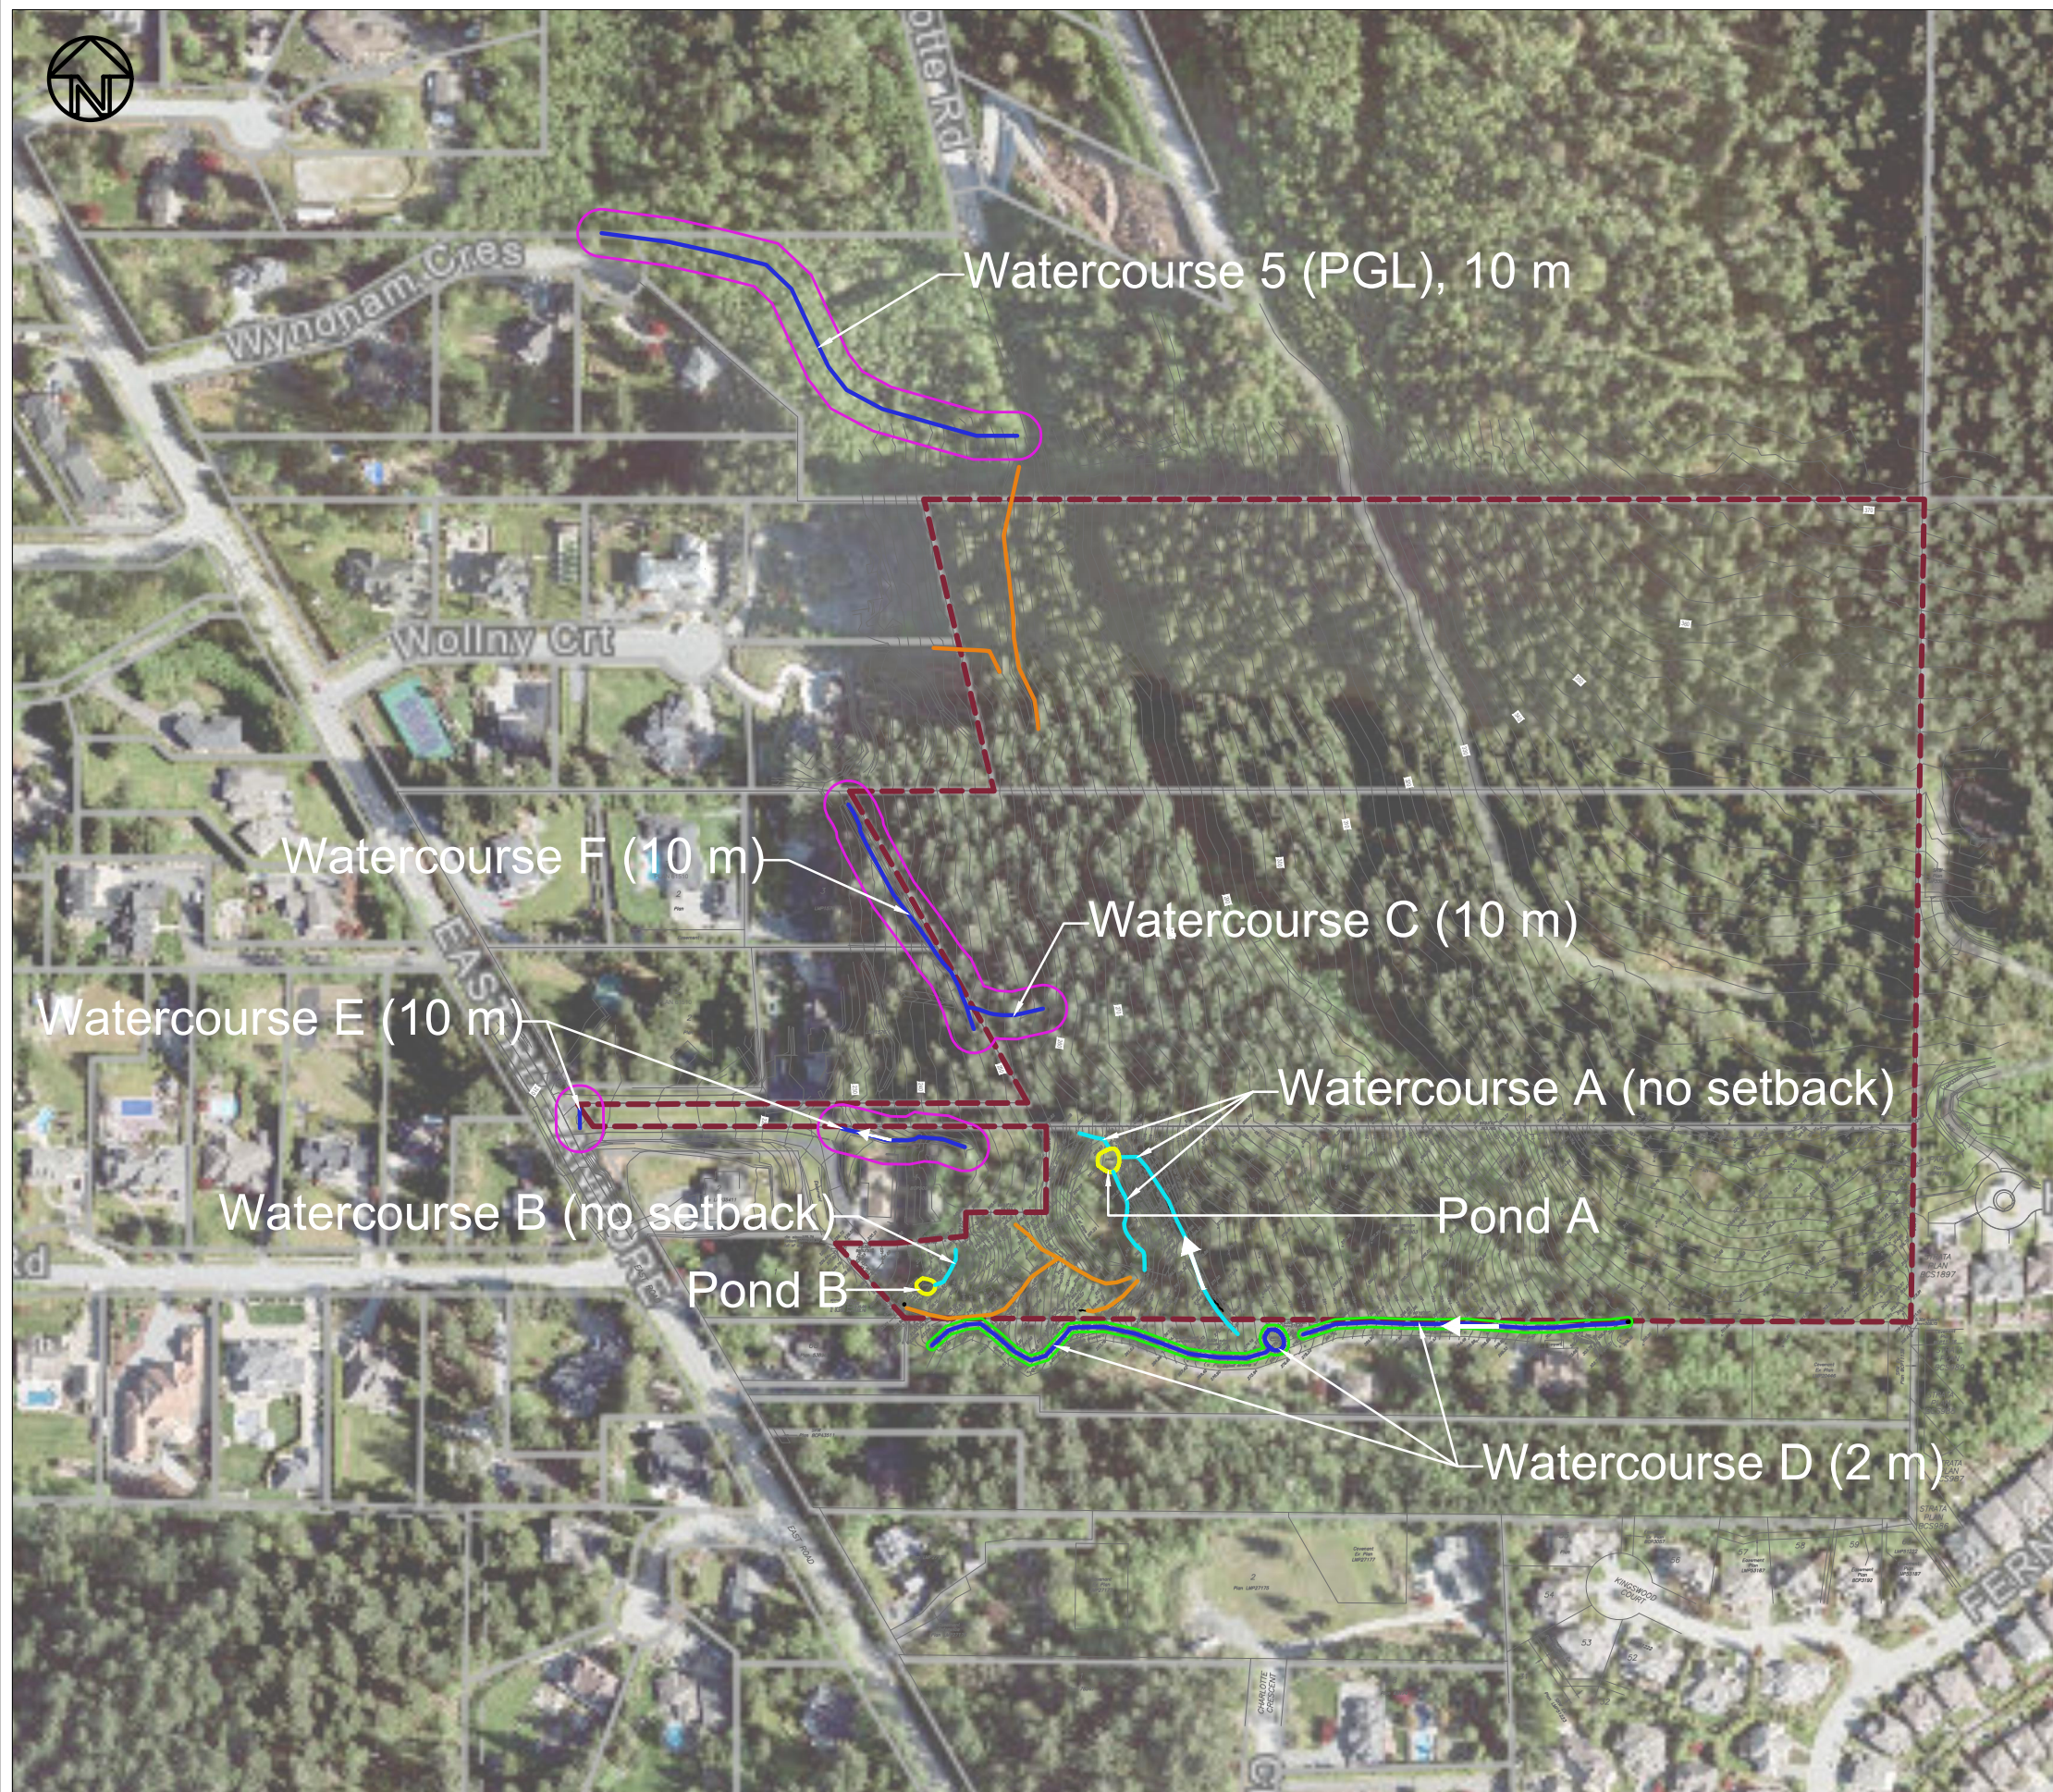
Streamsie Setback Map

There are three (3) watercourses and two (2) WSA Ponds within the Site. Watercourse A and Watercourse B are not RAPR streams and are not subject to RAPR streamside setbacks (SPEA). Watercourse C is a RAPR stream that is subject to a 10 m SPEA measured from the Stream Boundary; however, Watercourse C is only a few metres inside the western boundary of the Site. While being WSA ‘streams’ that require retention, or alternatively need to be replaced elsewhere, Pond A and Pond B are both isolated and unconnected to other streams and are not subject to SPEA under the RAPR.

The watercourses that are subject to streamside setbacks (SPEA) under the RAPR (see Appendix A) are to be protected from disturbance to the greatest extent possible in planning for future development at the Site. While not regulated under the RAPR, Pond A and Pond B are protected under the WSA as unconnected water resources and should be retained in place. There are no prescribed setbacks for these isolated ponds at the Site, but retention of a 30-m vegetated buffer for amphibian breeding and rearing purposes are recommended as per section 8.3 and discussed previously in this report.

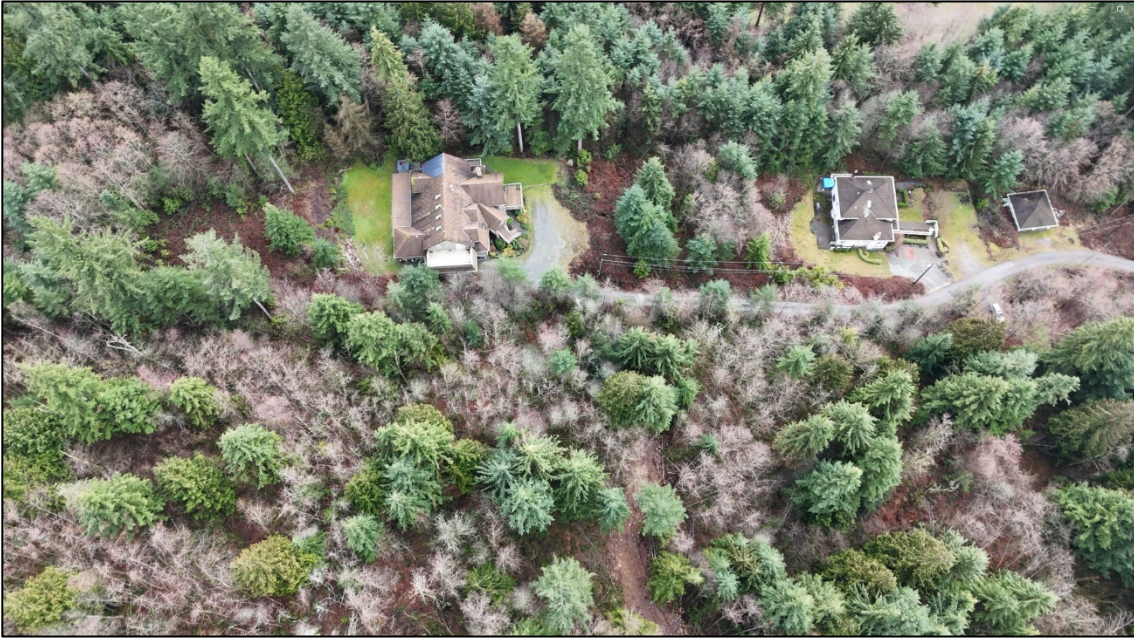
Photograph 1. Aerial drone image of the Regenerating Forest Vegetation Type (February 22, 2024).

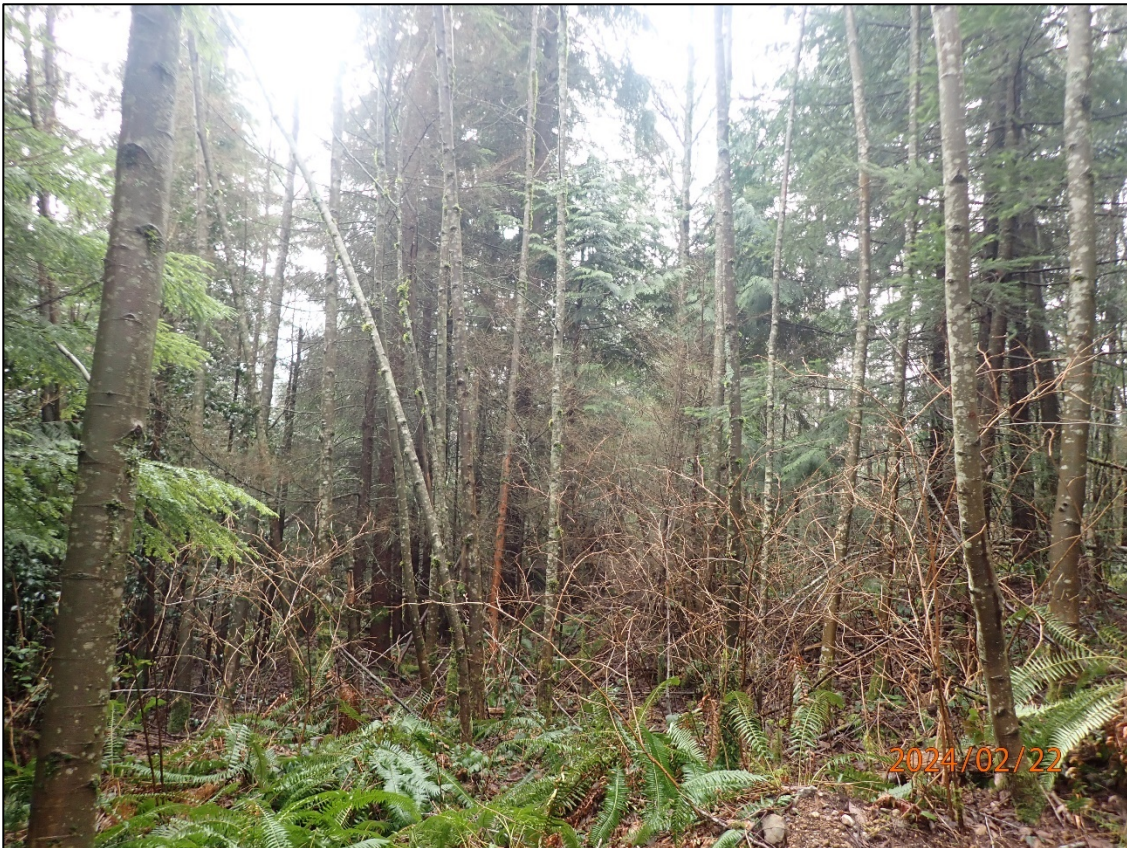
Photograph 2. Typical understory vegetation composition of the Regenerating Forest Vegetation Type (February 22, 2024).

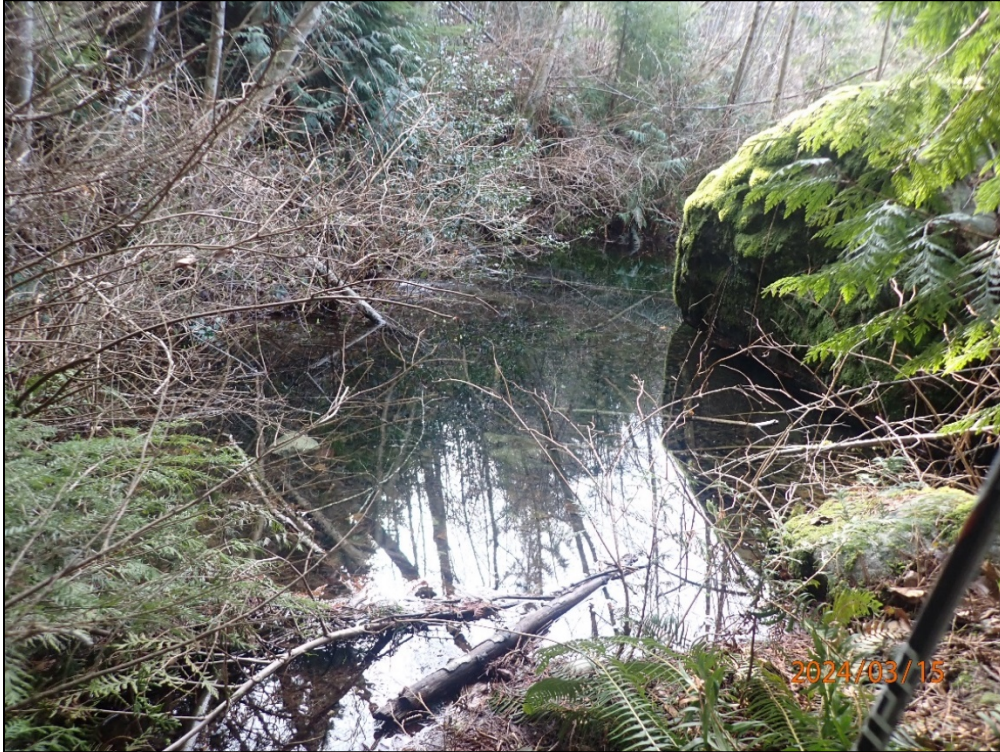
No Northern Red-legged Frogs were detected during the field survey. Northern Red-legged Frogs are generally not active in the winter which limits their detection. Two suitable breeding ponds were observed in the RFVT (Appendix A; Figure 2, Appendix B; Photographs 3 and 4). The forested portions of the RFVT and MFVT provided suitable general living habitat for Northern Red-legged Frog and many other amphibian species. No BCCDC records occurred within 2 km of the study area.

Western Toads are expected to occur throughout the forested habitats within the study area. Two suitable breeding ponds were observed in the RFVT (Appendix A; Figure 2: Appendix B; Photographs 3 and 4).

Photograph 3. A man-made pond detected near the northwest corner of the RFVT (March 15, 2024).

The amphibian best management practices (BMP) recommends minimum 30 m setbacks for all Western Toad and Northern Red-legged Frog breeding habitats (Develop with Care Factsheet 2014).

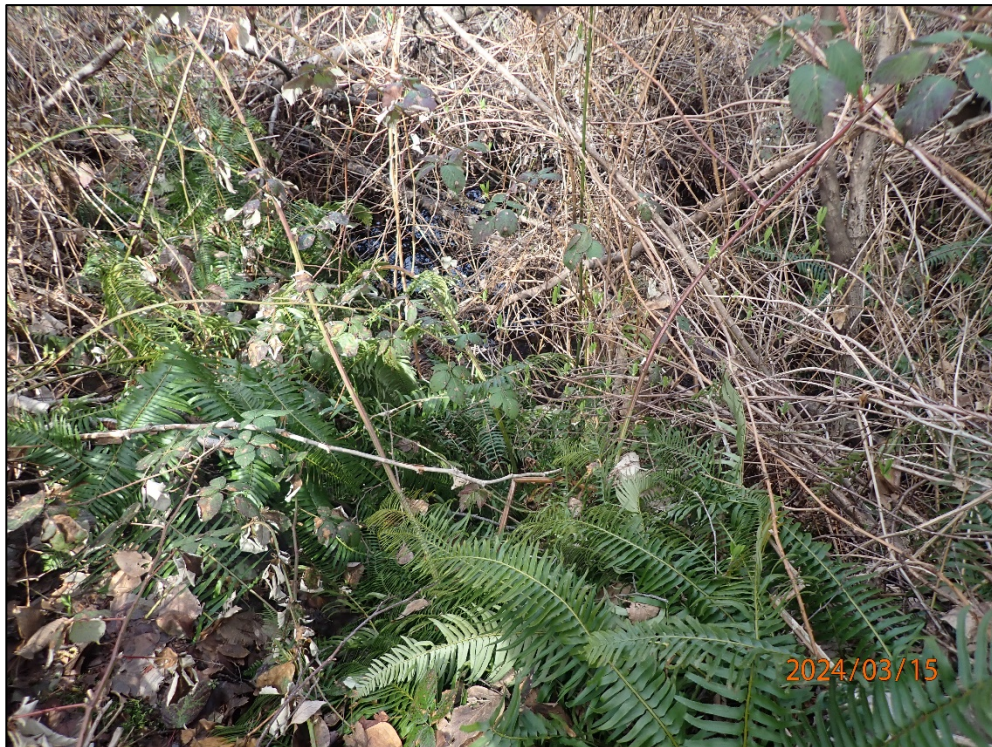
Photograph 4. A man-made pond surrounded by dense shrub vegetation detected near the southwest corner of the RFVT (March 15, 2024).

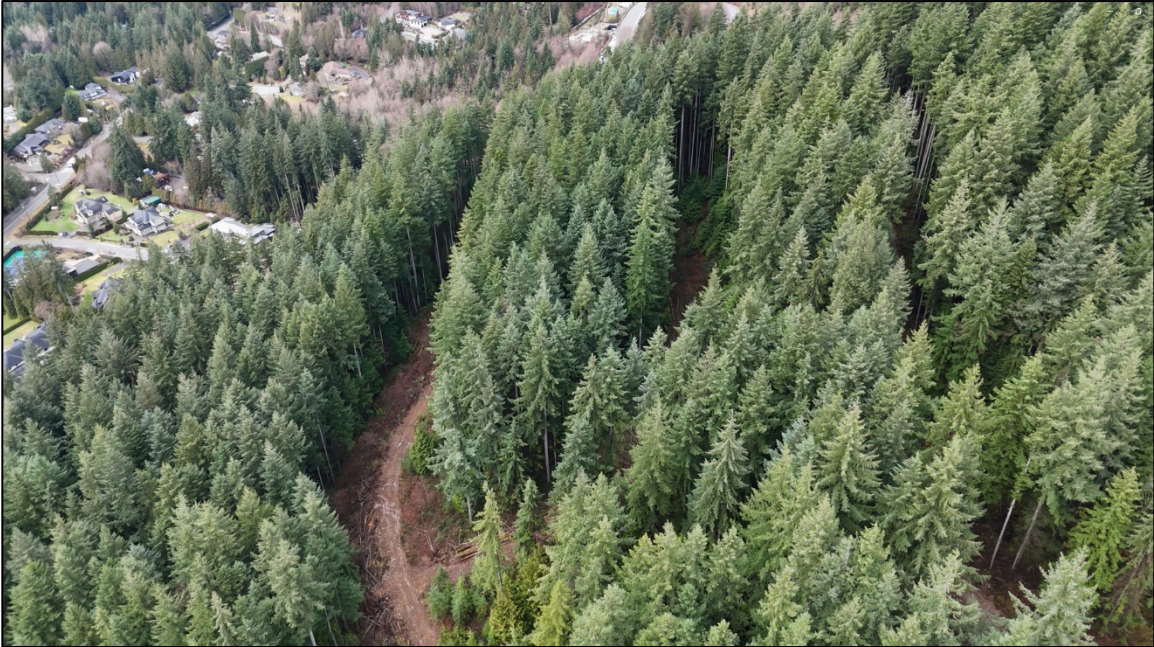
Photograph 5. Aerial drone image of the Mature Forest Vegetation Type (February 22, 2024).

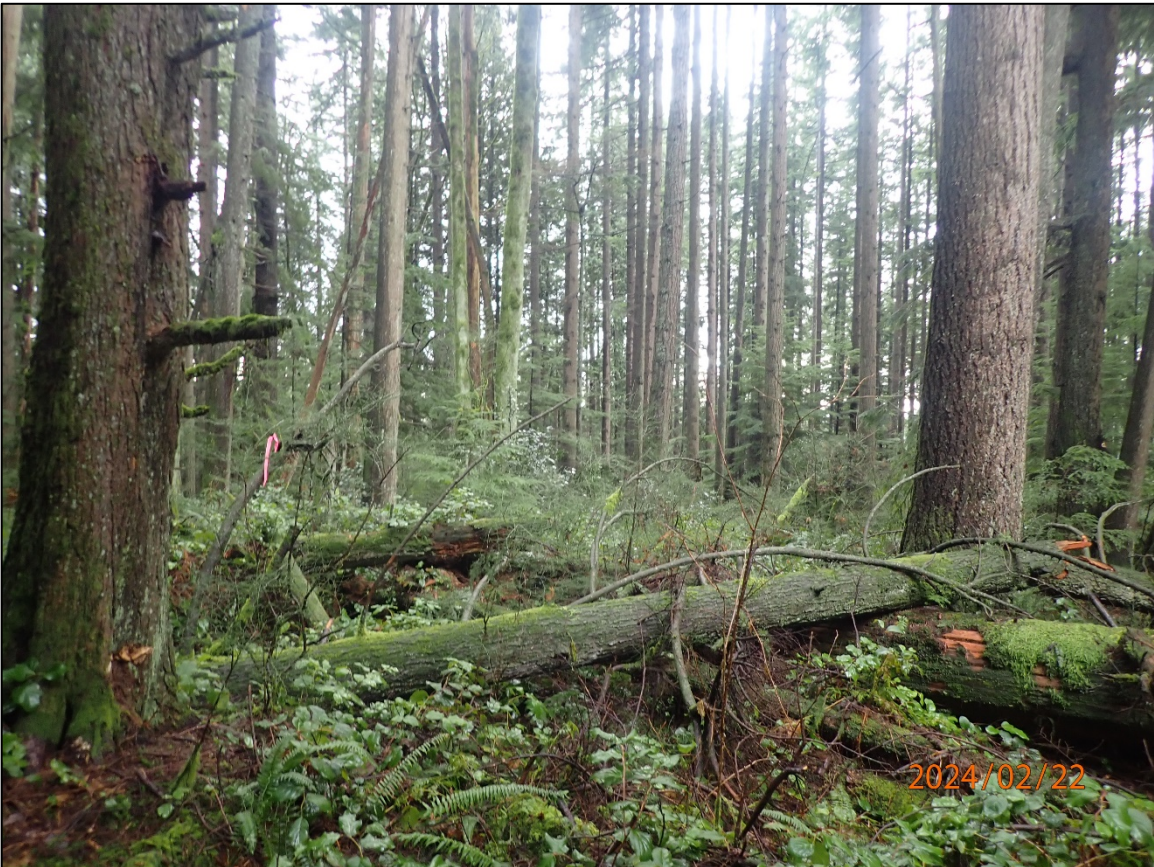
Photograph 6. Typical understory vegetation composition of the Mature Forest Vegetation Type (February 22, 2024).

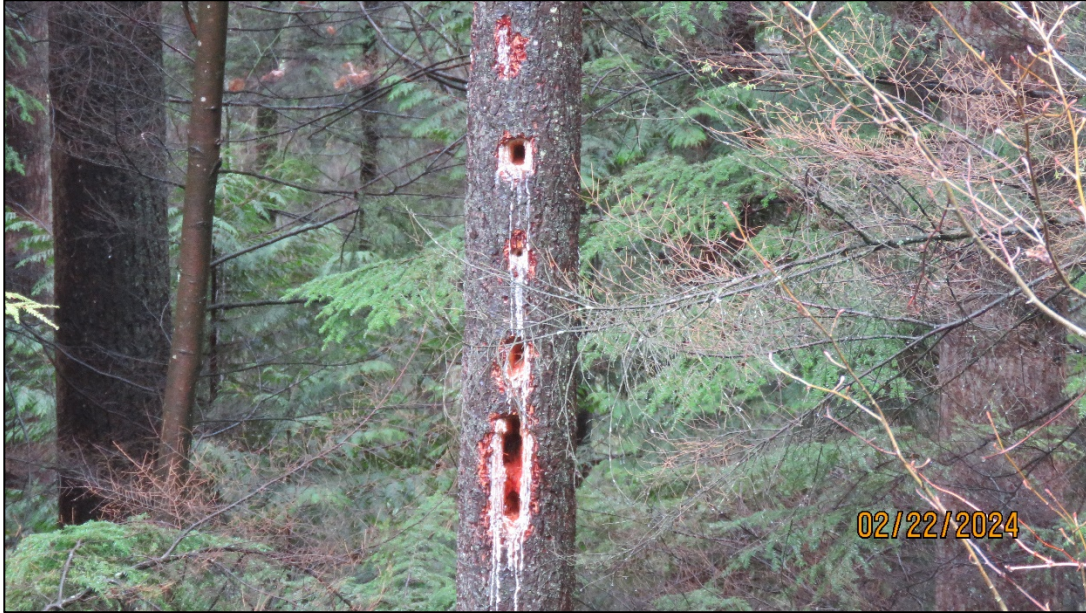
Significant Pileated Woodpecker foraging sign was observed on many wildlife trees within the Mature Forest and Regenerating Forest Vegetation Types (Appendix B; Photograph 7 and 8). Many of the wildlife trees within the study area provided suitable nesting habitat. No recent nest cavities attributed to Pileated Woodpecker were detected during the field assessments.

Photograph 7. A Class 6 western hemlock wildlife tree with recent Pileated Woodpecker feeding sign observed within the MFVT (February 22, 2024).

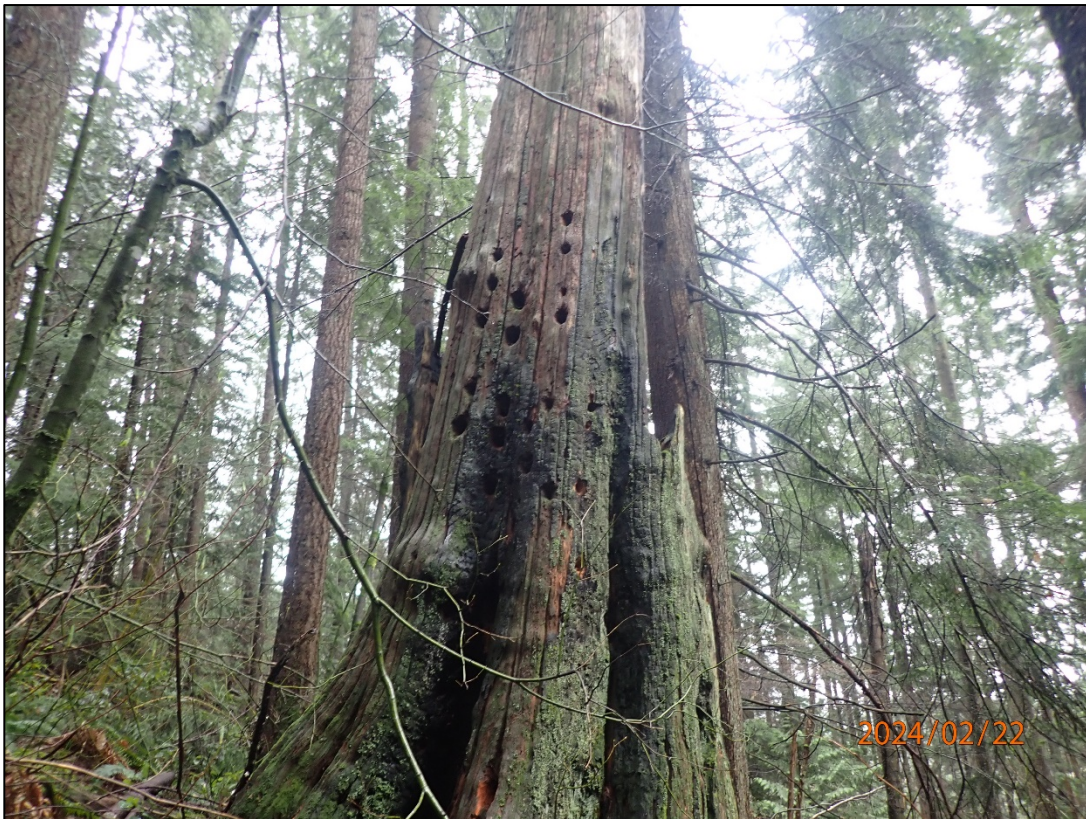
Photograph 8. A Class 6 western redcedar wildlife tree with evidence of historical burning and Pileated Woodpecker feeding sign observed within the MFVT (February 22, 2024).

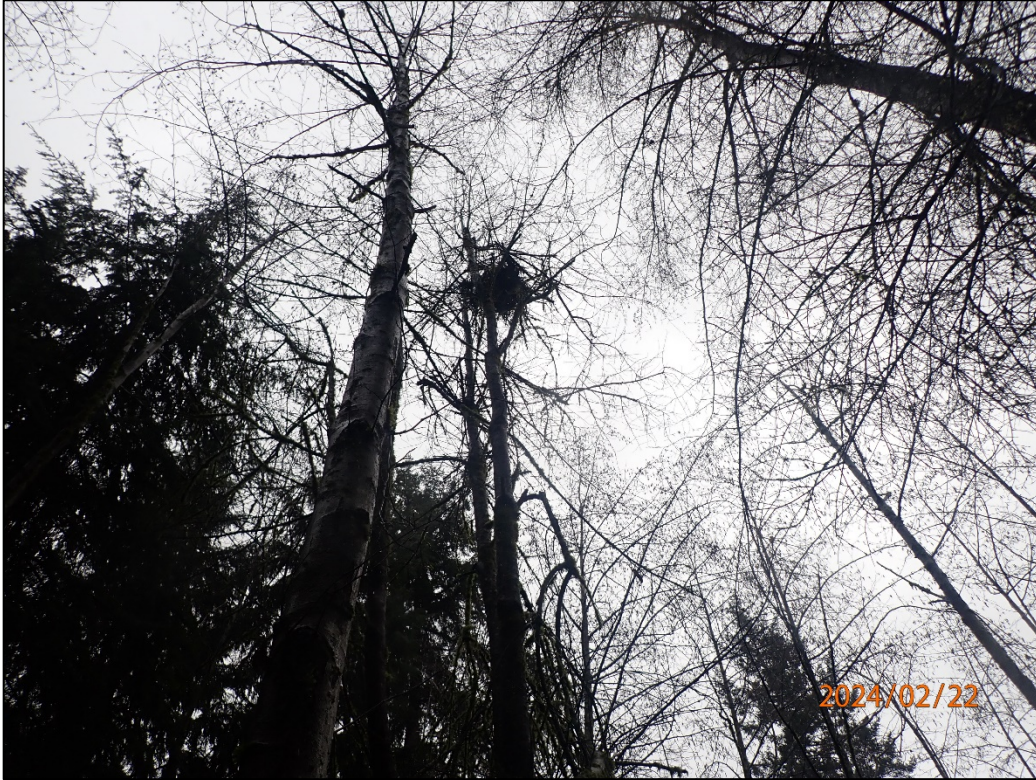
A stick nest attributed to Common Raven was detected within the Site. One Bald Eagle was observed flying over the Site. The treed portions of the Site provide suitable breeding and roosting habitat for the Blue-listed Band-tailed Pigeon and many raptor species including Bald Eagle, Cooper's Hawk and owls as well as songbirds and woodpeckers.

Photograph 9. A Common Raven stick nest detected in a red alder tree within the Regenerating Forest Vegetation Type (February 22, 2024).

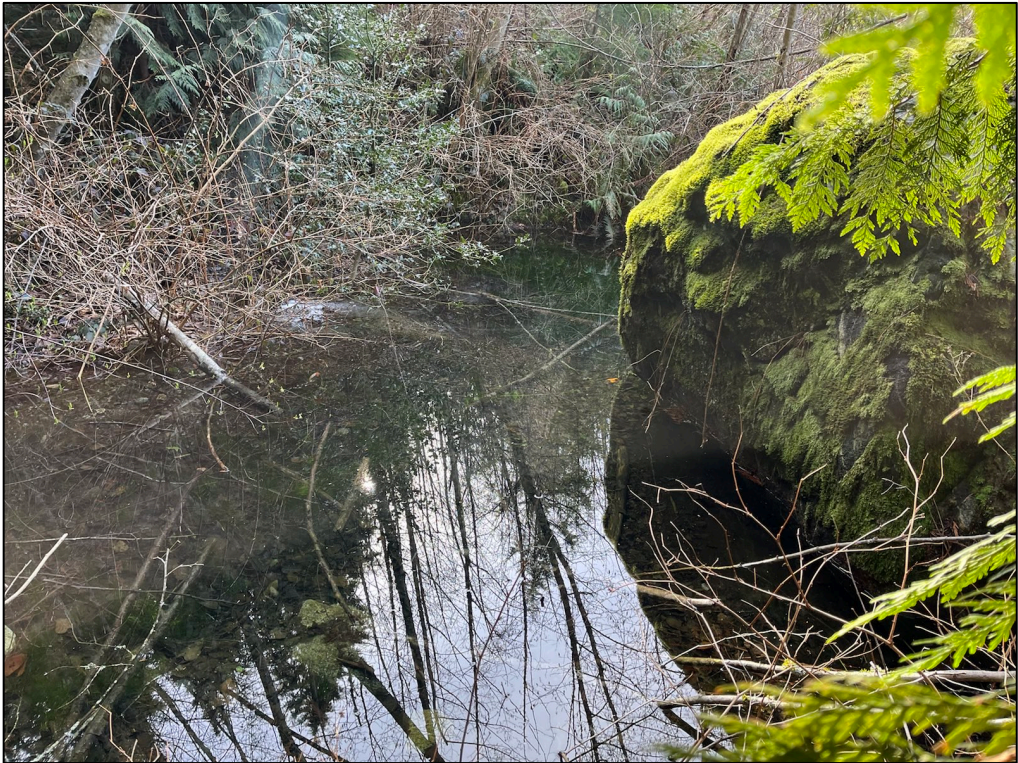
Watercourse A comprises two tributary drainage ditches observed to contain flows draining to Pond A, and a short ditch draining from Pond A that soaks into the ground and is not connected by surface flow to other fish habitat streams (i.e. not a RAPR stream). Pond A is the largest pond at the Site. This pond is reported by neighbours to the south of the Site to have been previously constructed and modified by a former owner of the Site. Pond A was identified as the most significant aquatic feature at the Site in terms of its potential for supporting amphibian populations from a wildlife perspective and is discussed further in Section 4.9. Isolated wetlands or ponds (e.g. Pond A) are WSA streams in so far as being a natural source of water supply. However, because isolated ponds are not connected by surface flow to another watercourse or body of water, isolated or confined ponds do not constitute a stream under the RAPR and therefore are not subject to streamside setbacks (SPEA) prescribed by the RAPR.

Photograph 10. View of Watercourse A (March 15, 2024).

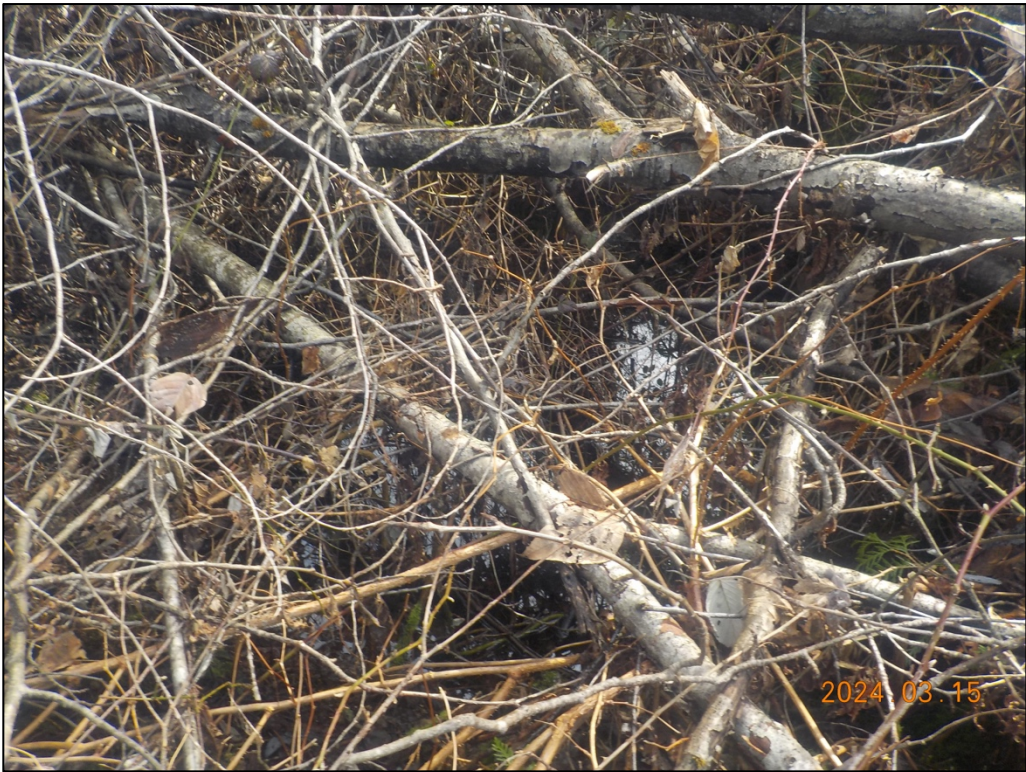
Watercourse B is a short ditch with observed flows draining to Pond B, another confined or isolated pond. Pond B does not seem to drain into anything (i.e., no outlet ditch with water flowing downstream of the pond). Based on the observed infiltration potential at this Site, it appears evident that the pond infiltrates to ground or recedes to the depth where the pond intersects the water table in this area of the Site. Pond B is a WSA pond but is not a RAPR stream. Watercourse B is a short ditch but is not a RAPR stream. There are no RAPR SPEA that apply to Pond B or Watercourse B.

Photograph 11. View of Watercourse B (March 15, 2024).

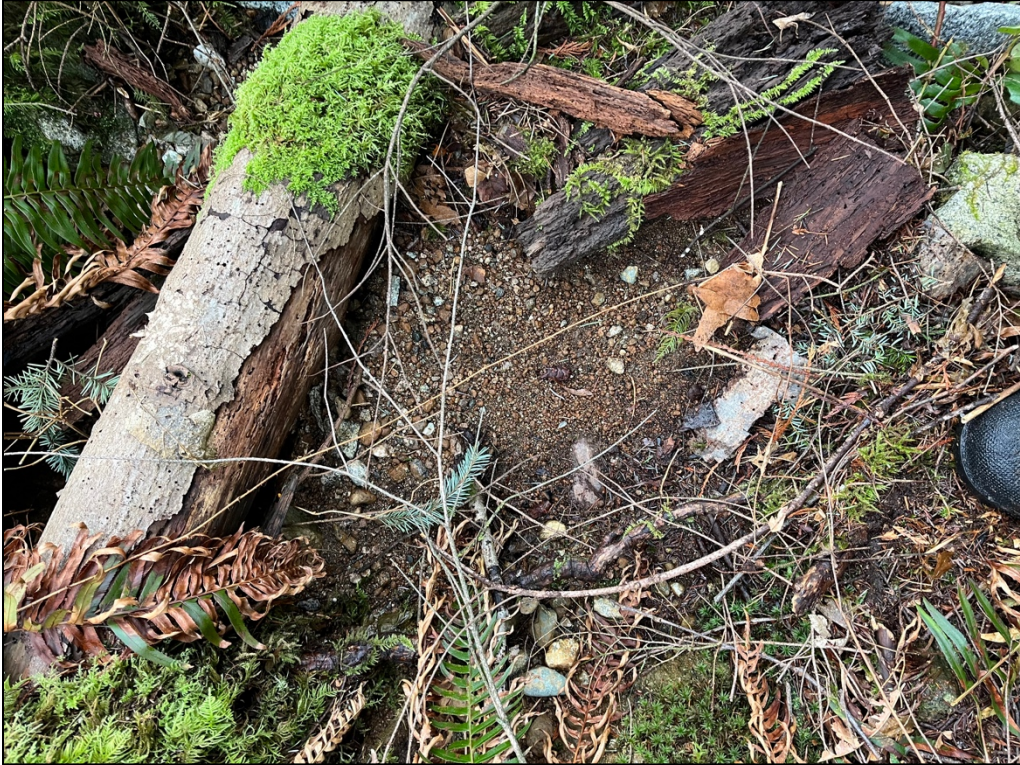
Watercourse C has been observed to convey minor trickle flow in an unconstructed natural channel within a few metres of its confluence with an off-site adjacent rock lined constructed ditch on the property adjacent to the west of the Site (Watercourse F). Upslope of the mapped extent of Watercourse C (see Appendix A), a shallow channel was observed to be dry and discontinuous, even when other watercourses were flowing. The shallow channel upslope of Watercourse C appears to go sub-surface (e.g., infiltrate into the ground), which is a notable pattern at the Site. Minor flow was observed in this shallow channel originating from an old logging road. However, this flow infiltrated to subsurface as Phoenix followed the feature down from the road on February 22. The flow originating from the logging road appeared to be emerging from the slope cut along the side of the logging road, with no apparent stream up-slope of logging road slope cut. Watercourse C is a RAPR stream and based on its narrow channel width is subject to a 10 m RAPR SPEA, which is the minimum SPEA width under the RAPR.

Photograph 12. View of Watercourse C (March 15, 2024).

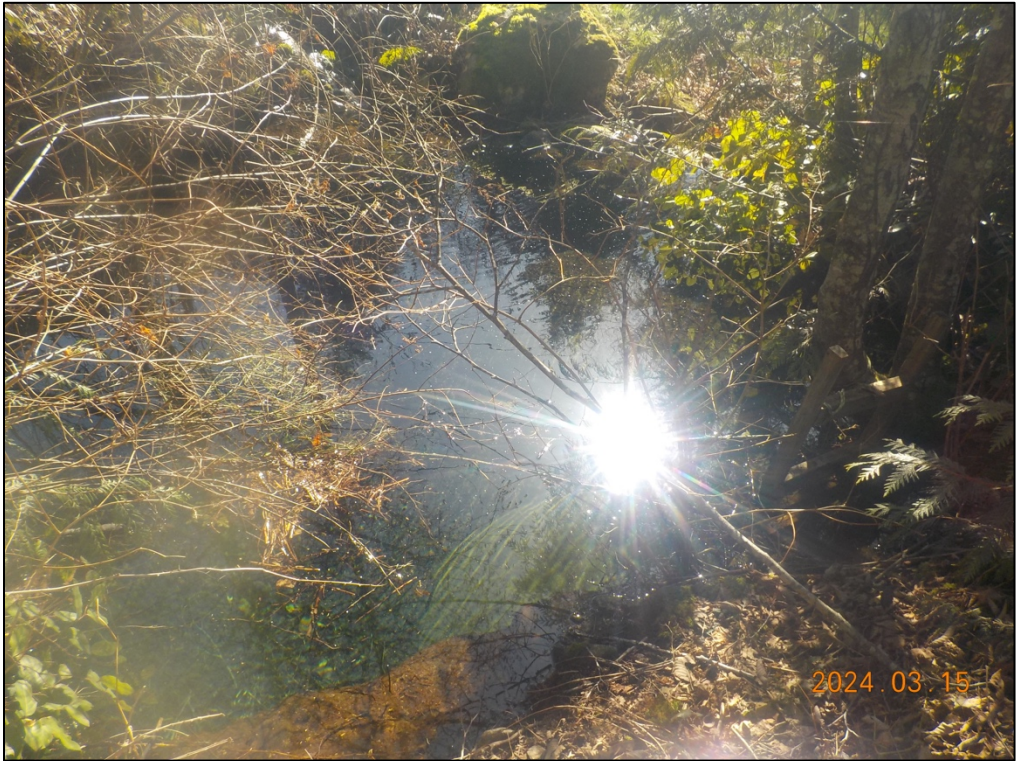
Photograph 13. View of Watercourse D (March 15, 2024).

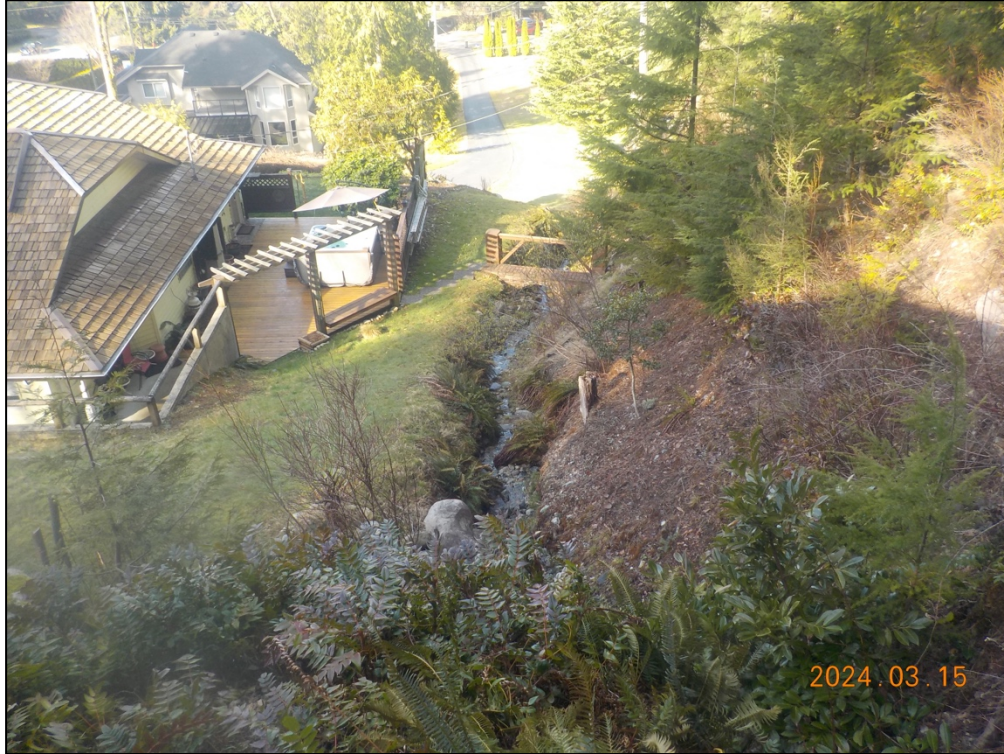
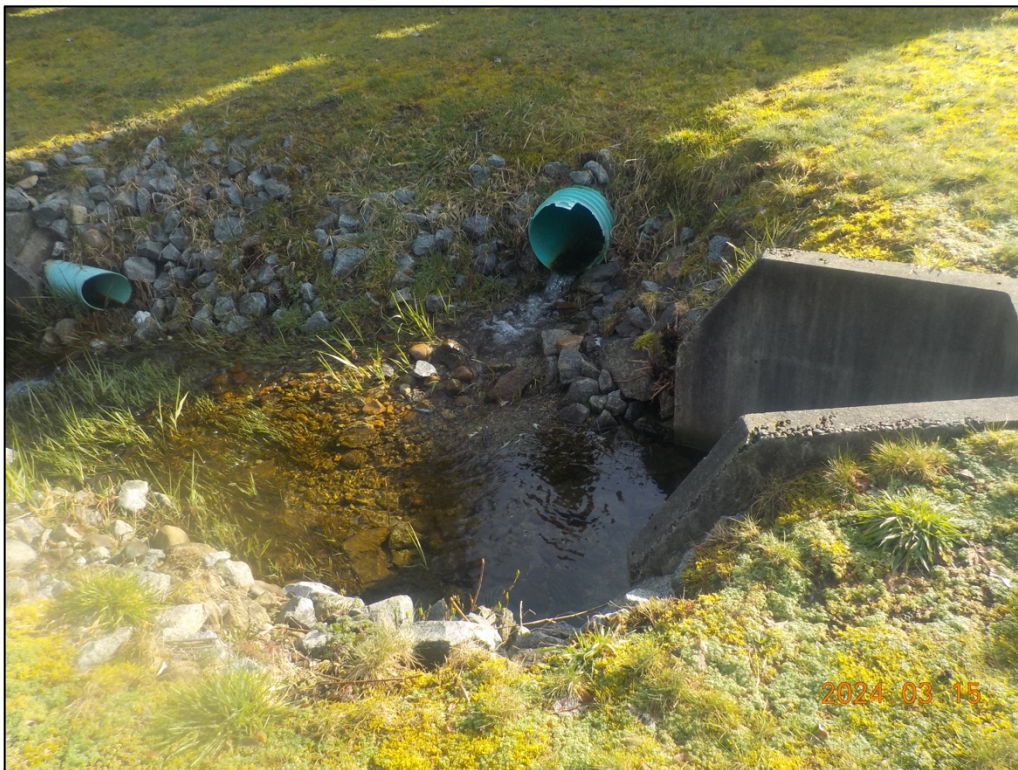
Photograph 14. View of Watercourse E (March 15, 2024).

Photograph 15. View of Watercourse E (March 15, 2024).

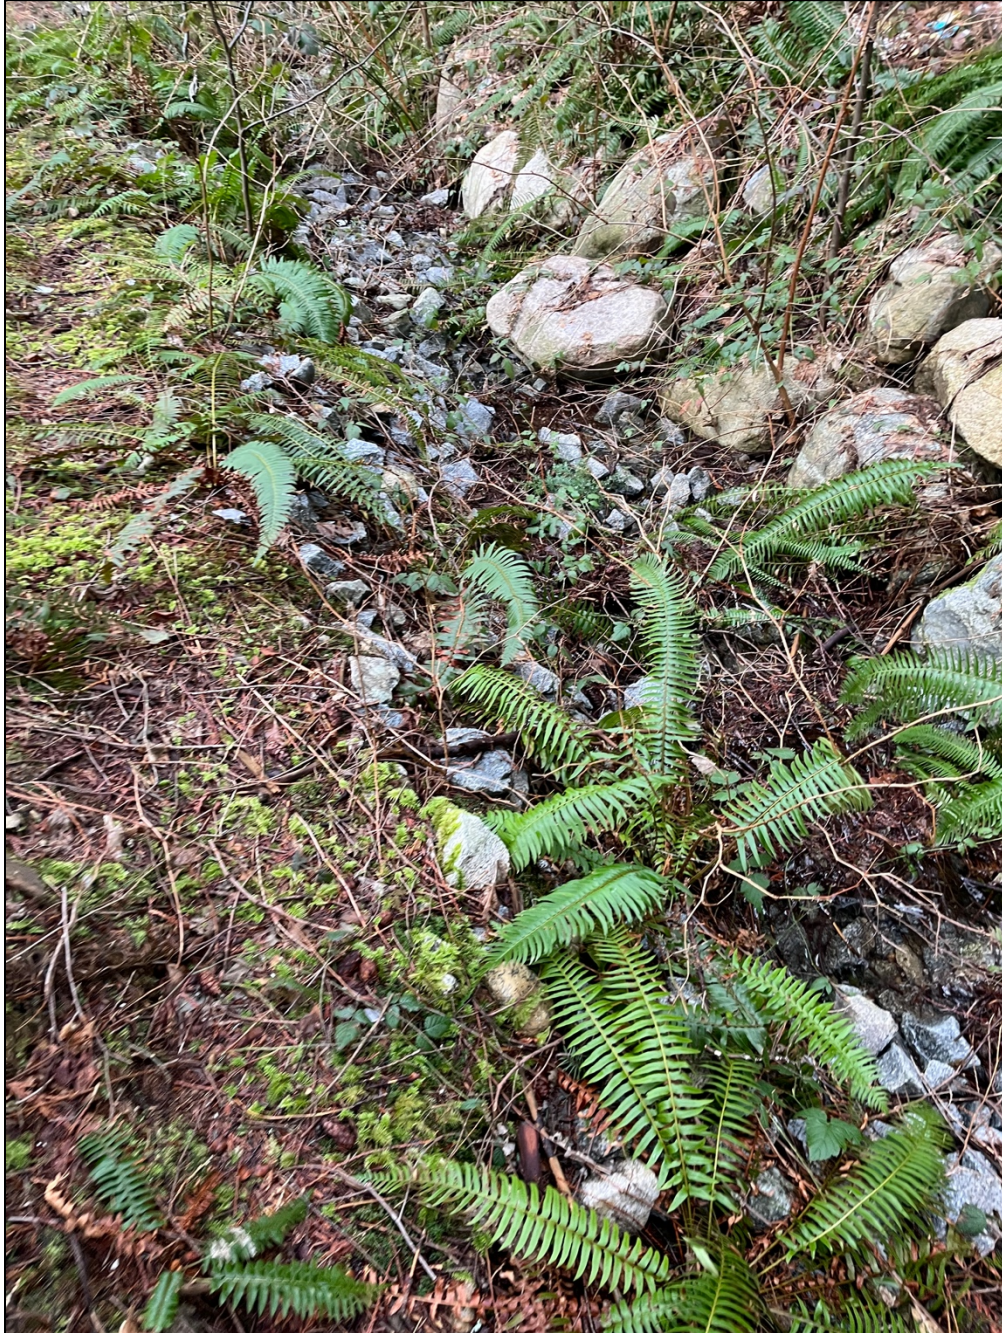
Photograph 16. View of Watercourse F (March 15, 2024).
