# OVERVIEW ENVIRONMENTAL ASSESSMENT

Vacant Lots  
PIDs: 027-687-309, 002-811-626, and 028-856-589,  
Anmore, B.C.

Prepared for:  
Anmore Gate & Bella Terra Investments 2 Inc.

March 2024

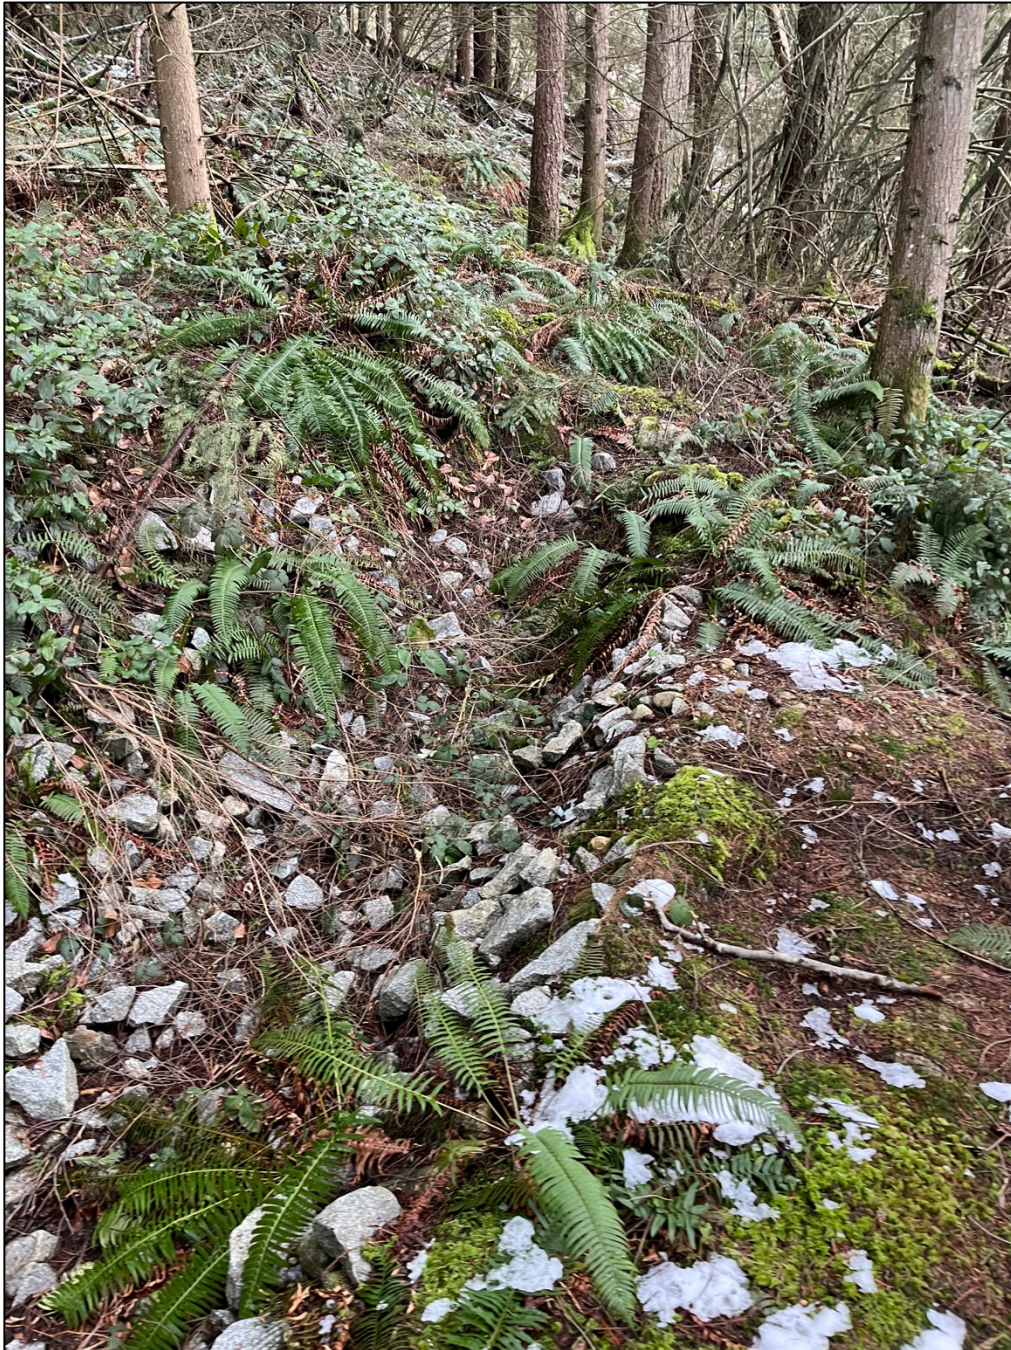
Photograph 17. View of dry ditch along a historical skidder road at the Site (March 15, 2024).

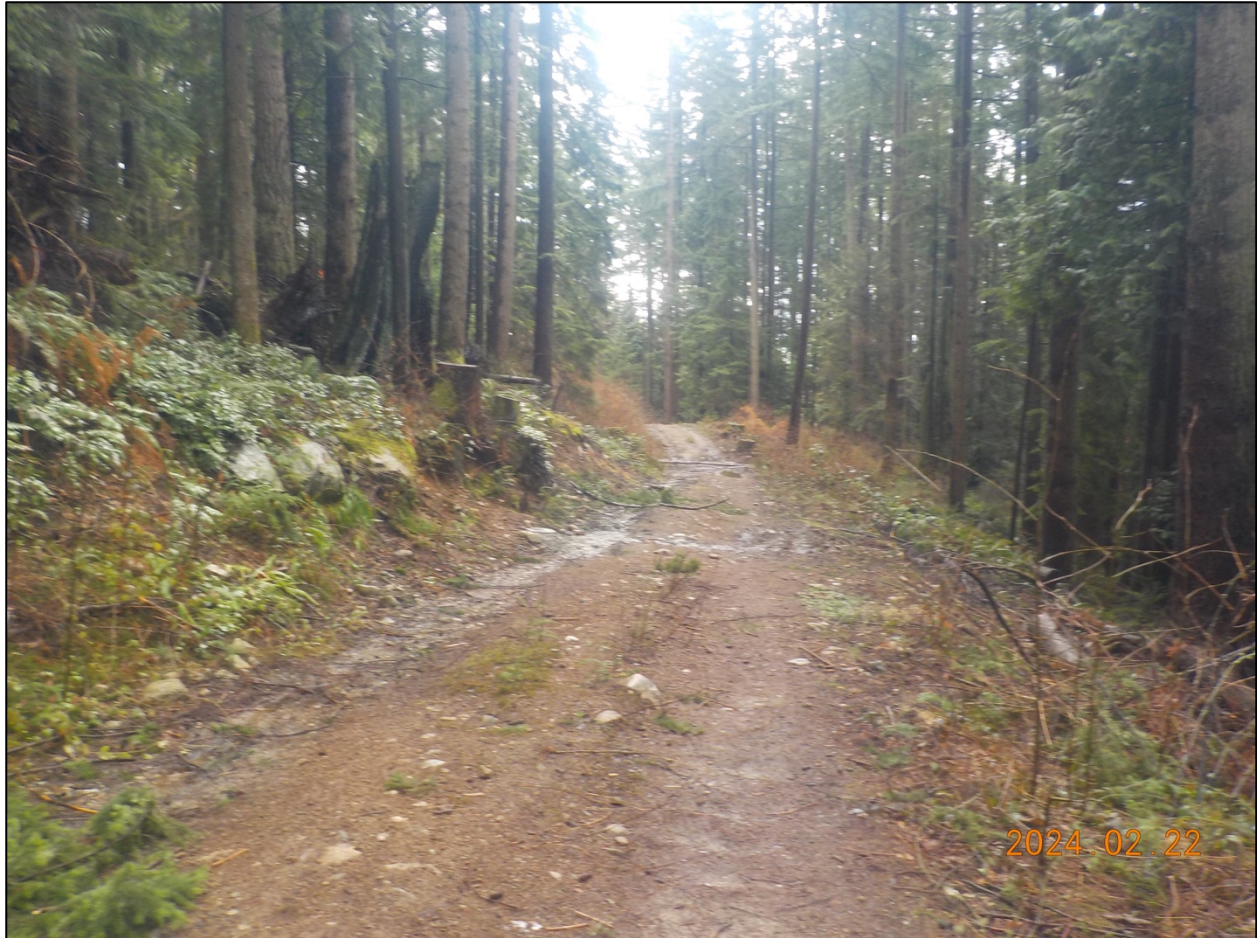
Photograph 18. View of typical section of a logging road at the Site (February 22, 2024).
