OVERVIEW ENVIRONMENTAL ASSESSMENT

Vacant Lots
PIDs: 027-687-309, 002-811-626, and 028-856-589,
Anmore, B.C.

Prepared for:
Anmore Gate & Bella Terra Investments 2 Inc.

Prepared by:
PHOENIX ENVIRONMENTAL SERVICES LTD.

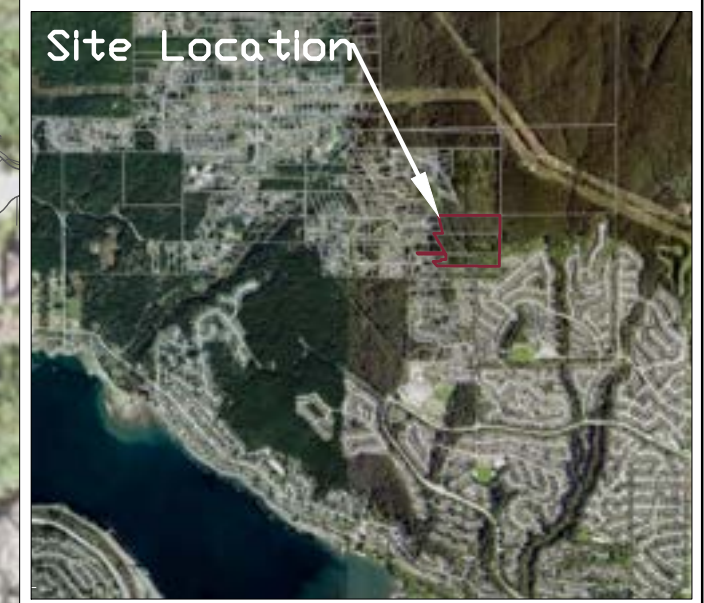
Refer to the Watercourse Location Map in Appendix A for details. Streams, channelized streams, and ditches regulated under the RAPR are shown in dark blue. Ditches coloured light blue on the Watercourse Location Map have been observed to be flowing during the field assessments but infiltrating and terminating to ground or draining to ponds that are unconnected and isolated. There are ditches coloured orange (Appendix A) that have been previously mapped on topographic surveys of the Site but have been observed to be dry during all field assessments.

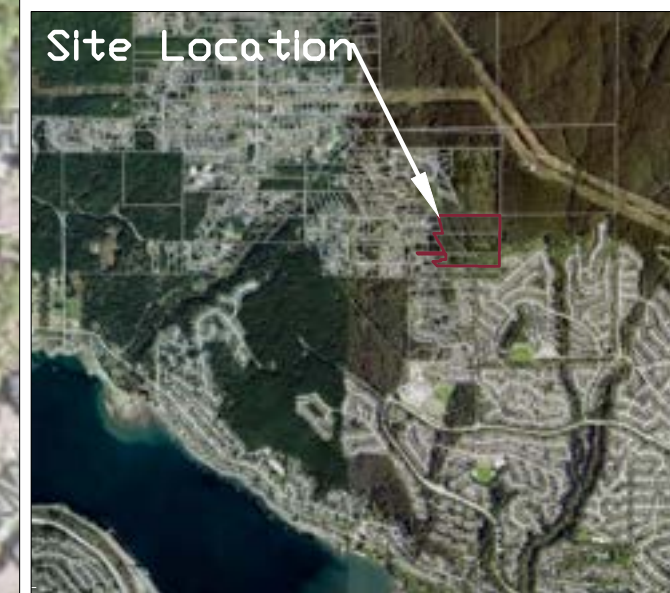
Streamside Setback Map

There are three (3) watercourses and two (2) WSA Ponds within the Site. Watercourse A and Watercourse B are not RAPR streams and are not subject to RAPR streamside setbacks (SPEA). Watercourse C is a RAPR stream that is subject to a 10 m SPEA measured from the Stream Boundary; however, Watercourse C is only a few metres inside the western boundary of the Site. While being WSA ‘streams’ that require retention, or alternatively need to be replaced elsewhere, Pond A and Pond B are both isolated and unconnected to other streams and are not subject to SPEA under the RAPR.

The watercourses that are subject to streamside setbacks (SPEA) under the RAPR (see Appendix A) are to be protected from disturbance to the greatest extent possible in planning for future development at the Site. While not regulated under the RAPR, Pond A and Pond B are protected under the WSA as unconnected water resources and should be retained in place. There are no prescribed setbacks for these isolated ponds at the Site, but retention of a 30-m vegetated buffer for amphibian breeding and rearing purposes are recommended as per section 8.3 and discussed previously in this report.

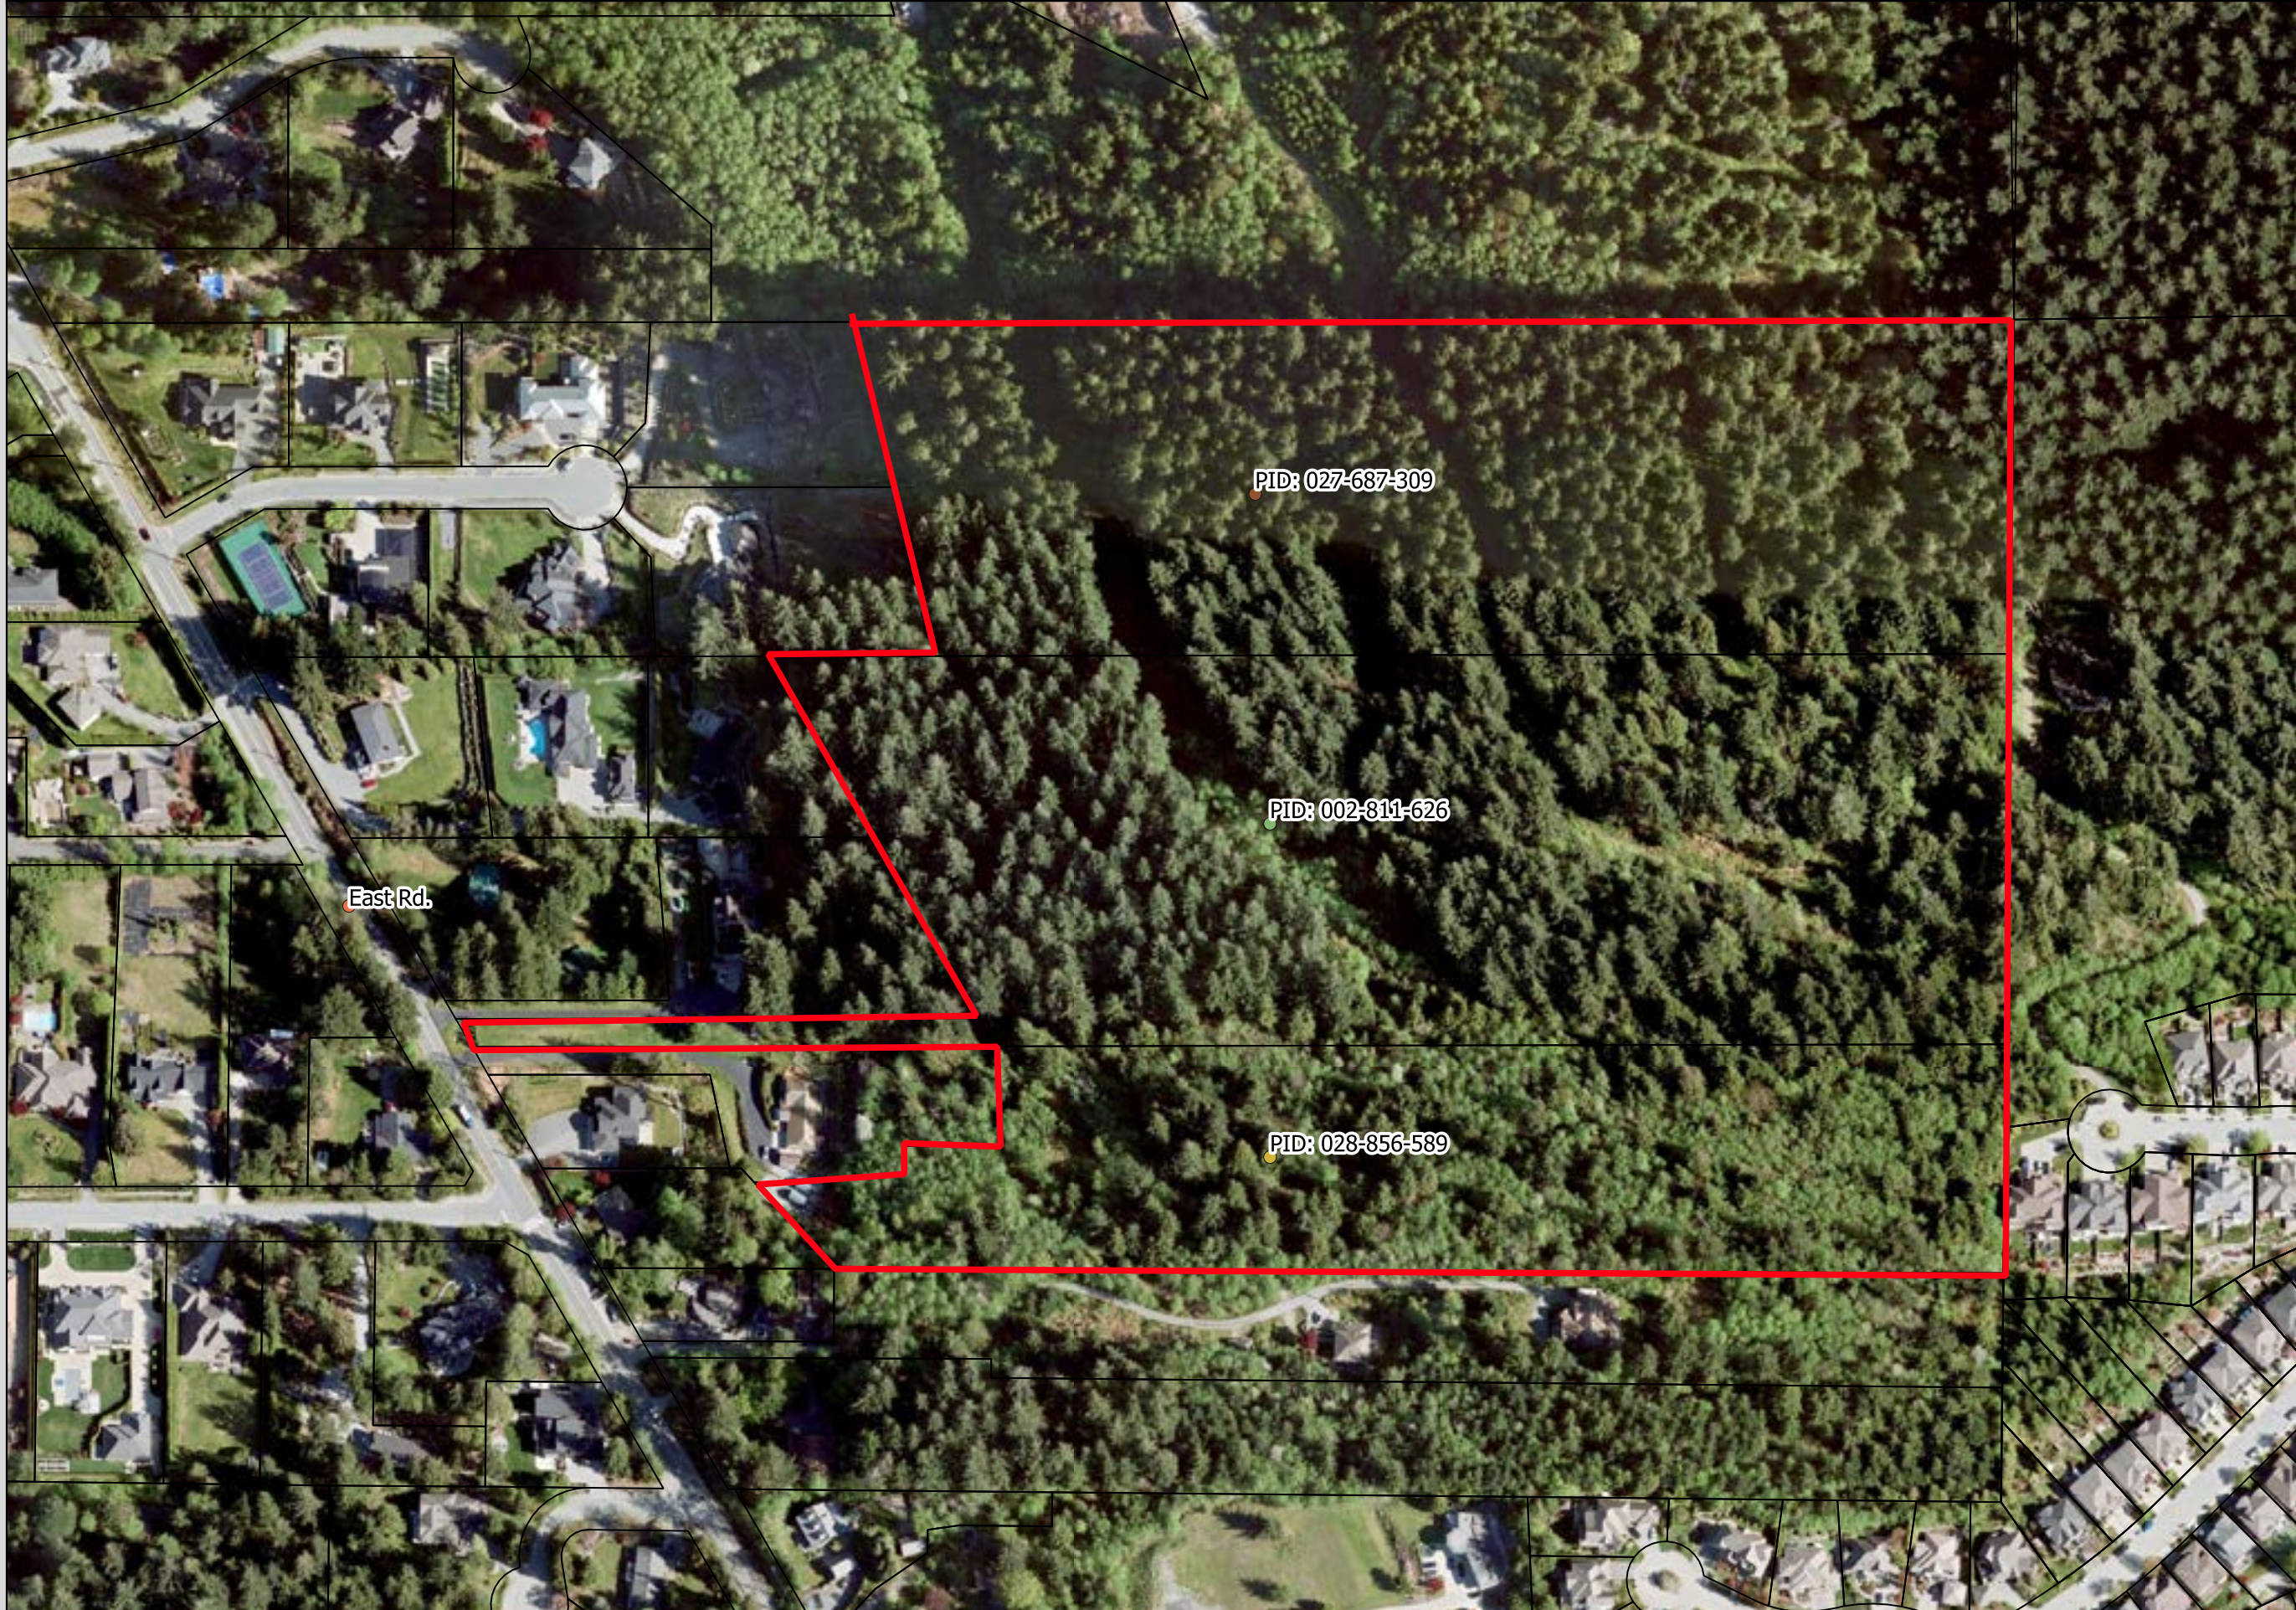
Anmore Gate Study Area Vegetation Types and Significant Wildlife Findings

- Study Area
- Property Lines
- Regenerating Forest VT
- Mature Forest VT
- Access Roads
- Ponds
- Common Raven Nest

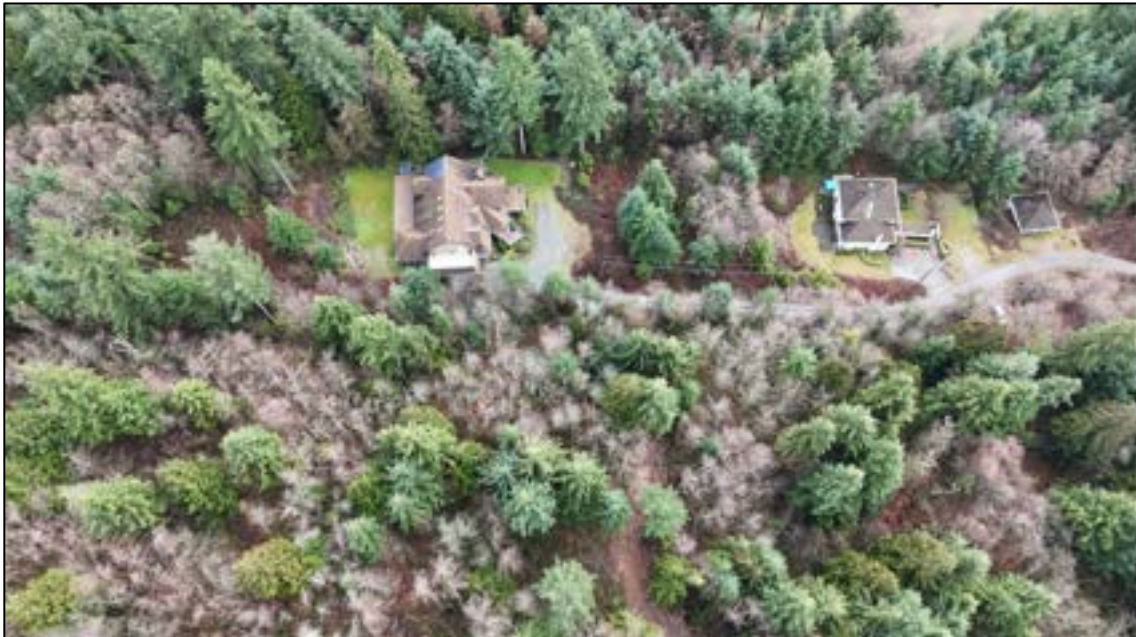
Photograph 1. Aerial drone image of the Regenerating Forest Vegetation Type (February 22, 2024).

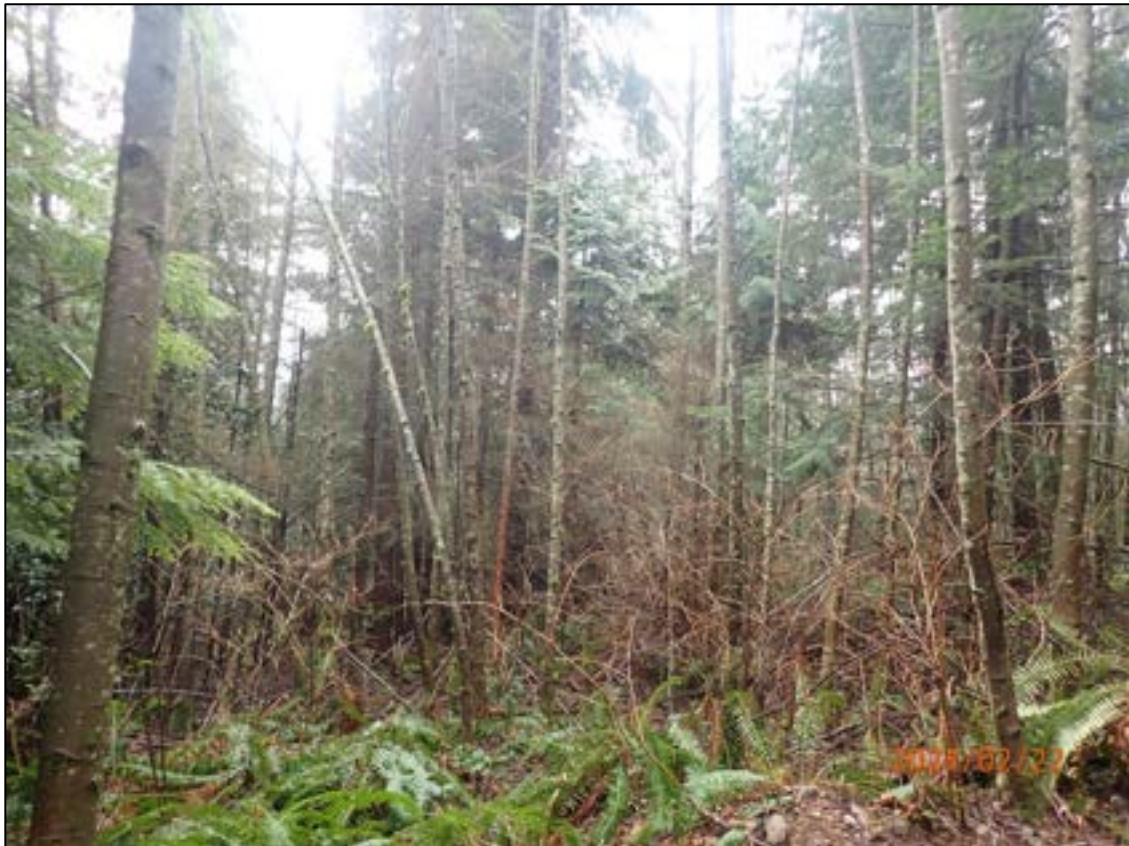
Photograph 2. Typical understory vegetation composition of the Regenerating Forest Vegetation Type (February 22, 2024).

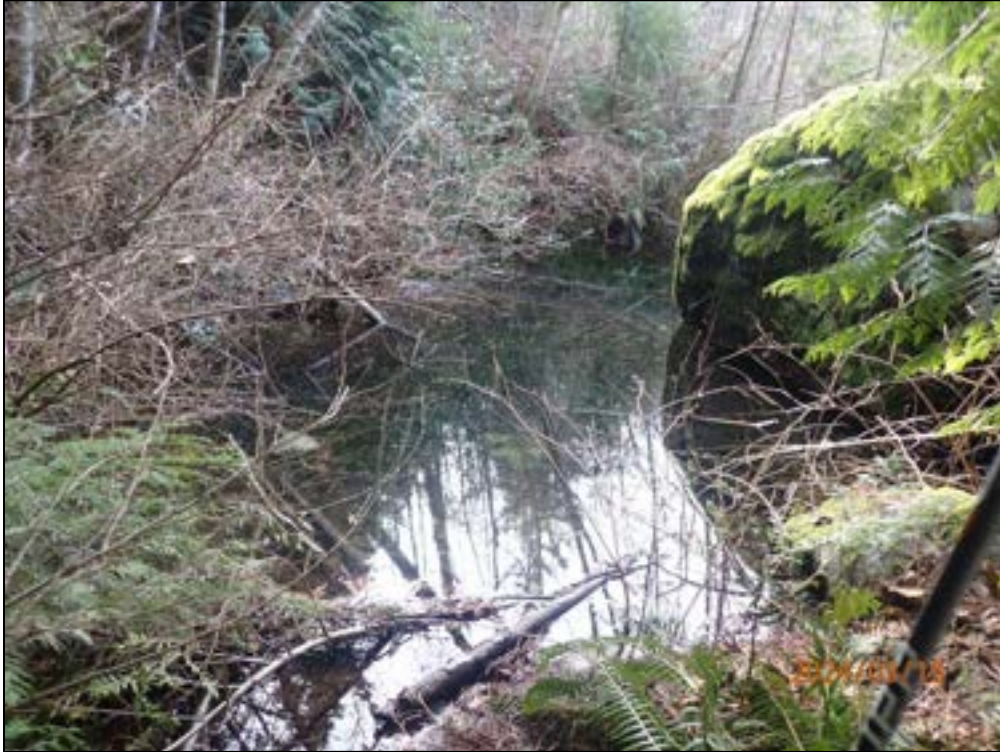
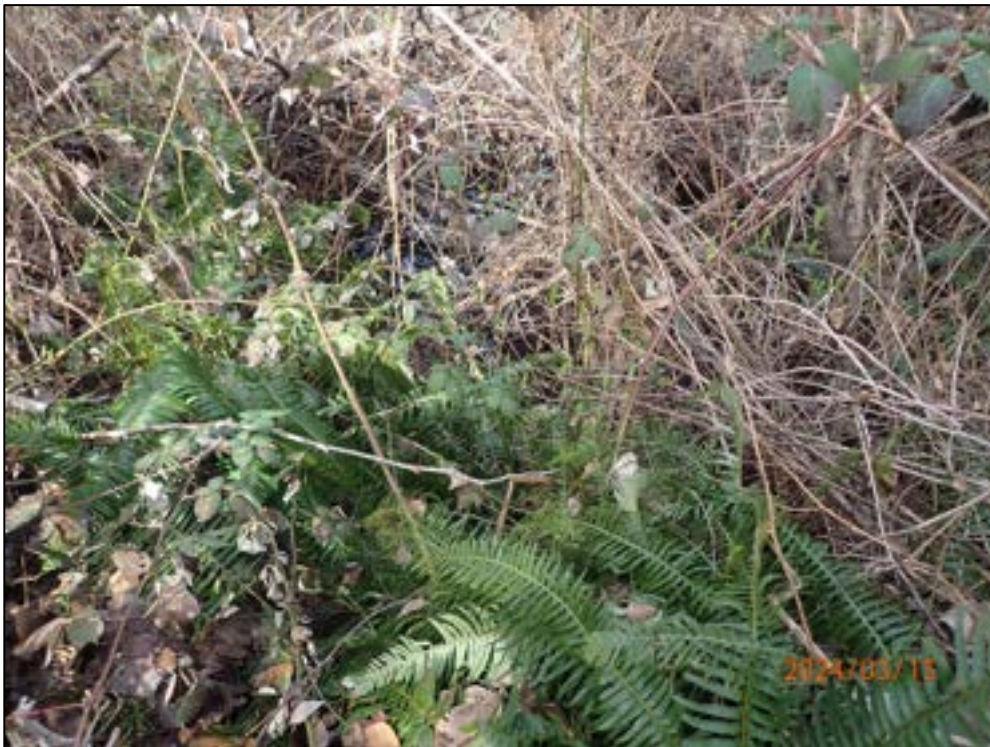
No Northern Red-legged Frogs were detected during the field survey. Northern Red-legged Frogs are generally not active in the winter which limits their detection. Two suitable breeding ponds were observed in the RFVT (Appendix A; Figure 2, Appendix B; Photographs 3 and 4). The forested portions of the RFVT and MFVT provided suitable general living habitat for Northern Red-legged Frog and many other amphibian species. No BCCDC records occurred within 2 km of the study area.

Western Toads are expected to occur throughout the forested habitats within the study area. Two suitable breeding ponds were observed in the RFVT (Appendix A; Figure 2: Appendix B; Photographs 3 and 4).

Photograph 3. A man-made pond detected near the northwest corner of the RFVT (March 15, 2024).

Photograph 4. A man-made pond surrounded by dense shrub vegetation detected near the southwest corner of the RFVT (March 15, 2024).

The amphibian best management practices (BMP) recommends minimum 30 m setbacks for all Western Toad and Northern Red-legged Frog breeding habitats (Develop with Care Factsheet 2014).

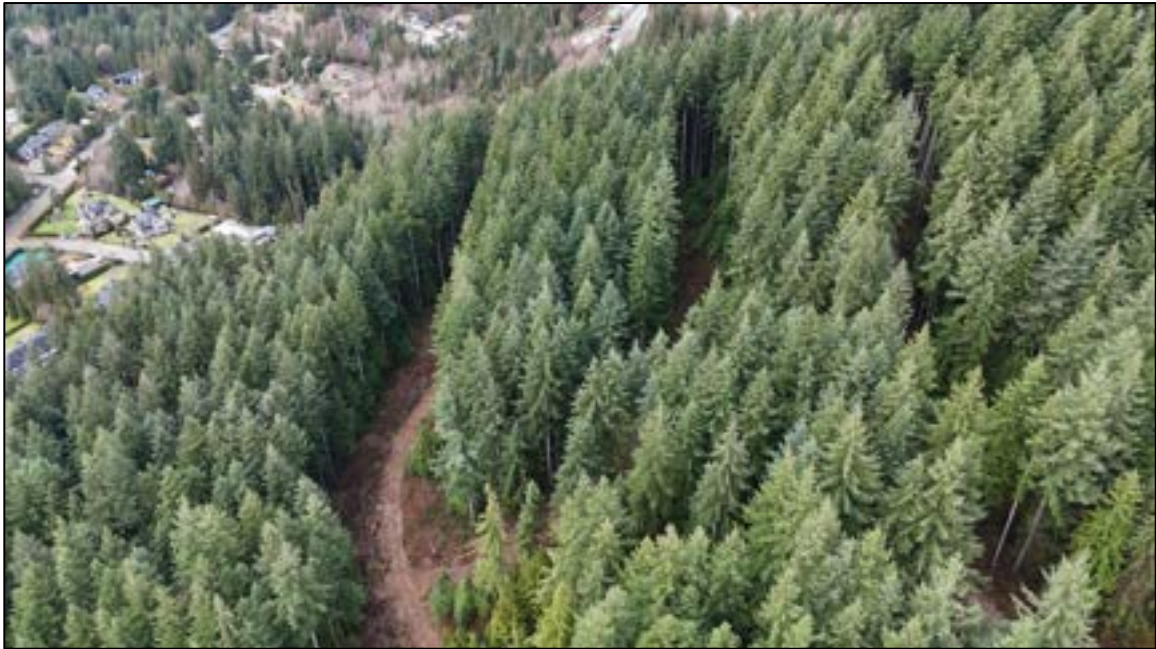
Photograph 5. Aerial drone image of the Mature Forest Vegetation Type (February 22, 2024).

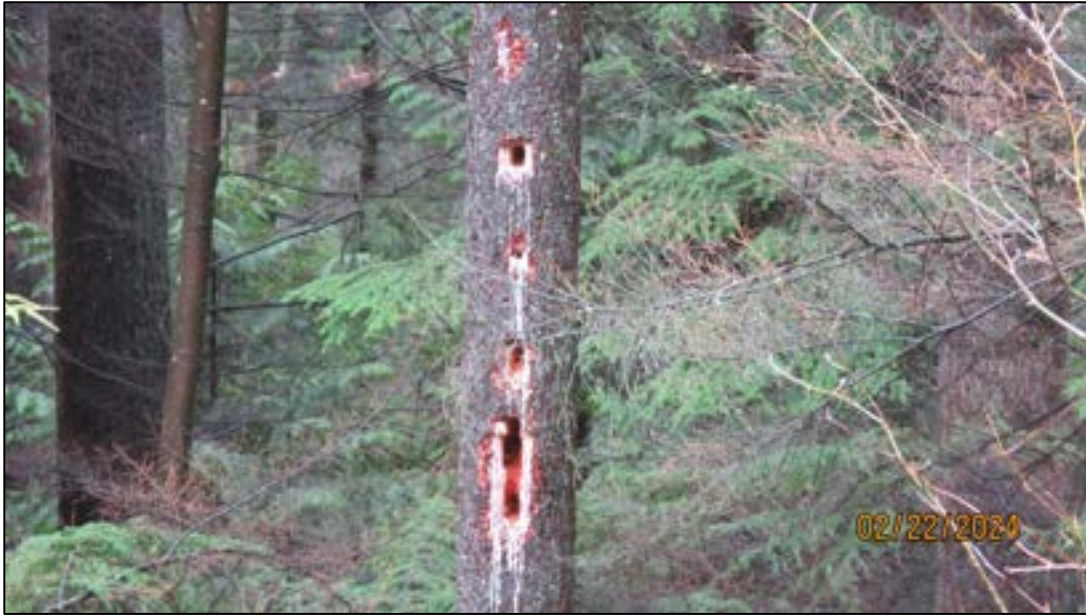
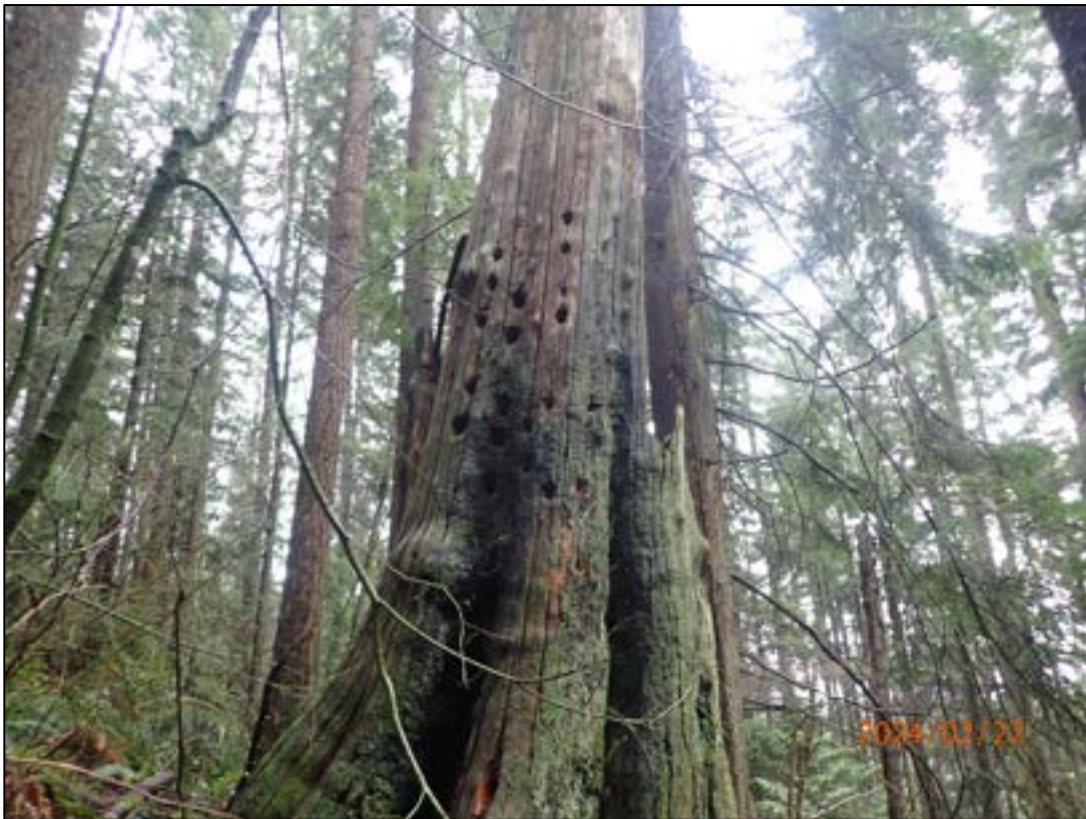
Significant Pileated Woodpecker foraging sign was observed on many wildlife trees within the Mature Forest and Regenerating Forest Vegetation Types (Appendix B; Photograph 7 and 8). Many of the wildlife trees within the study area provided suitable nesting habitat. No recent nest cavities attributed to Pileated Woodpecker were detected during the field assessments.

Photograph 7. A Class 6 western hemlock wildlife tree with recent Pileated Woodpecker feeding sign observed within the MFVT (February 22, 2024).

Photograph 8. A Class 6 western redcedar wildlife tree with evidence of historical burning and Pileated Woodpecker feeding sign observed within the MFVT (February 22, 2024).

Significant Pileated Woodpecker foraging sign was observed on many of the wildlife trees within the Site and one Pileated Woodpecker was observed and heard during the field assessments. Pileated Woodpecker nests are protected year-round under the federal MBR (2022). A Pileated Woodpecker nest survey will be required prior to any clearing or construction activities. If a Pileated Woodpecker nest cavity is detected within the proposed works area and is required for

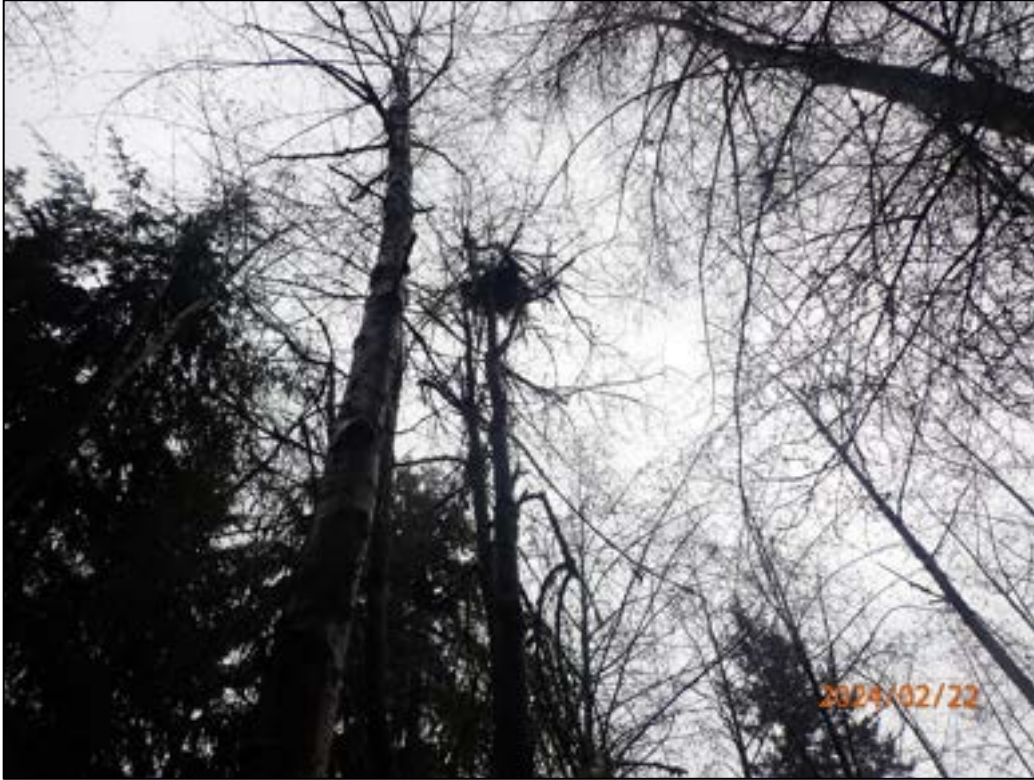
A stick nest attributed to Common Raven was detected within the Site. One Bald Eagle was observed flying over the Site. The treed portions of the Site provide suitable breeding and roosting habitat for the Blue-listed Band-tailed Pigeon and many raptor species including Bald Eagle, Cooper's Hawk and owls as well as songbirds and woodpeckers.

Photograph 9. A Common Raven stick nest detected in a red alder tree within the Regenerating Forest Vegetation Type (February 22, 2024).

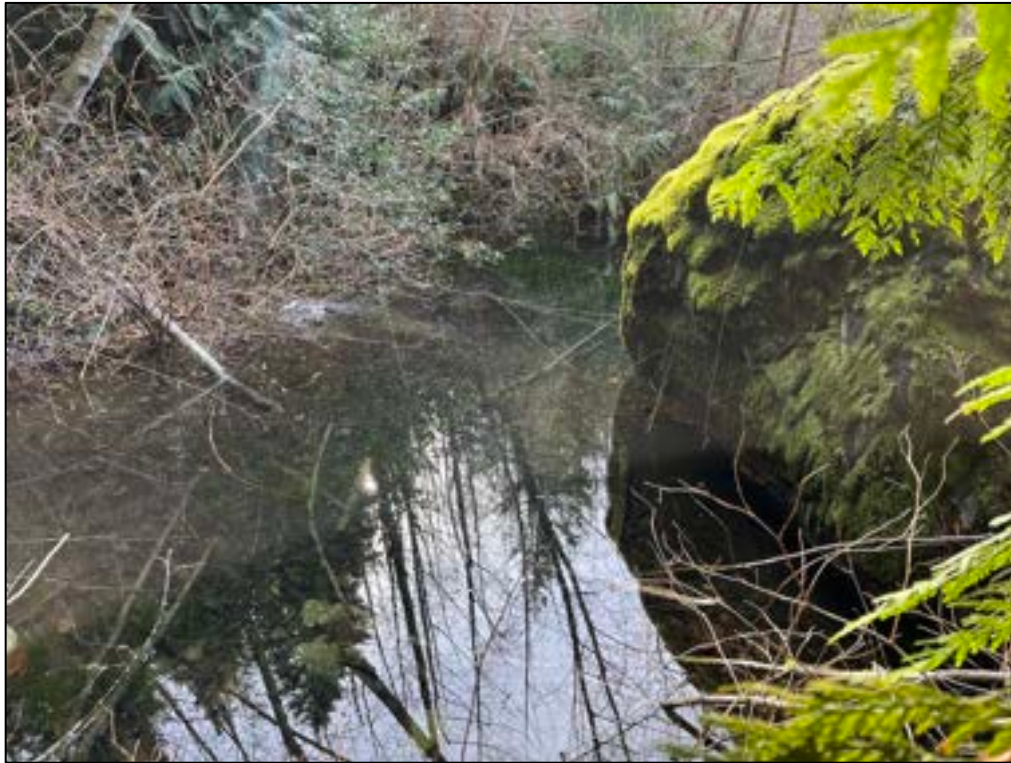
Watercourse A comprises two tributary drainage ditches observed to contain flows draining to Pond A, and a short ditch draining from Pond A that soaks into the ground and is not connected by surface flow to other fish habitat streams (i.e. not a RAPR stream). Pond A is the largest pond at the Site. This pond is reported by neighbours to the south of the Site to have been previously constructed and modified by a former owner of the Site. Pond A was identified as the most significant aquatic feature at the Site in terms of its potential for supporting amphibian populations from a wildlife perspective and is discussed further in Section 4.9. Isolated wetlands or ponds (e.g. Pond A) are WSA streams in so far as being a natural source of water supply. However, because isolated ponds are not connected by surface flow to another watercourse or body of water, isolated or confined ponds do not constitute a stream under the RAPR and therefore are not subject to streamside setbacks (SPEA) prescribed by the RAPR.

Photograph 10. View of Watercourse A (March 15, 2024).

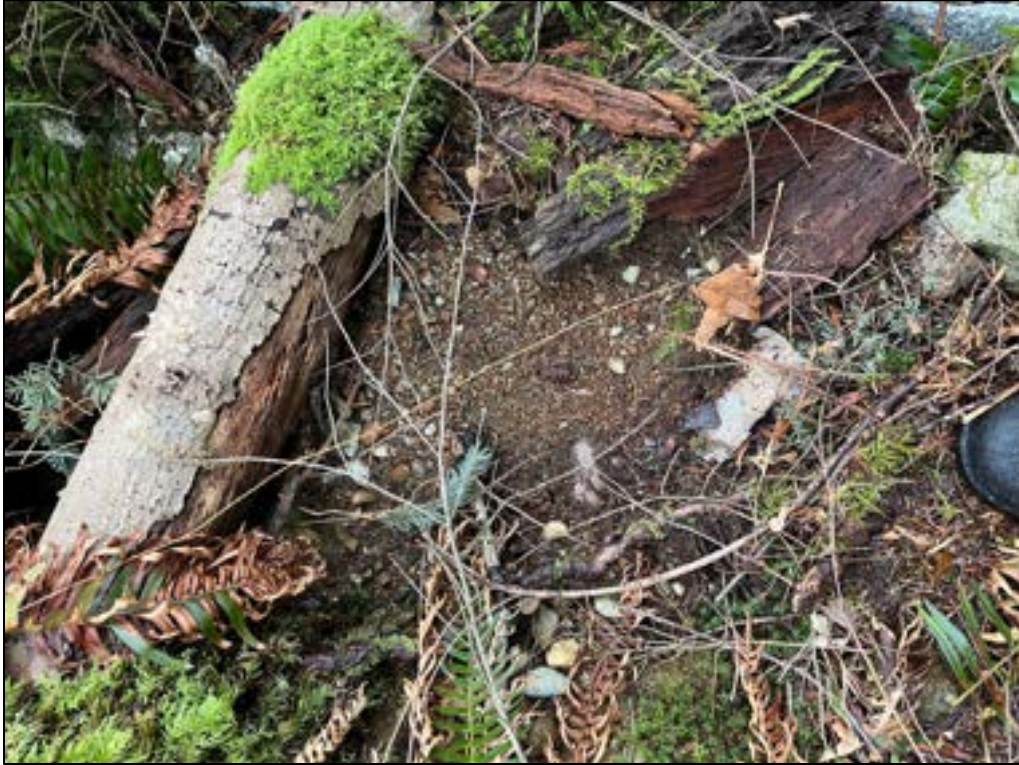
Watercourse C has been observed to convey minor trickle flow in an unconstructed natural channel within a few metres of its confluence with an off-site adjacent rock lined constructed ditch on the property adjacent to the west of the Site (Watercourse F). Upslope of the mapped extent of Watercourse C (see Appendix A), a shallow channel was observed to be dry and discontinuous, even when other watercourses were flowing. The shallow channel upslope of Watercourse C appears to go sub-surface (e.g., infiltrate into the ground), which is a notable pattern at the Site. Minor flow was observed in this shallow channel originating from an old logging road. However, this flow infiltrated to subsurface as Phoenix followed the feature down from the road on February 22. The flow originating from the logging road appeared to be emerging from the slope cut along the side of the logging road, with no apparent stream up-slope of logging road slope cut. Watercourse C is a RAPR stream and based on its narrow channel width is subject to a 10 m RAPR SPEA, which is the minimum SPEA width under the RAPR.

Photograph 12. View of Watercourse C (March 15, 2024).

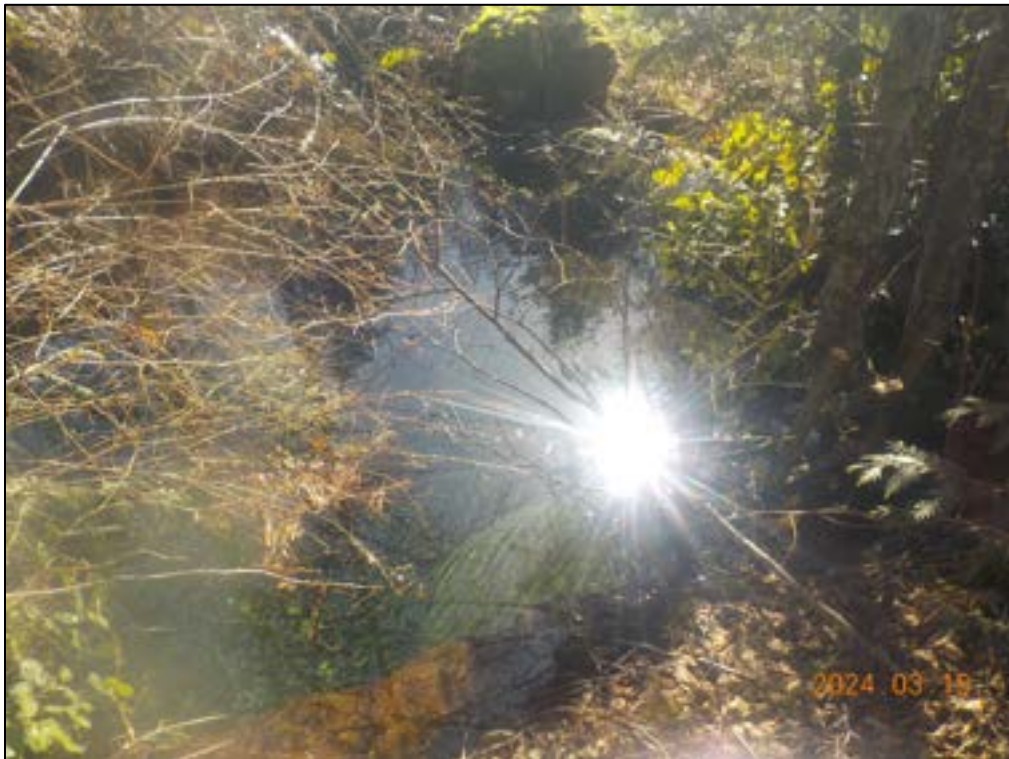
Photograph 13. View of Watercourse D (March 15, 2024).

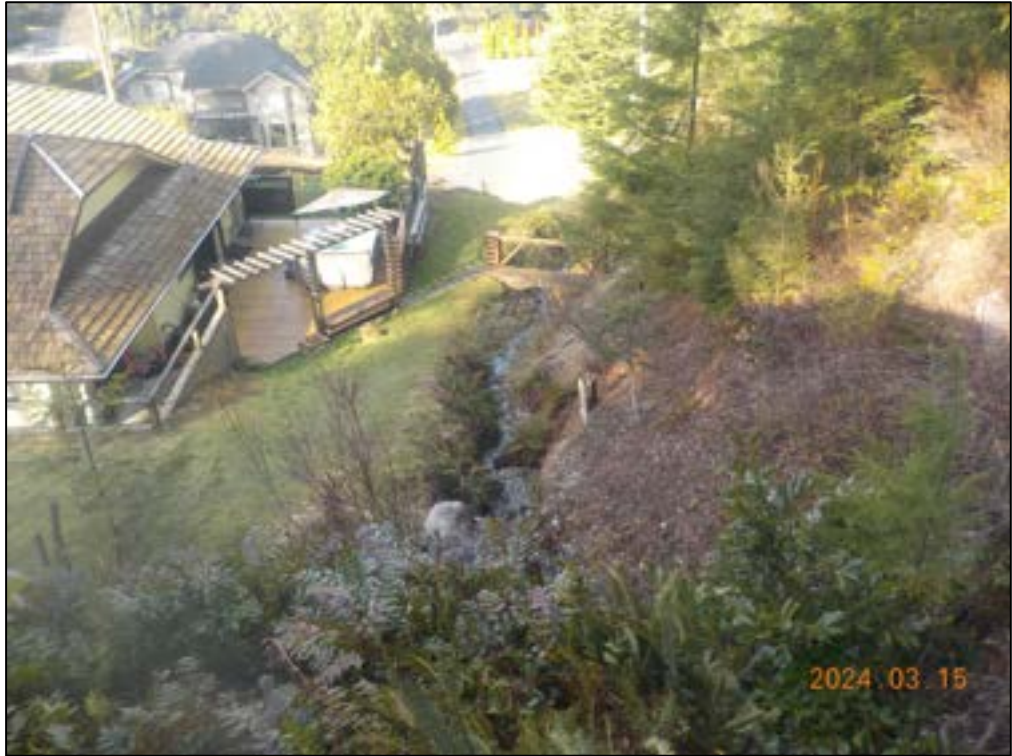
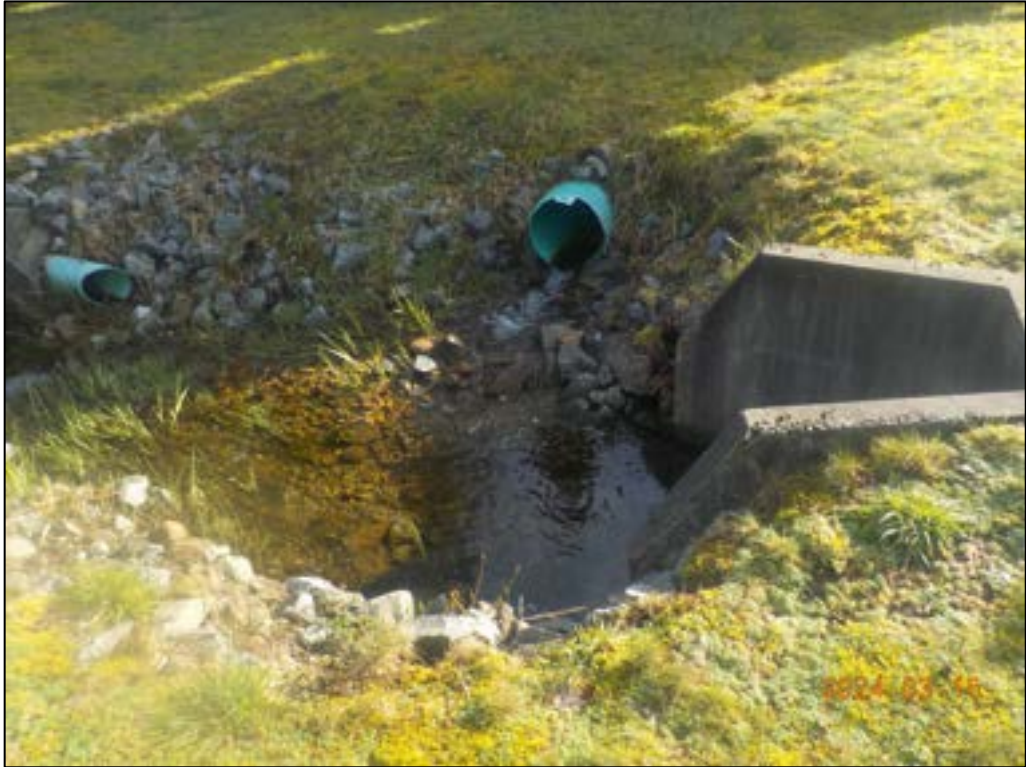
Photograph 14. View of Watercourse E (March 15, 2024).

Photograph 15. View of Watercourse E (March 15, 2024).

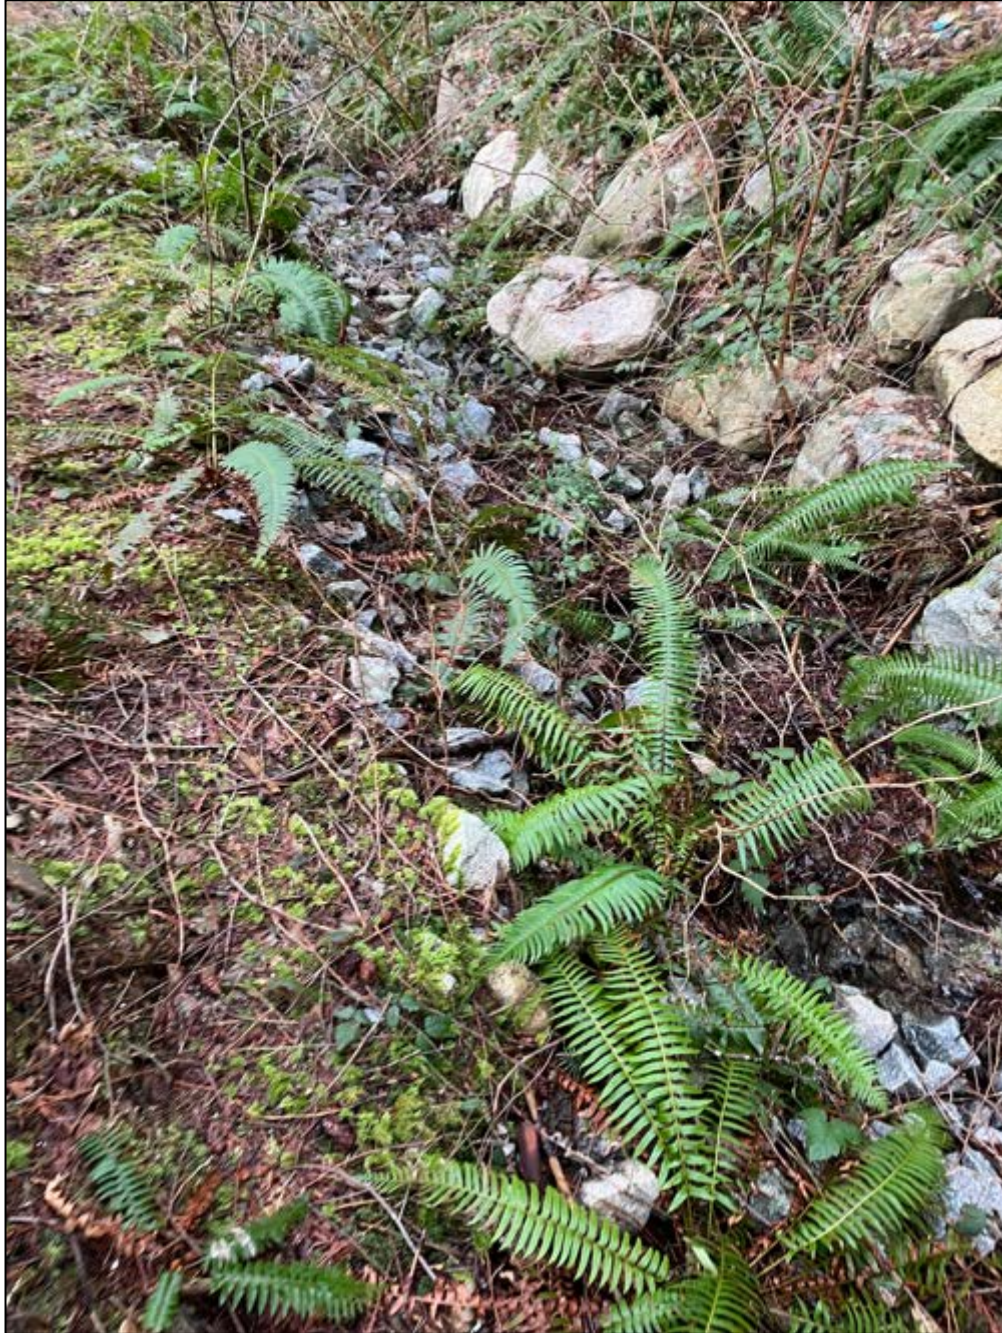
Photograph 16. View of Watercourse F (March 15, 2024).

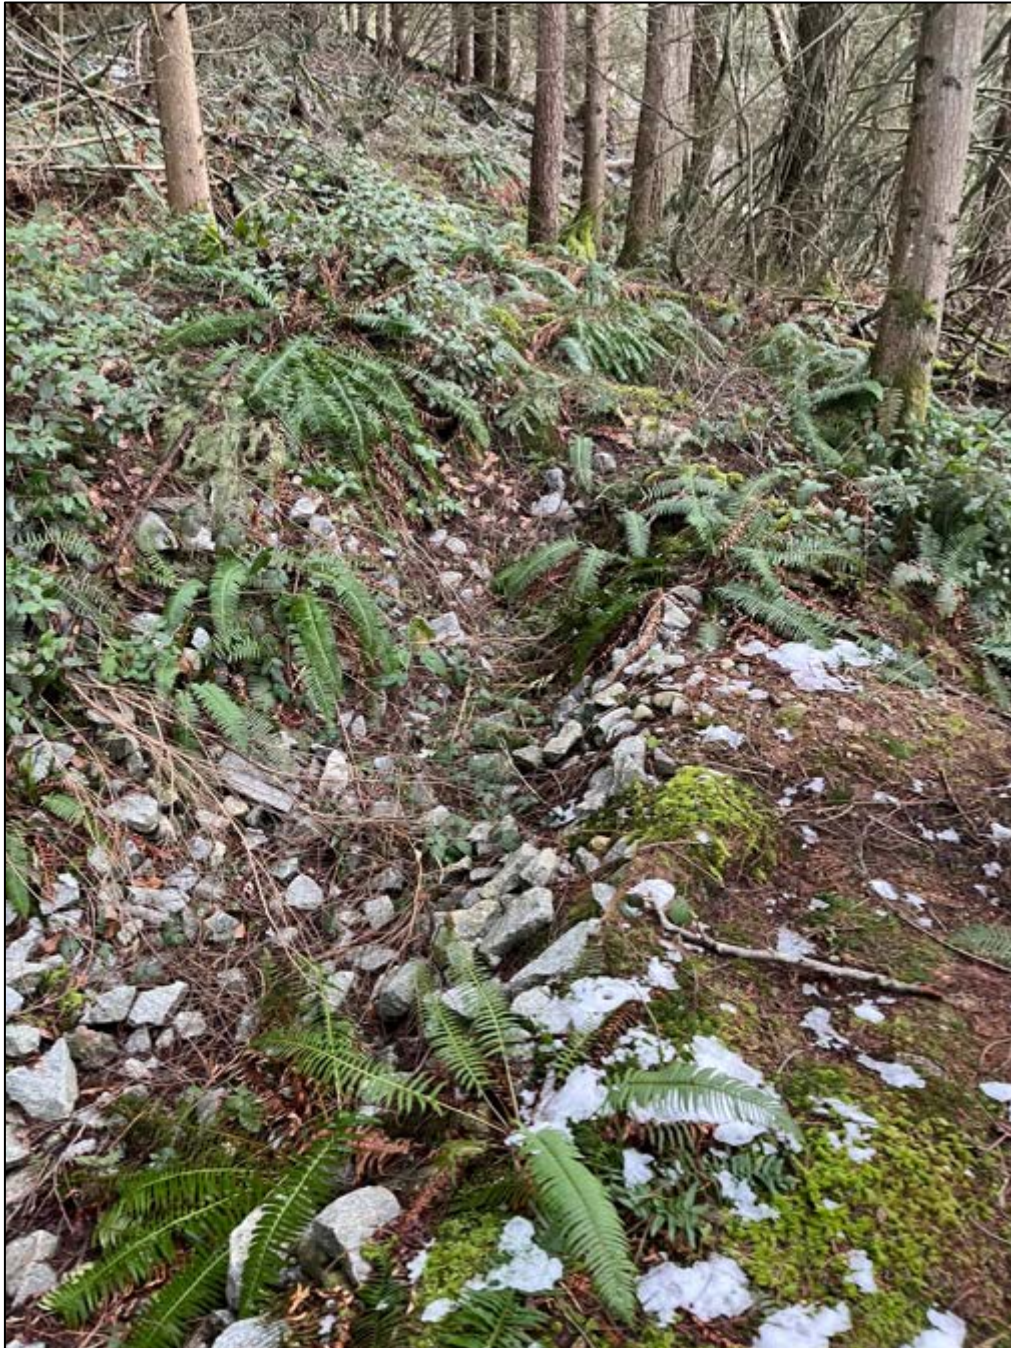
Photograph 17. View of dry ditch along a historical skidder road at the Site (March 15, 2024).

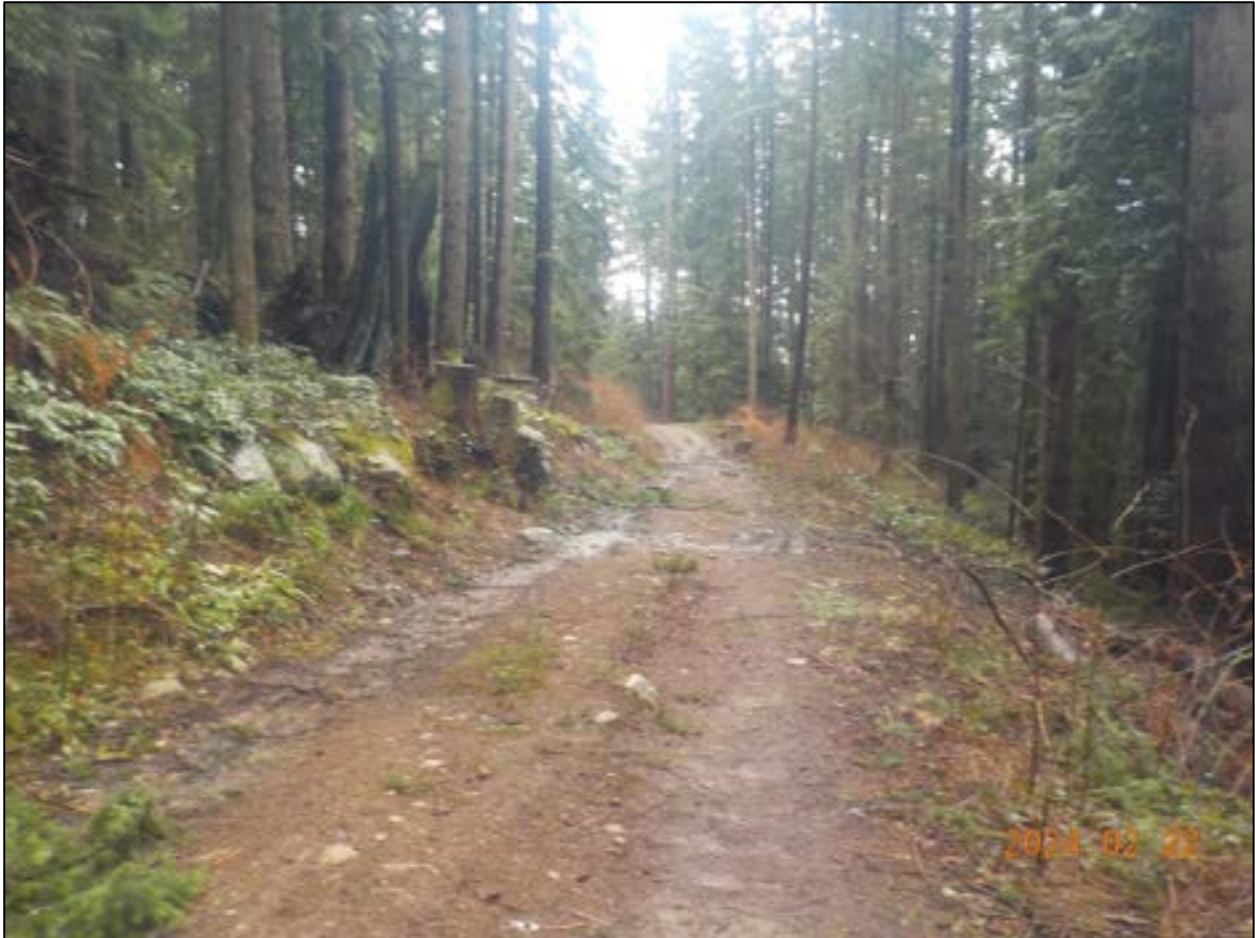
Photograph 18. View of typical section of a logging road at the Site (February 22, 2024).
