## Final Report

# Stormwater Master Plan

*Village of Anmore, BC  
September 19, 2018*

Project ID: 2017-051-ANM

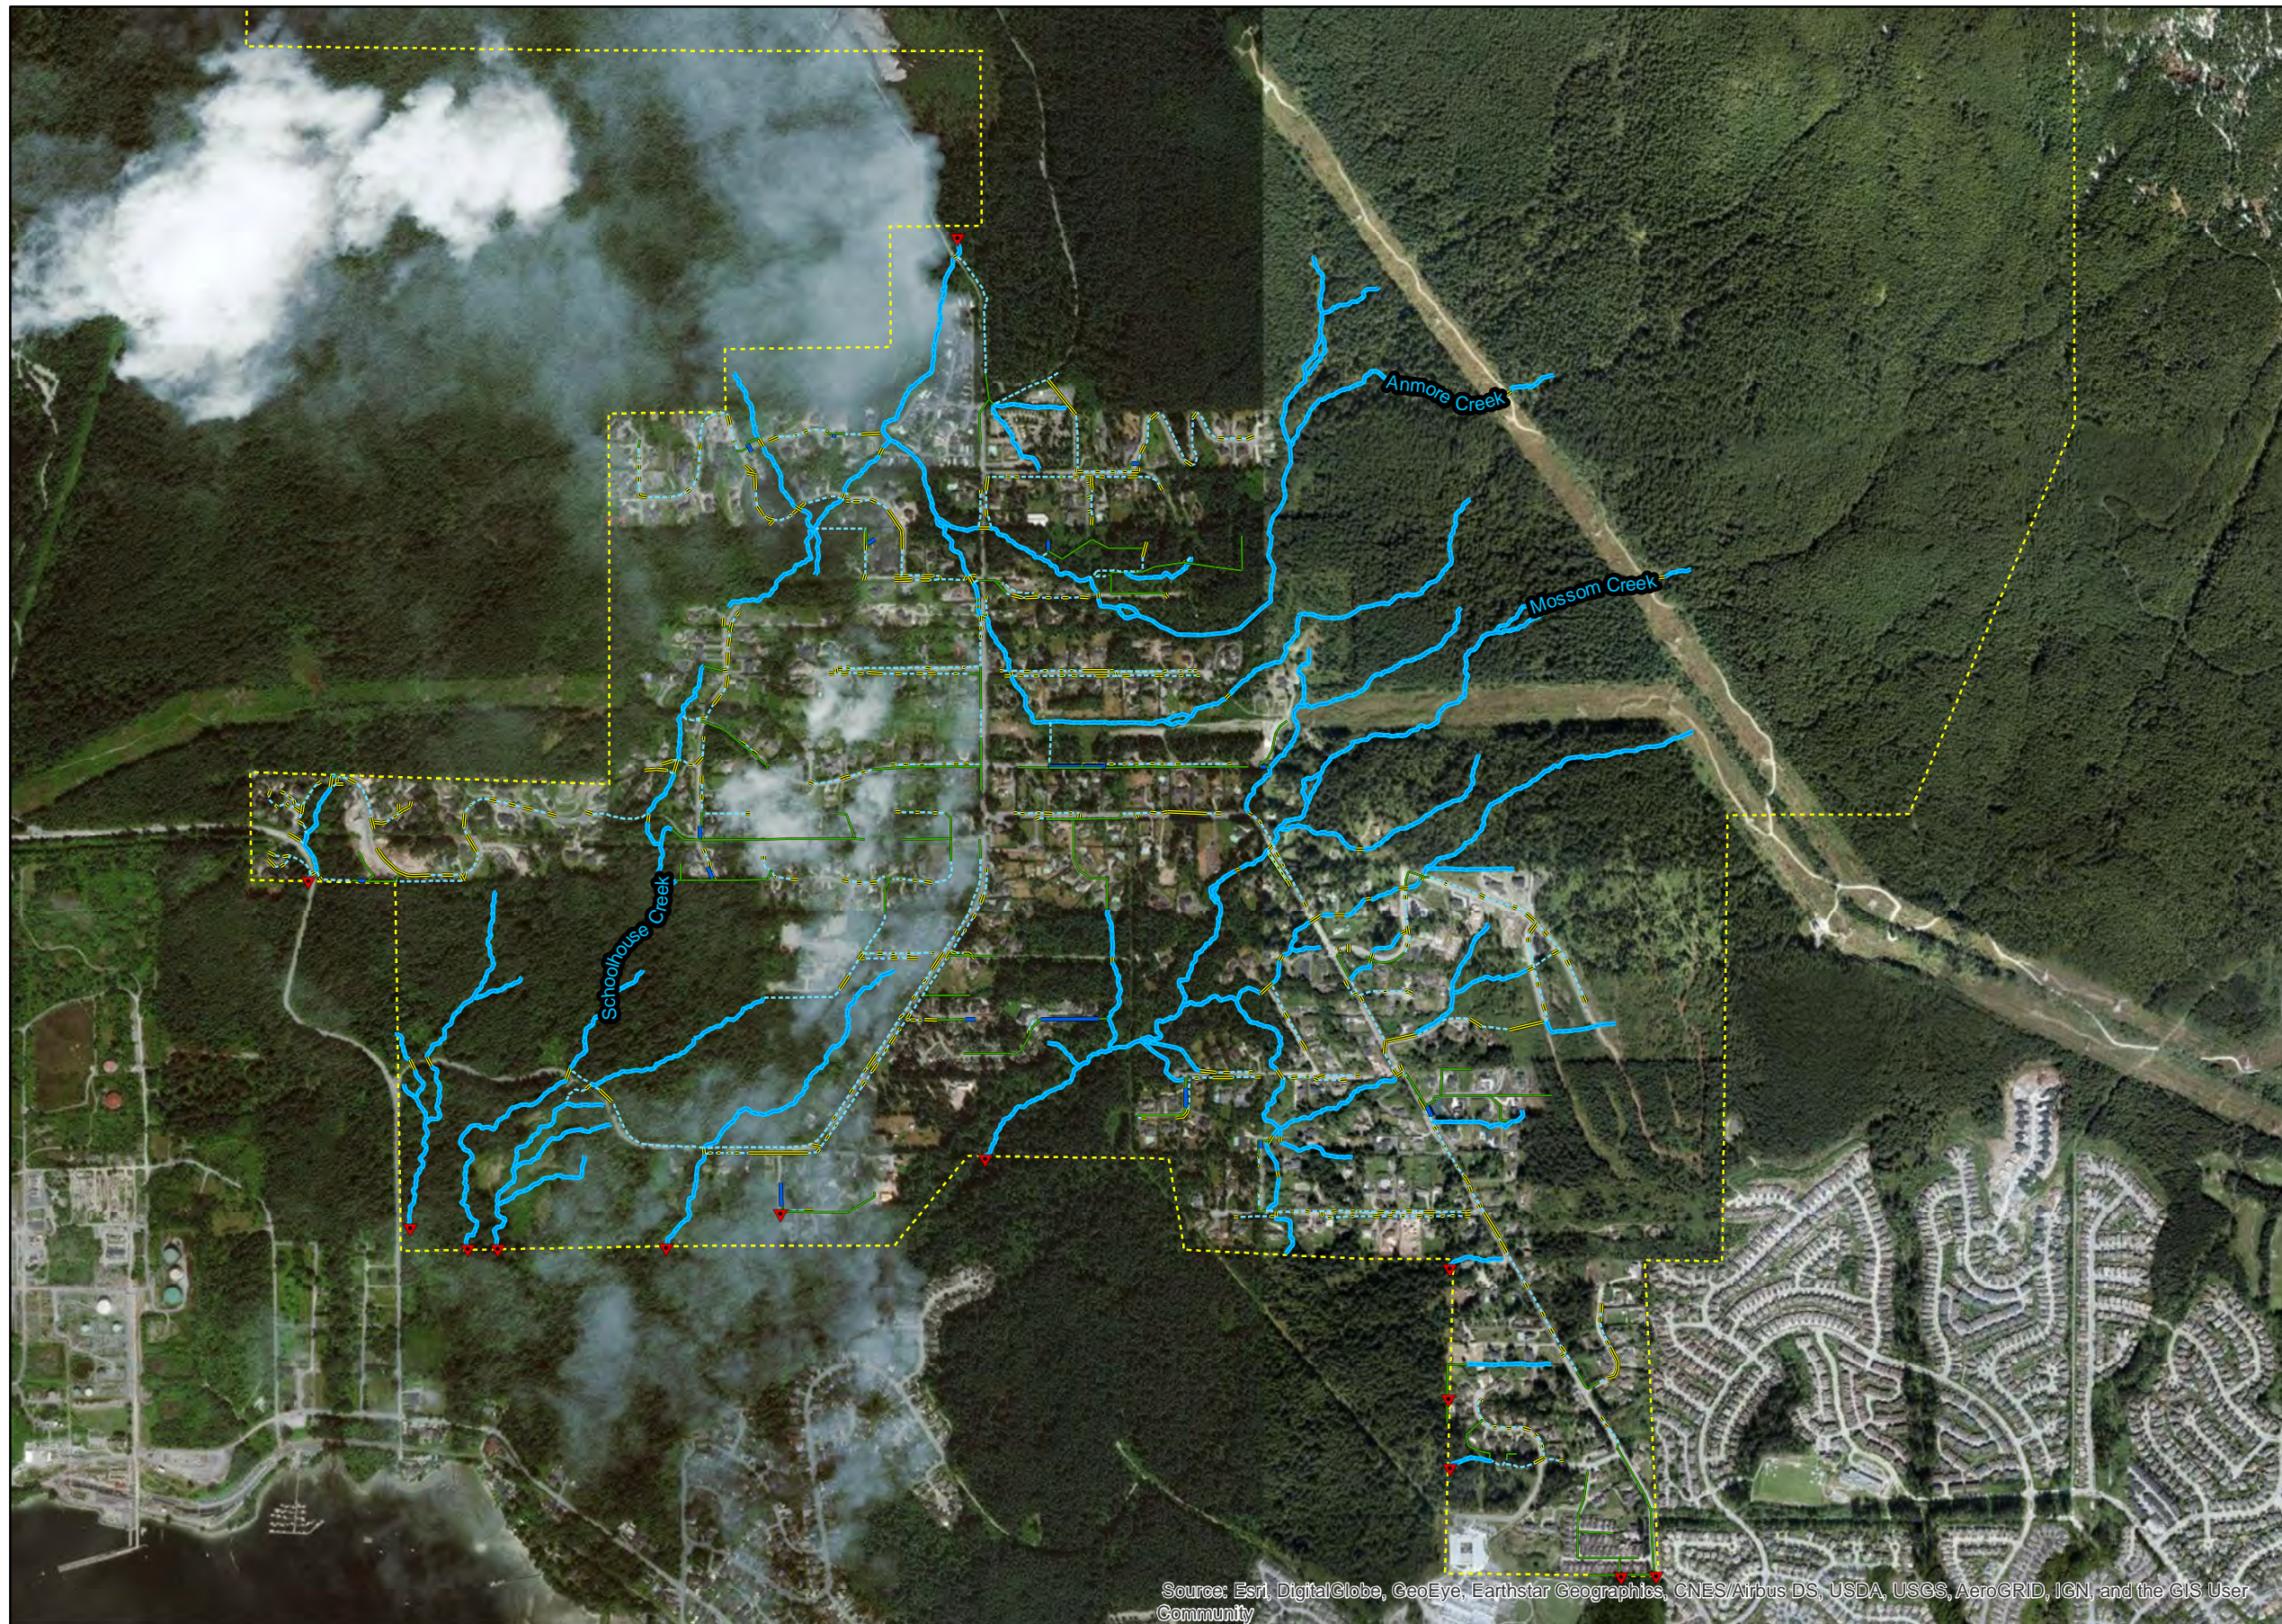
**Village of Anmore  
Stormwater System**

- ▼ Outfall
- Culvert
- Storm Main
- Creek
- - - Ditch
- Detention Main
- Village of Anmore Boundary

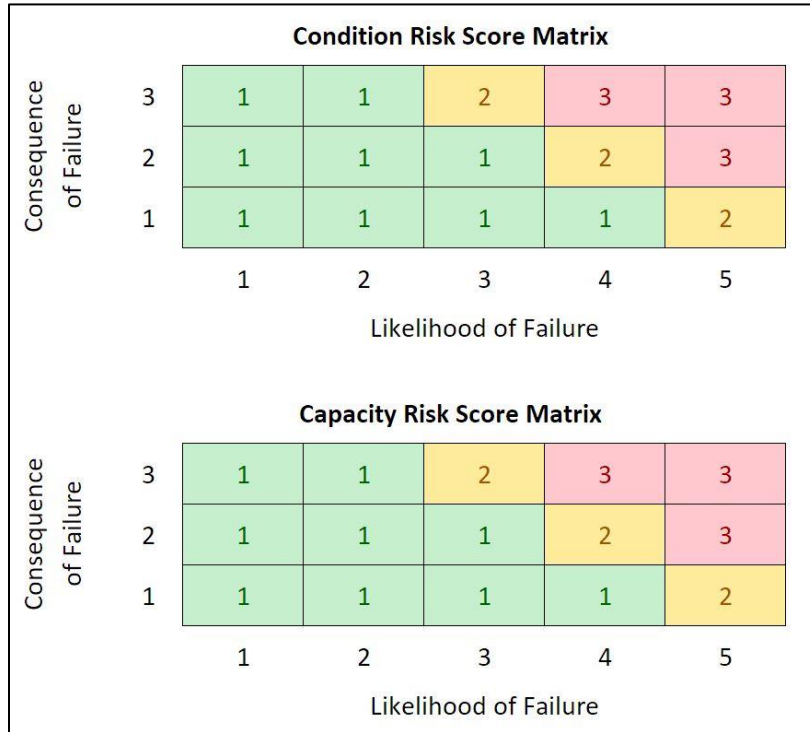
**Figure 6.6: Condition and Capacity Risk Score Matrices**

Matrices of the relationship between an asset’s condition and capacity LoF ratings and its consequence of failure ratings are shown in **Figure 6.6**. The matrices were used to assign condition and capacity risk scores to each asset. A risk score of ‘1’ represents the lowest risk while a risk score of ‘3’ represents the highest risk.

Figure 6.6: Condition and Capacity Risk Score Matrices ..... 63

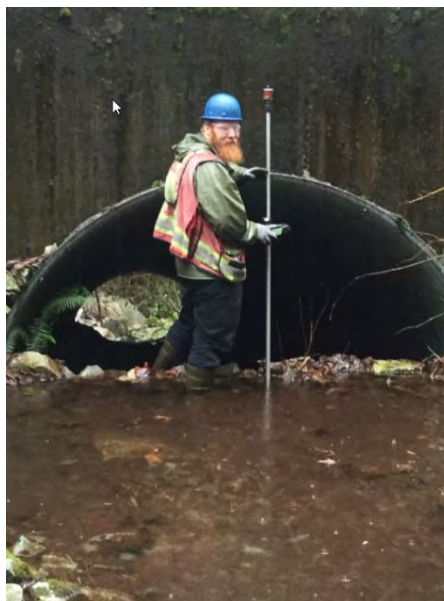
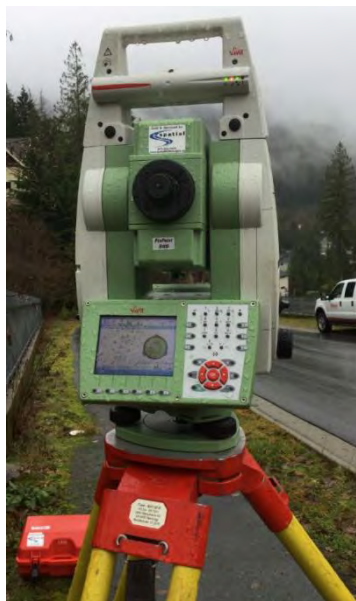
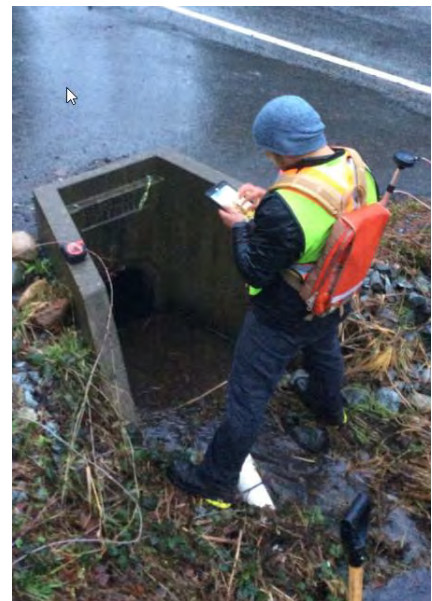
The 265 culverts over 300mm diameter were surveyed by an Urban Systems land surveyor to collect the precise location and invert elevations of each of these culverts. The larger diameter culverts were surveyed using a high accuracy survey grade system (TS15, GS24, CS15 system). The expected accuracy from this system is 1 cm. The location of the remaining 222 smaller diameter culverts was collected by field staff using a backpack SX Blue II + GNSS system. The location accuracy of the backpack GPS ranged from 20 cm – 100 cm, depending on location of the culvert. Below are sample photos taken during the field investigation:

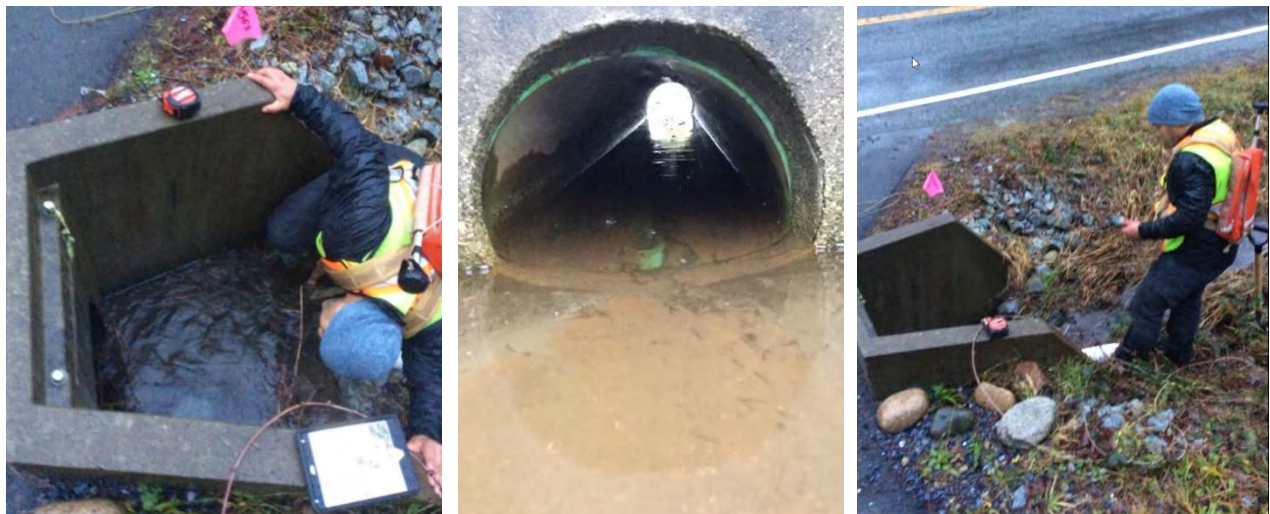
The data collection and culvert condition assessment were performed throughout a 3-week period from January 15<sup>th</sup> - February 2<sup>nd</sup>, 2018. during the hours of 8 am – 5 pm. Urban Systems field staff were tasked to assess all culverts in the Village. The final culvert count was 487. The inventory of the culverts included capturing the diameter, material, length, condition, notable deficiencies, maintenance needs and photos of assets and found deficiencies such as such as blockages, damaged ends, visible scour, degraded conduits, etc. Below are sample photos taken during the field condition assessment:
