Icona Properties
#900 – 1111 West Hastings Street
Vancouver, BC
V6E 2J3

November 15, 2023
File: 21741
R0

**Re: Geotechnical Investigation Report – Proposed Community Development
Anmore South – Sunnyside Road and First Avenue, Anmore, BC**

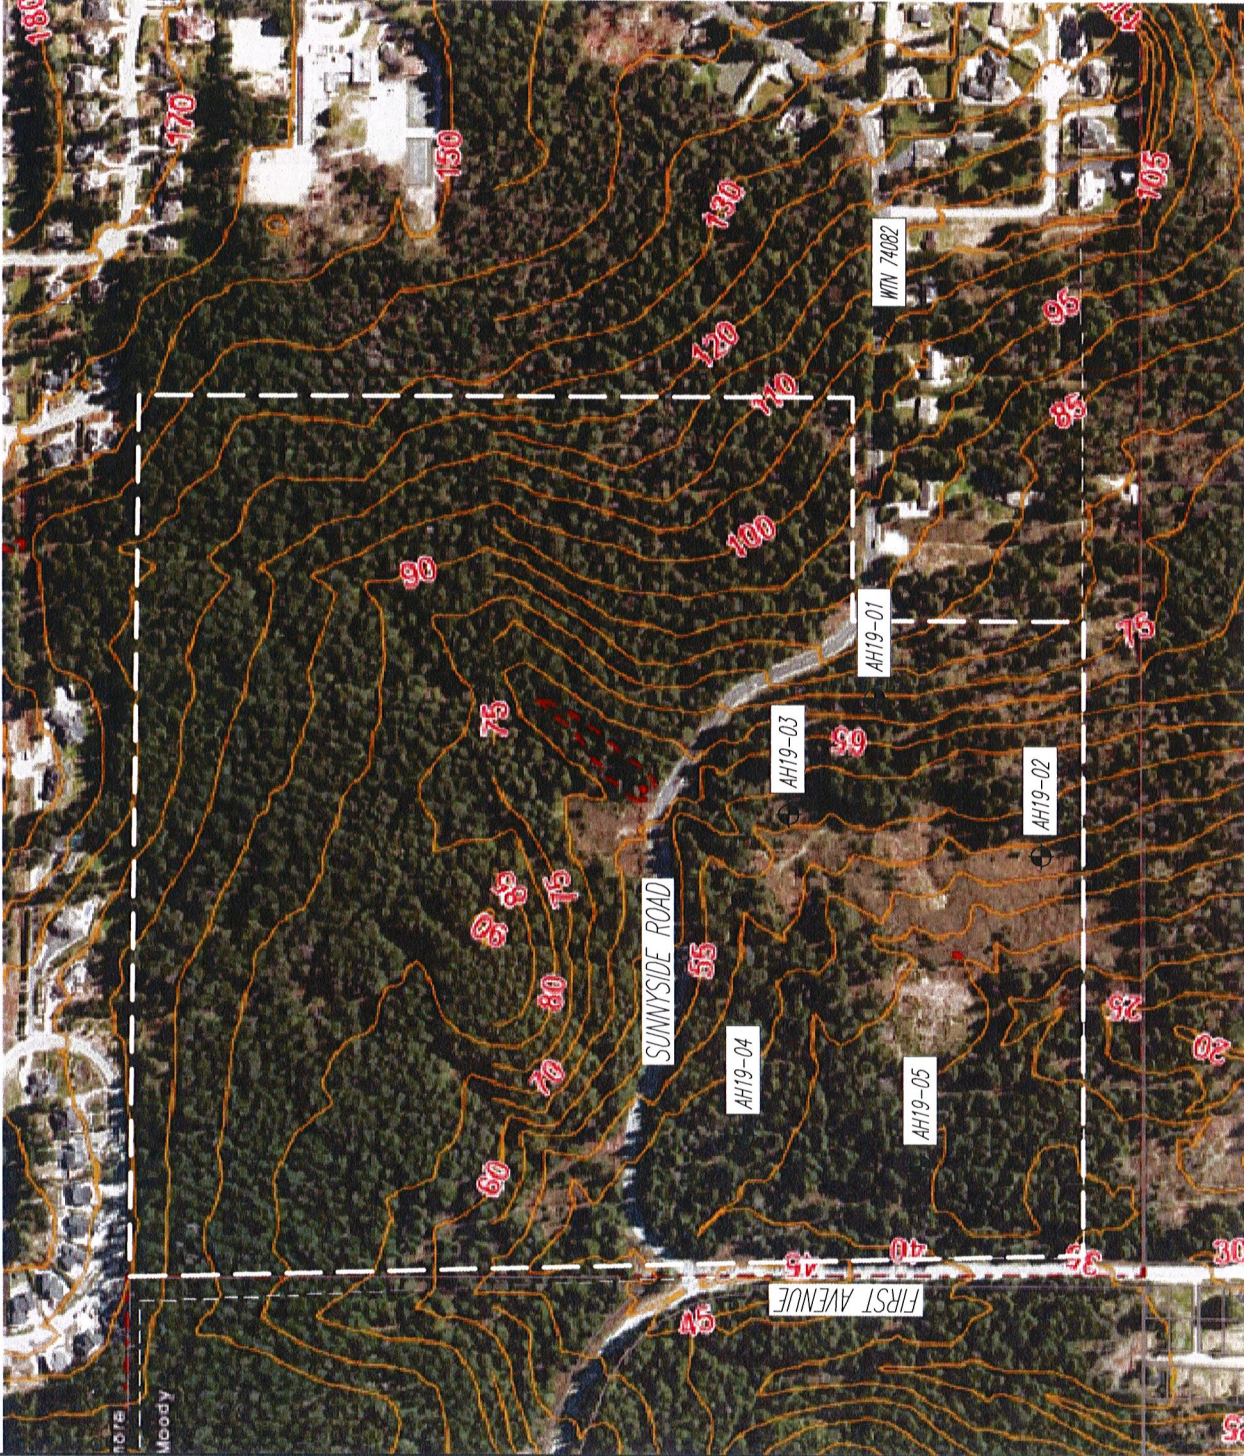
FILE NO.:	21741
DWG. NO.:	21741-02
	A.
	B.
	C.

GEOTECHNICAL INVESTIGATION

Anmore Lands; Anmore, BC
REFERENCE BOREHOLES

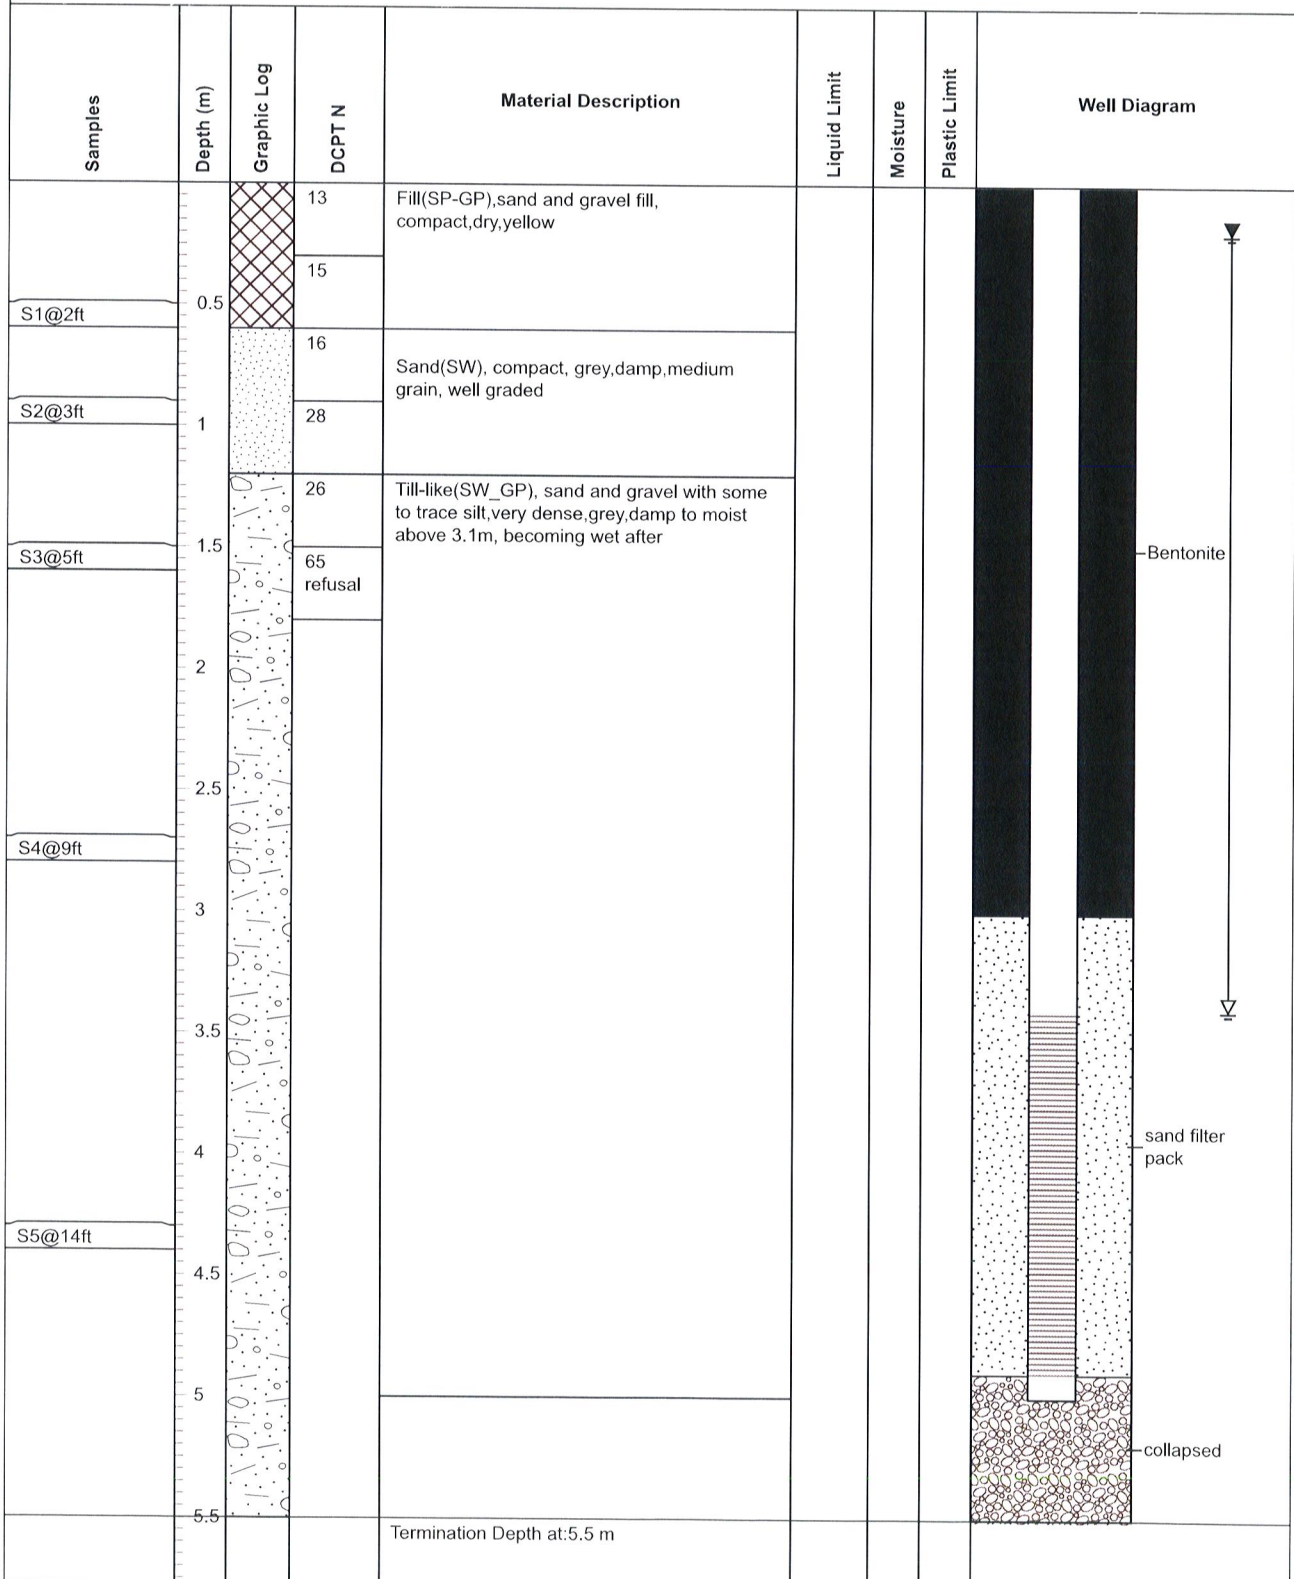
Soil LOG AH2019-04

COMMENTS middle of trail near north end-refer to Figure 1 in Appendix -A
