Icona Properties  
#900 – 1111 West Hastings Street  
Vancouver, BC  
V6E 2J3

November 15, 2023  
File: 21741  
R0

**Re: Geotechnical Investigation Report – Proposed Community Development  
Anmore South – Sunnyside Road and First Avenue, Anmore, BC**

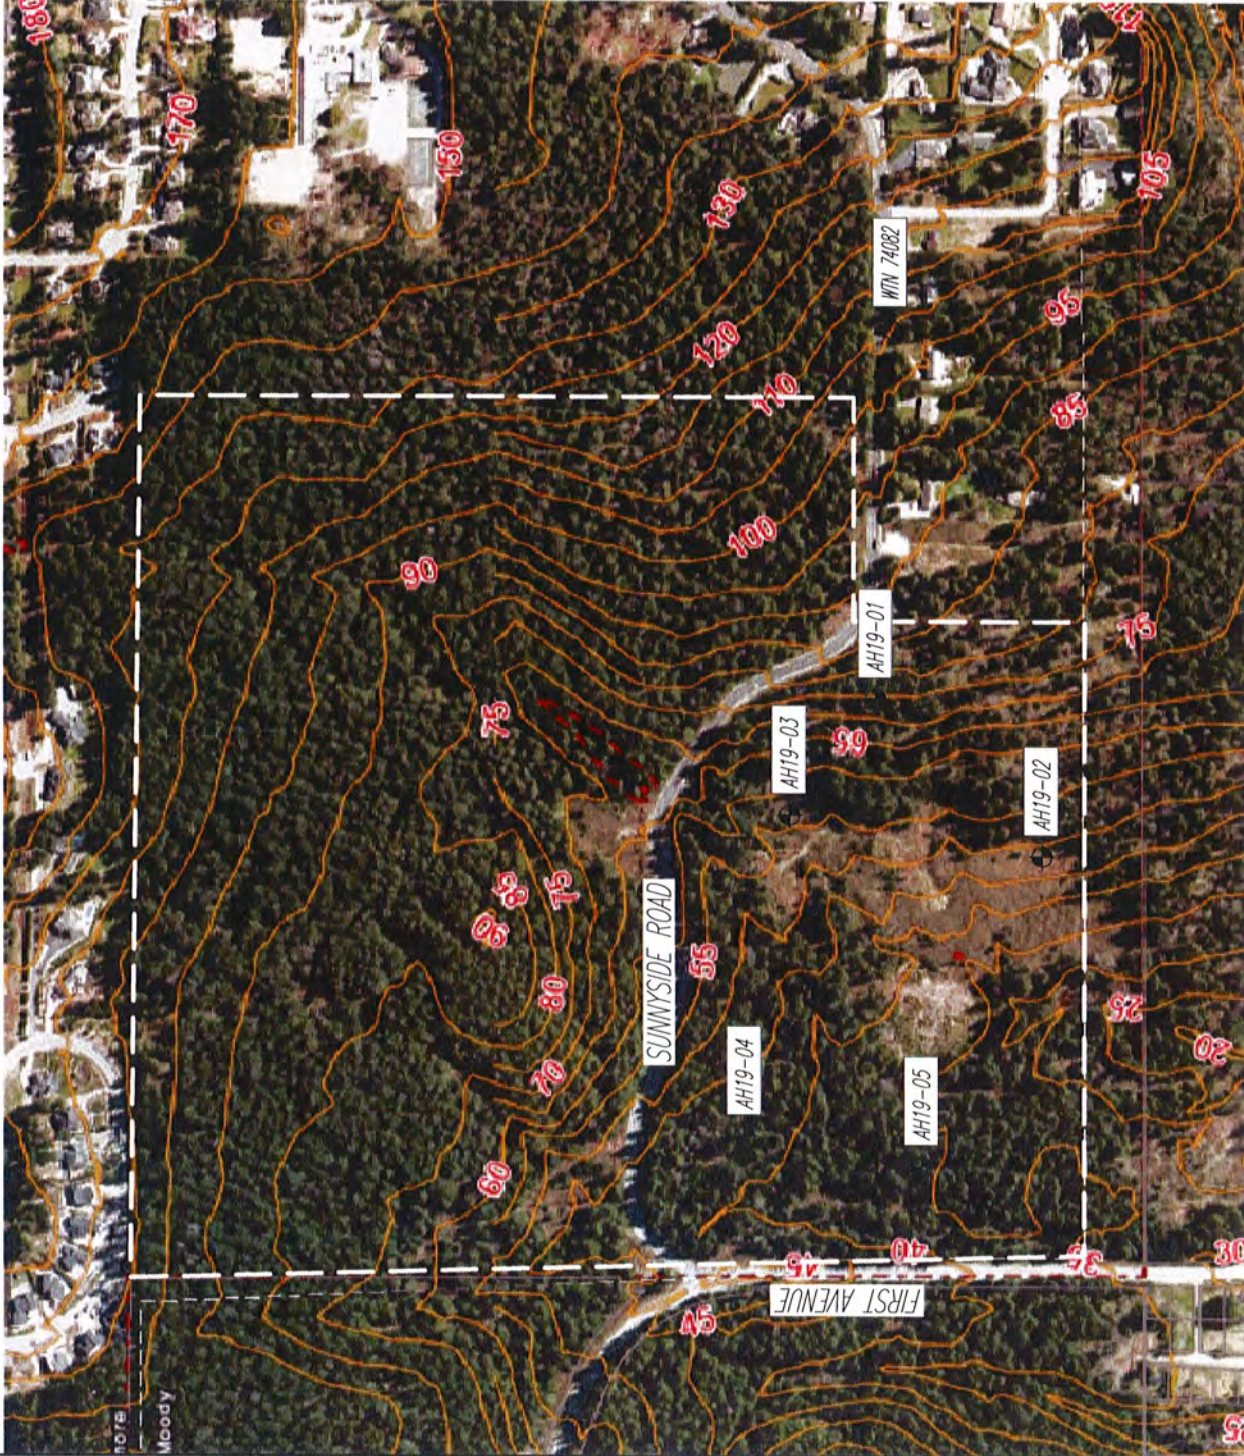
DWG. NO.: 21741-02

**GEOTECHNICAL INVESTIGATION**  
Anmore Lands, Anmore, BC  
REFERENCE BOREHOLES

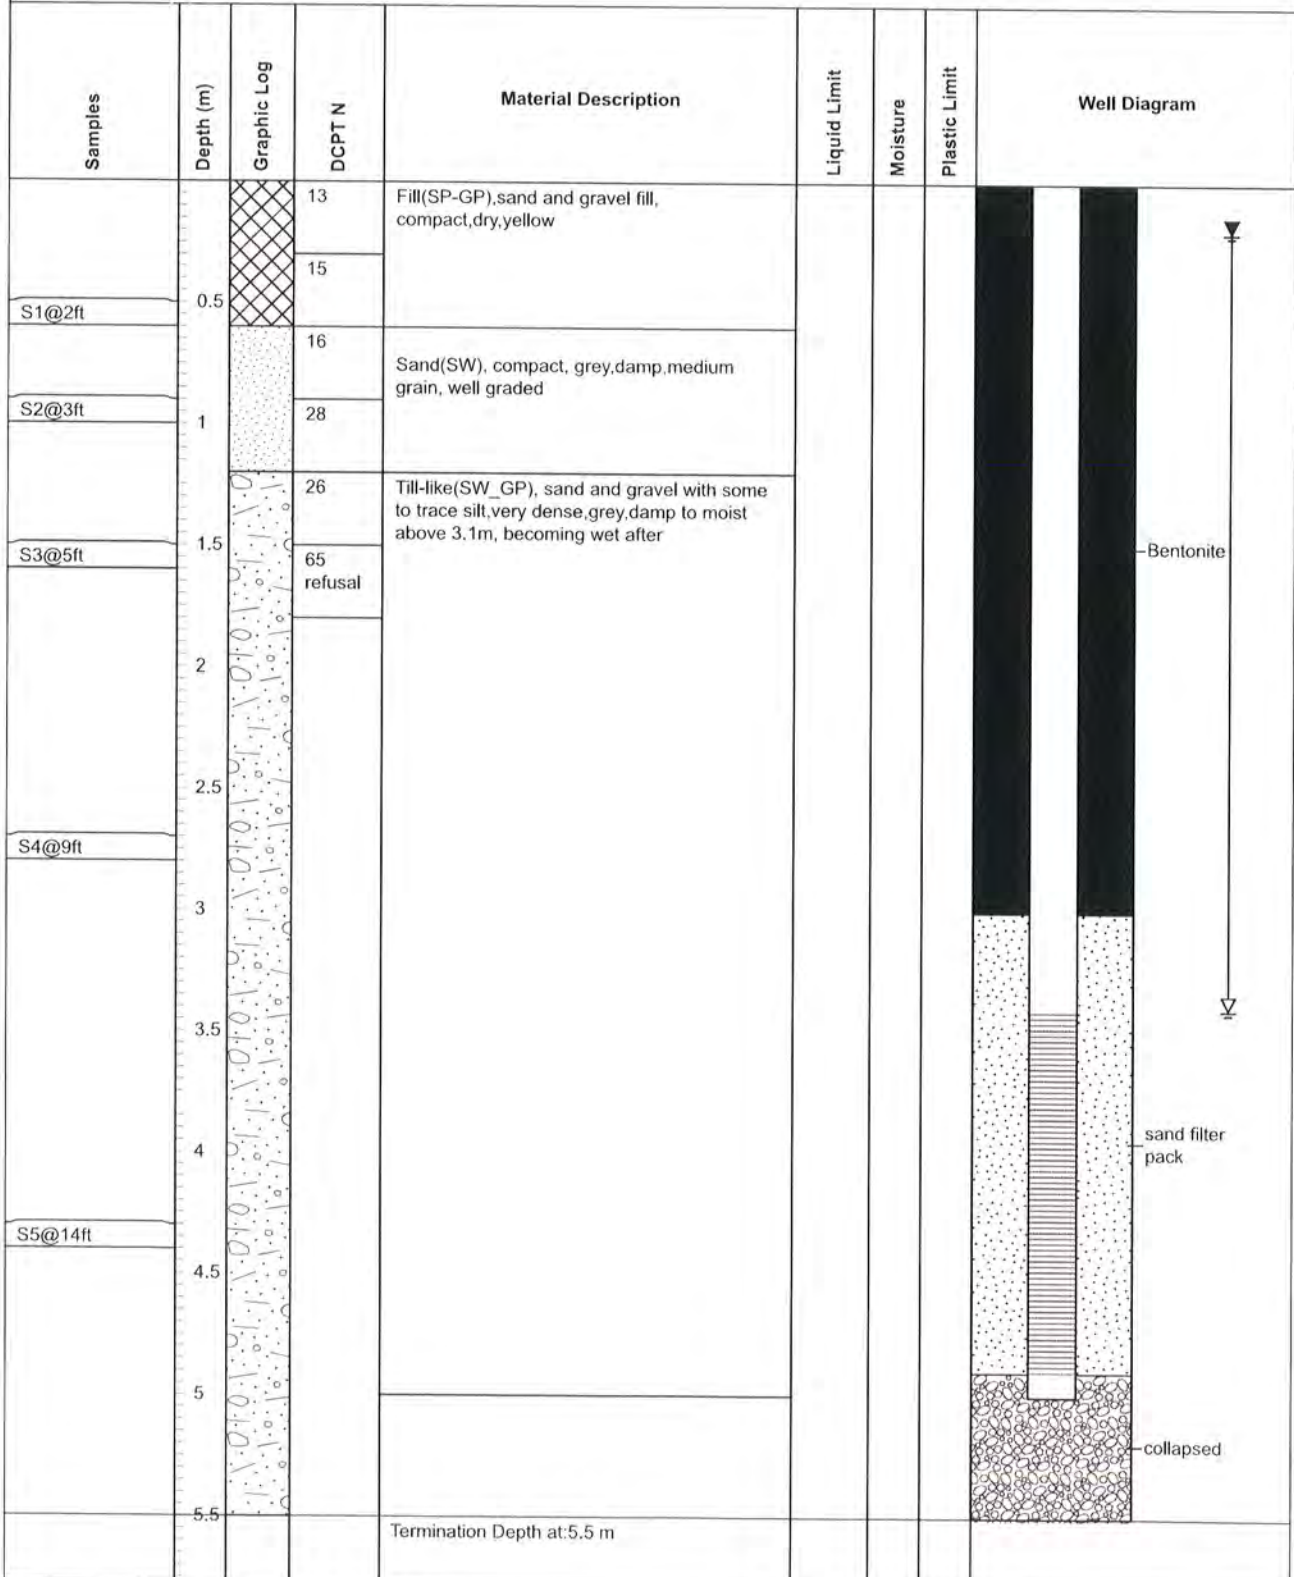
# Soil LOG AH2019-04

**COMMENTS** middle of trail near north end-refer to Figure 1 in Appendix -A
