### Re: Geotechnical Investigation Report – Proposed Subdivision Development – The Summit (TREZ) Pinnacle Ridge, Anmore, BC Lot 23 Sec 21 TP 39 New Westminster District PL BCP50736

### **1.0 INTRODUCTION**

We understand that MNP Ltd. intends to develop a new residential subdivision at the above referenced property. The Landmark Engineering & Planning Conceptual Lot Layout Plan drawings, dated November 20, 2023, show a residential subdivision that includes 34 lots with on-site paved roadways, utilities, and park dedication. This subdivision has been coordinated with adjoining residential subdivision developments proposed to the south, Anmore Gate and Bella Terra, among others, as part of a residential master plan, and future roadways for the subdivision development will be interconnected with these adjacent properties. The development would include the extension of the existing Ridge Mountain Drive, which provides access to the east portion of the sites, the extension of North Charlotte Drive, which connects to Charlotte Crescent in Port Moody, along with new internal roads and cul-de-sacs.

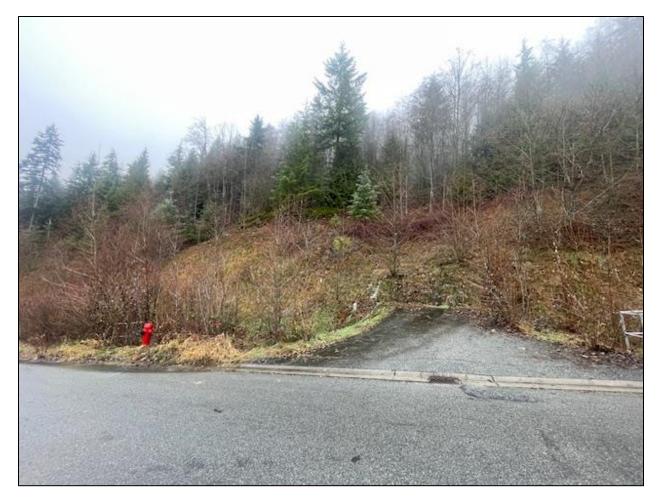
**Photo 5**: Transient stream flow north of Ridge Mountain Drive flowing into Minor Drainage System #1 ditch along upslope side of road (December 11, 2023)

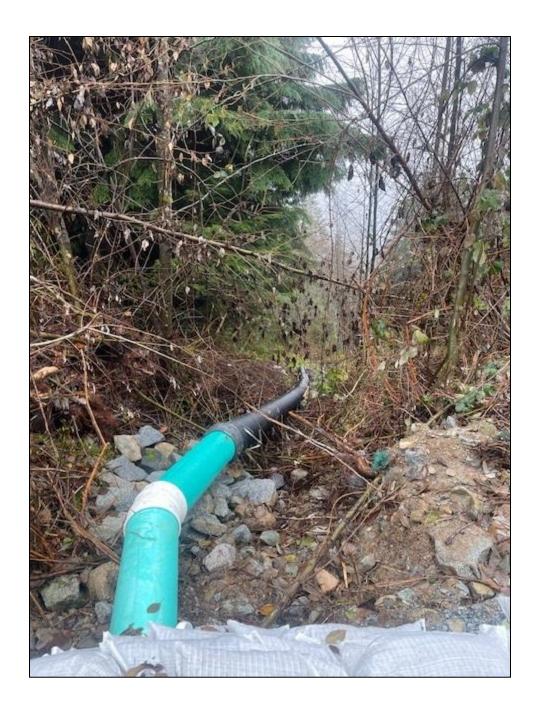
*Photo 8:* Minor Drainage System # 2, stormwater drainage pipe at south extent of asphalt paved Ridge Mountain Drive, collecting drainage from the swale shown in Photo 7, looking downslope/west (December 11, 2023)

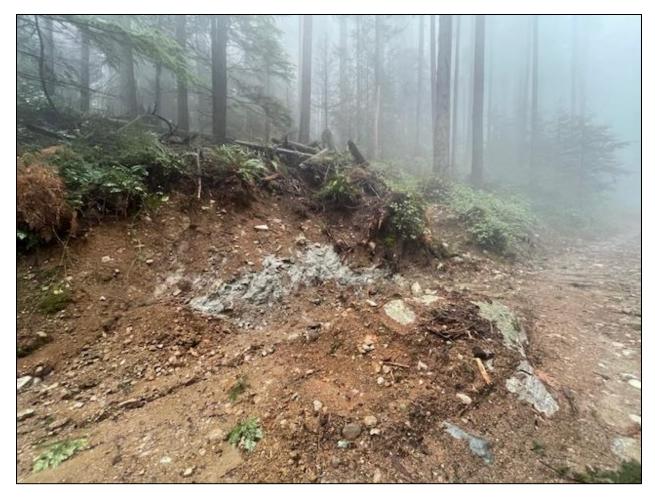
*Photo 9*: Exposed very dense glacial till and large boulder/bedrock outcrop along the Ridge Mountain Drive extension (December 11, 2023)

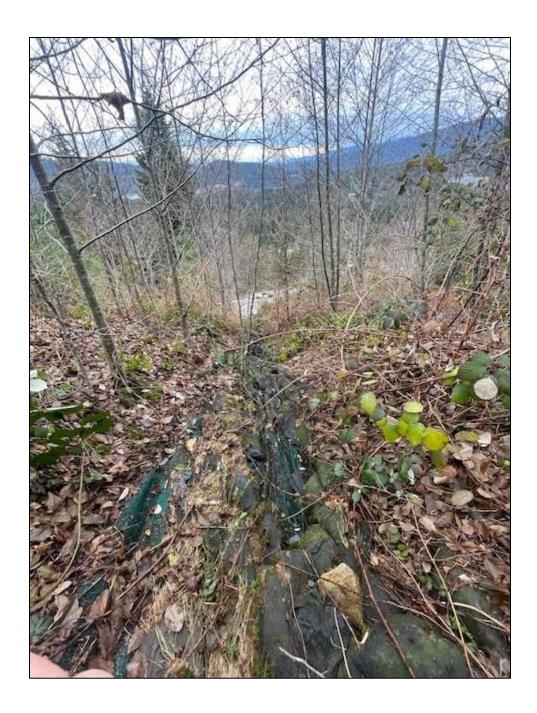
Photo 13: Upper extent of Minor Drainage System #2, downslope drainage swale at southern portion of TREZ development (December 13, 2023)

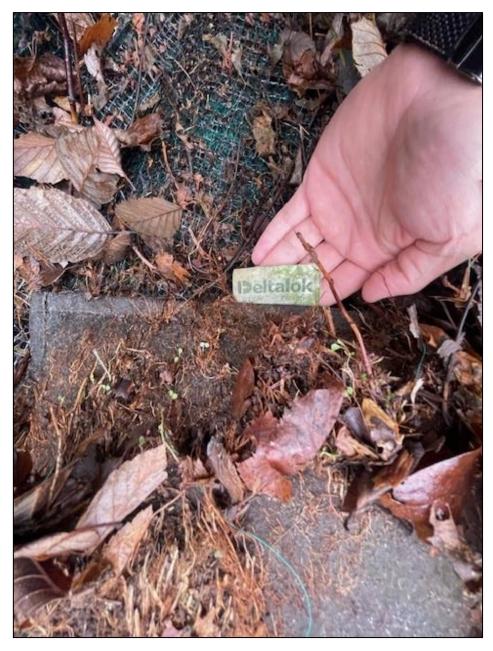
*Photo 14*: Downslope drainage swale at southern portion of TREZ development showing Deltalok<sup>™</sup> Geo-Modular Bags (December 13, 2023)

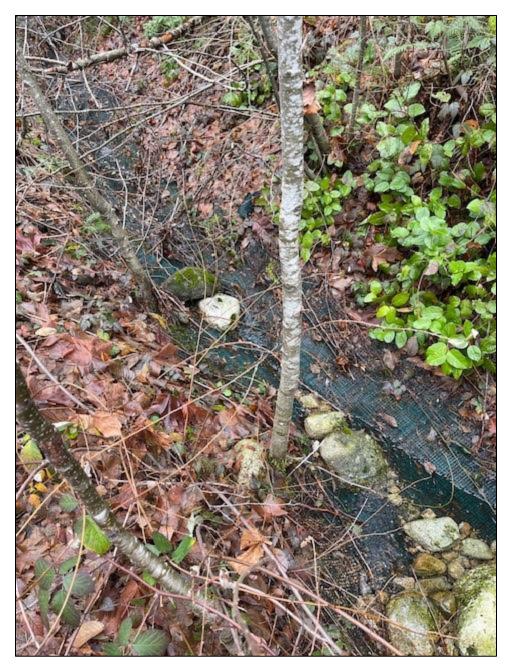
Photo 15: Cross-slope swale at southern portion of TREZ development (December 13, 2023)

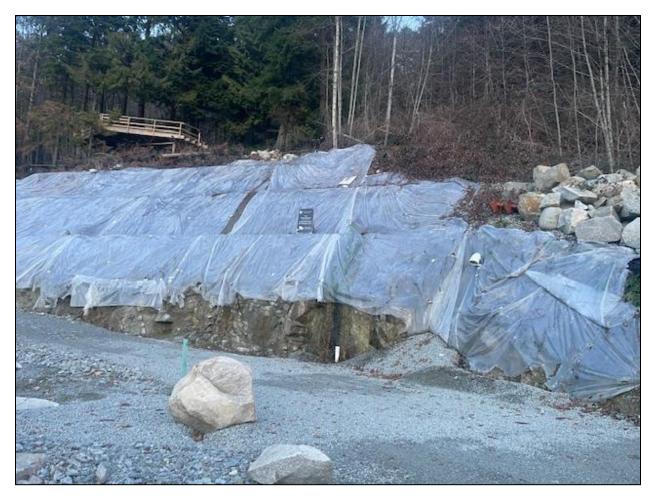
Photo 17: Bedrock outcrop at NE corner of intersection of Ridge Mountain Drive and North Charlotte Way (December 13, 2023)

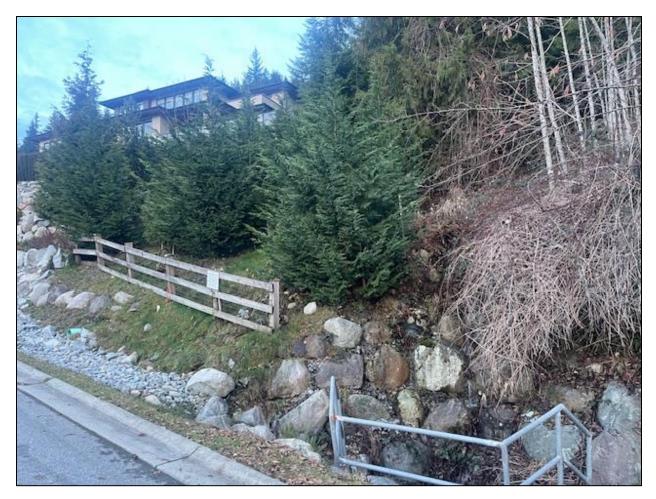
**Photo 18**: Minor System #1 draining into culvert at east side of North Charlotte Drive at south portion of 1983 North Charlotte Drive (December 13, 2023)

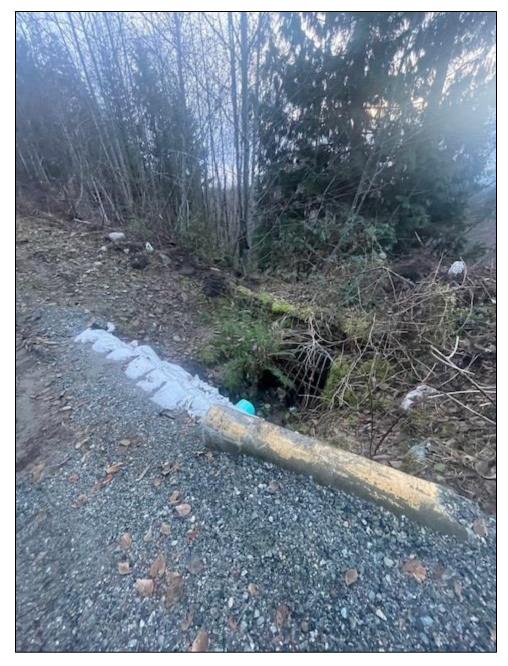
*Photo 20*: Minor Drainage System #2, stormwater drainage pipe intake at west side of North Charlotte Drive extension (December 13, 2023)

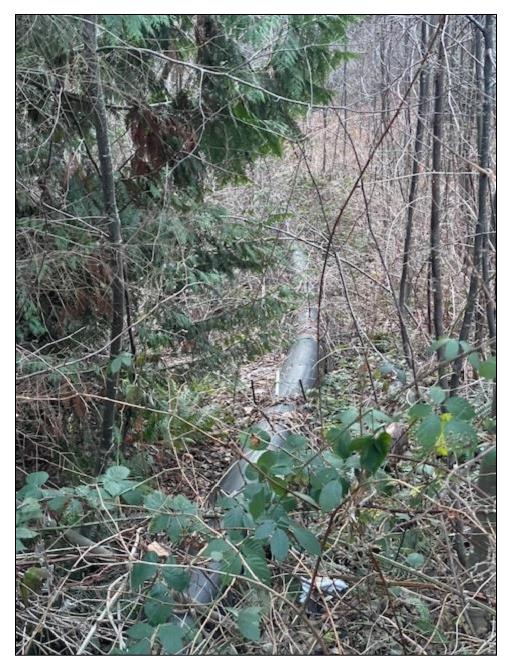
*Photo 21:* Minor Drainage System #2, stormwater drainage pipe at west side of North Charlotte Drive extension (December 13, 2023)

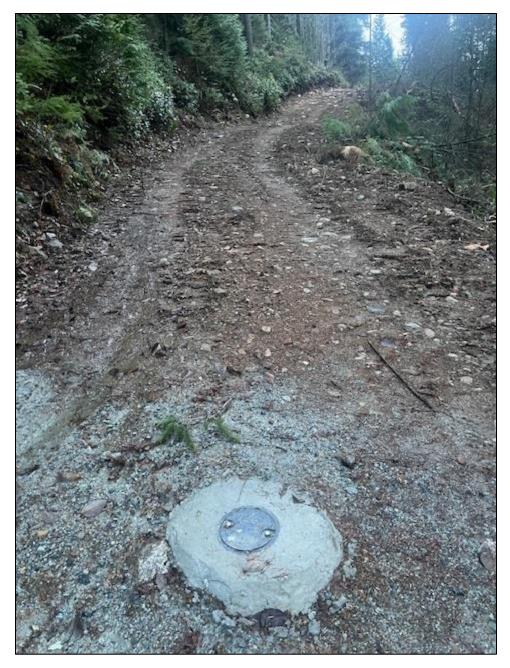
Photo 22: North Charlotte Drive extension and groundwater monitoring well (December 13, 2023)

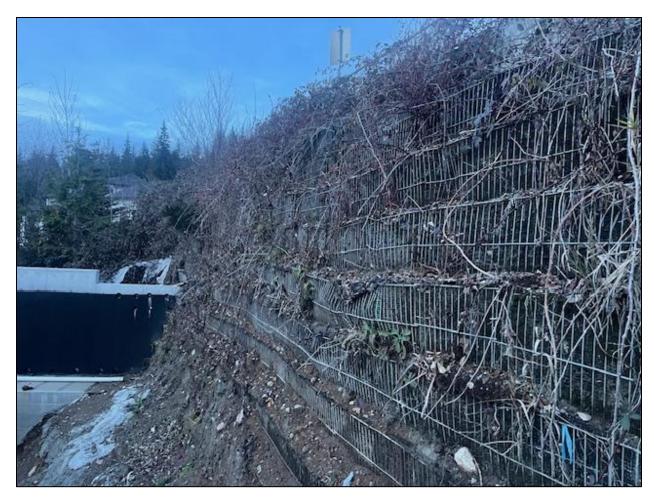
Photo 25: MSE Retaining wall along west/downslope side of North Charlotte Drive (December 13, 2023)

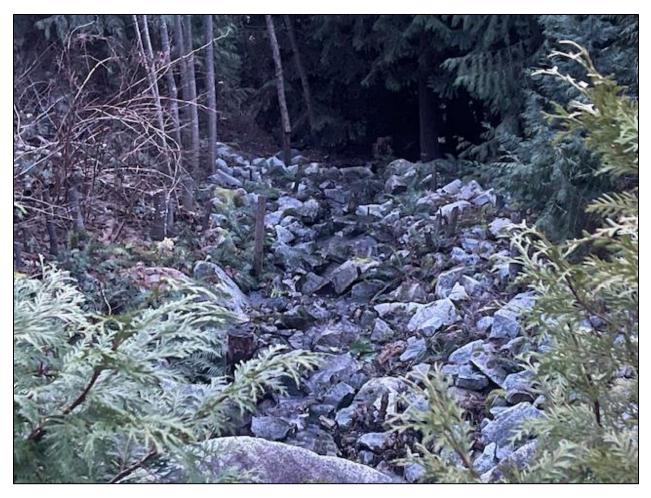
Photo 26: Minor Drainage System #1 downslope of culvert at Ridge Mountain Drive

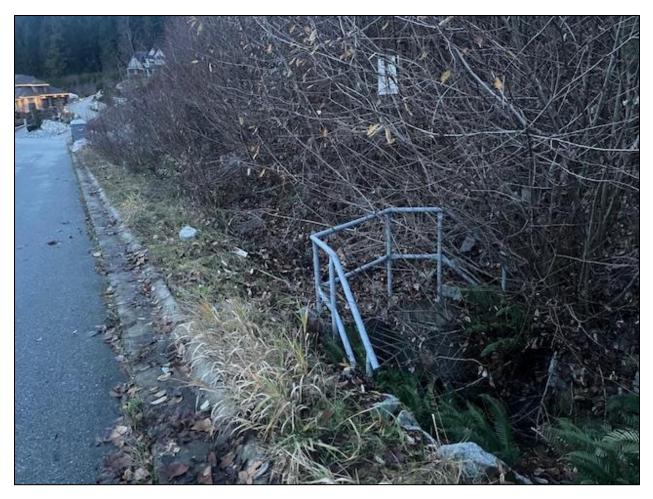
Photo 27: Minor Drainage System #1 upslope of culvert at Ridge Mountain Drive

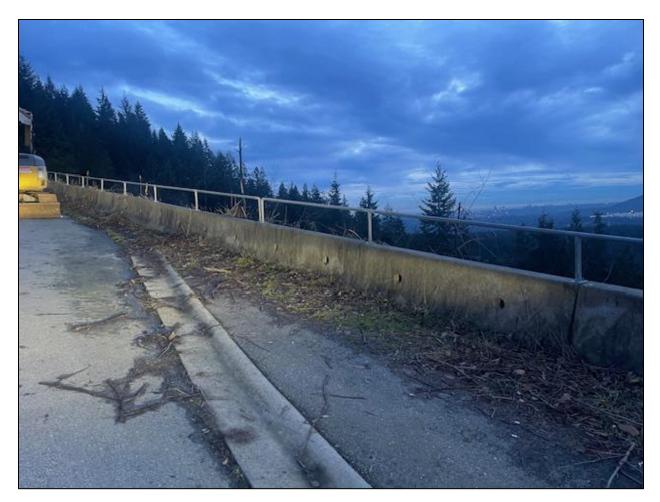
Photo 28: MSE Retaining wall along west/downslope side of Ridge Mountain Drive (December 13, 2023)

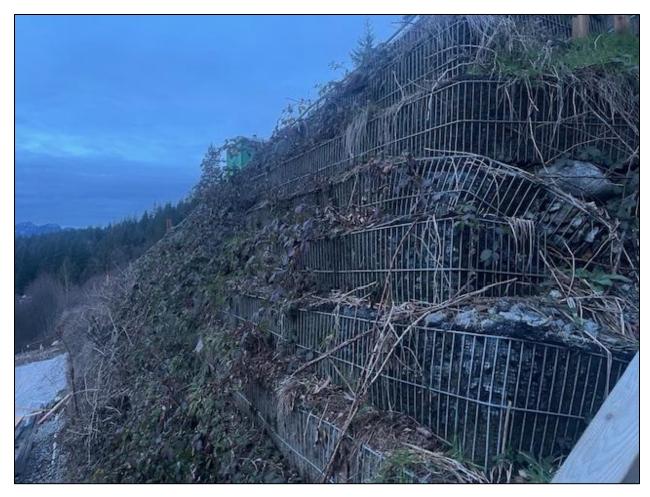
Photo 29: MSE Retaining wall along west/downslope side of Ridge Mountain Drive (December 13, 2023)
