*Village of Anmore*

# **Water Utility Master Plan**

Date: May 15, 2015  
Reference: D-85702.00  
Status: Final

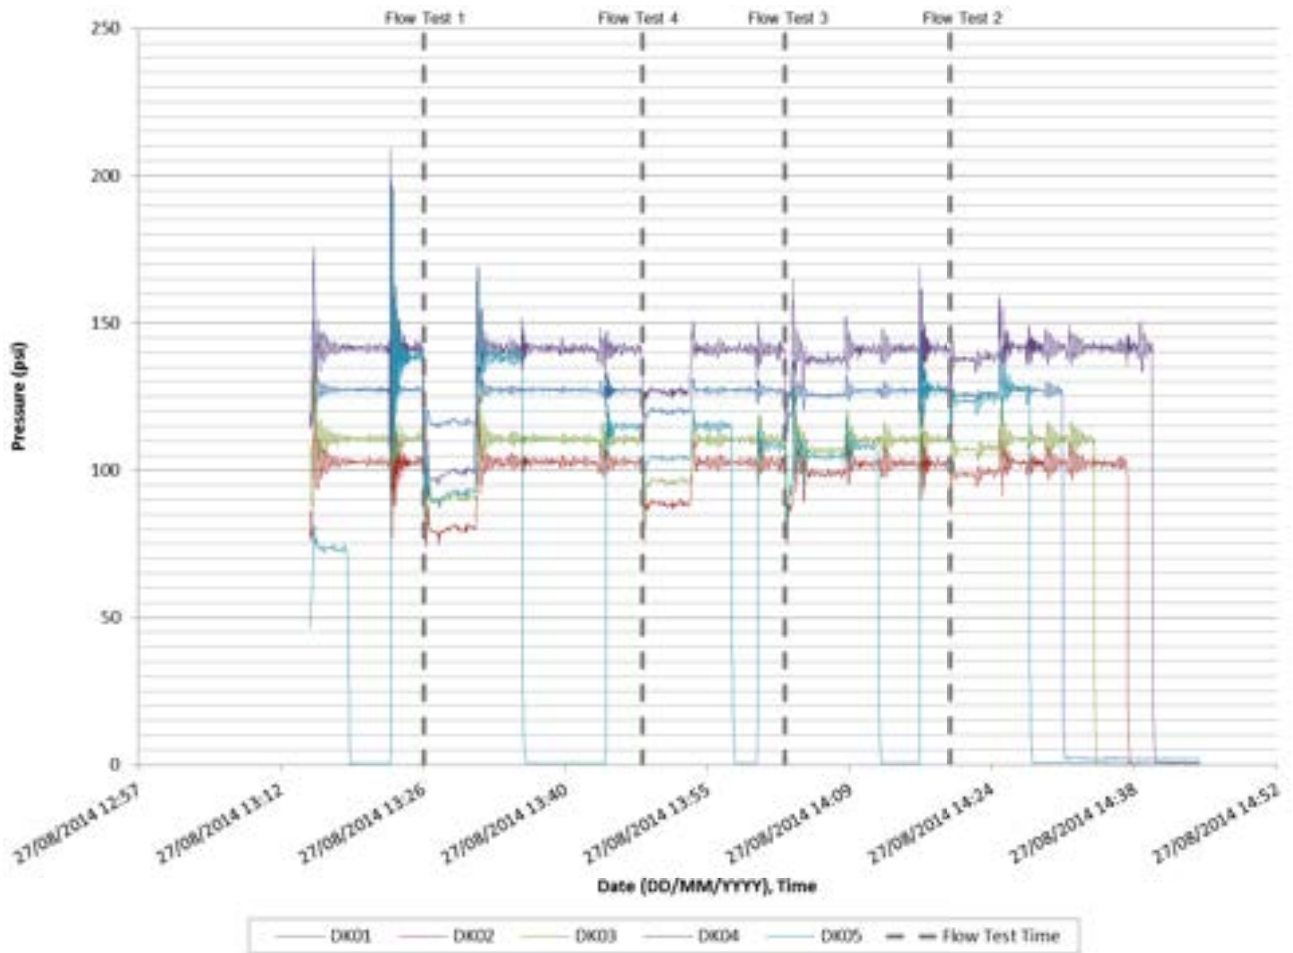
**Figure 4-2 Flow Test Set # 1**

#### 4.2.1 Test Set #1 (290m HGL Zone)

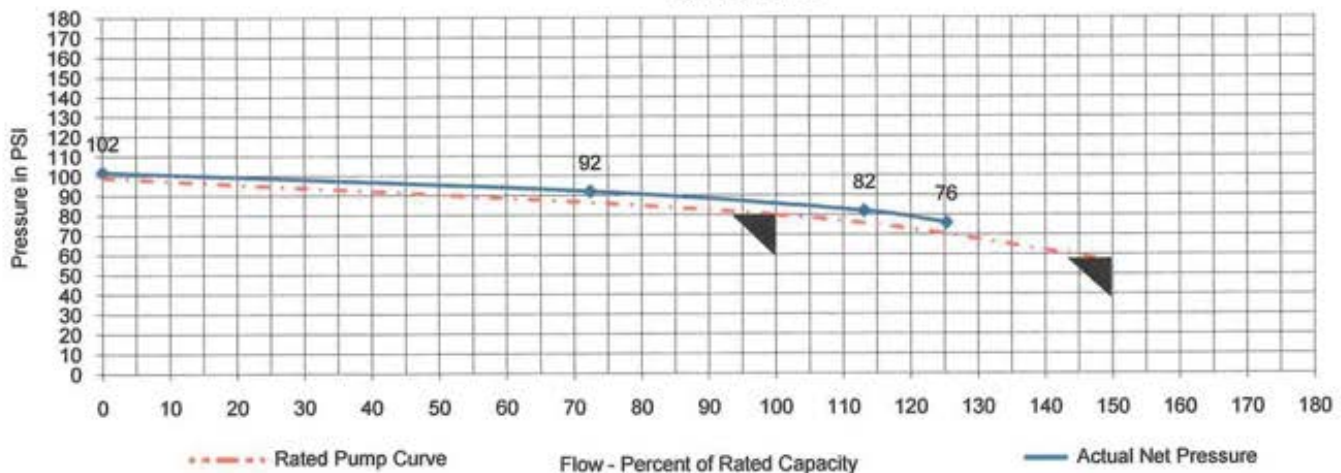
Flow Test Curve

We certify that this pump was tested in accordance with the NFPA 20/25 standards:      Pass:       Fail:       See Comments:
