2024 ANNUAL WATER QUALITY REPORT

Public Works Department
Village of Anmore
Prepared by: Scott Donaldson, Operations Superintendent

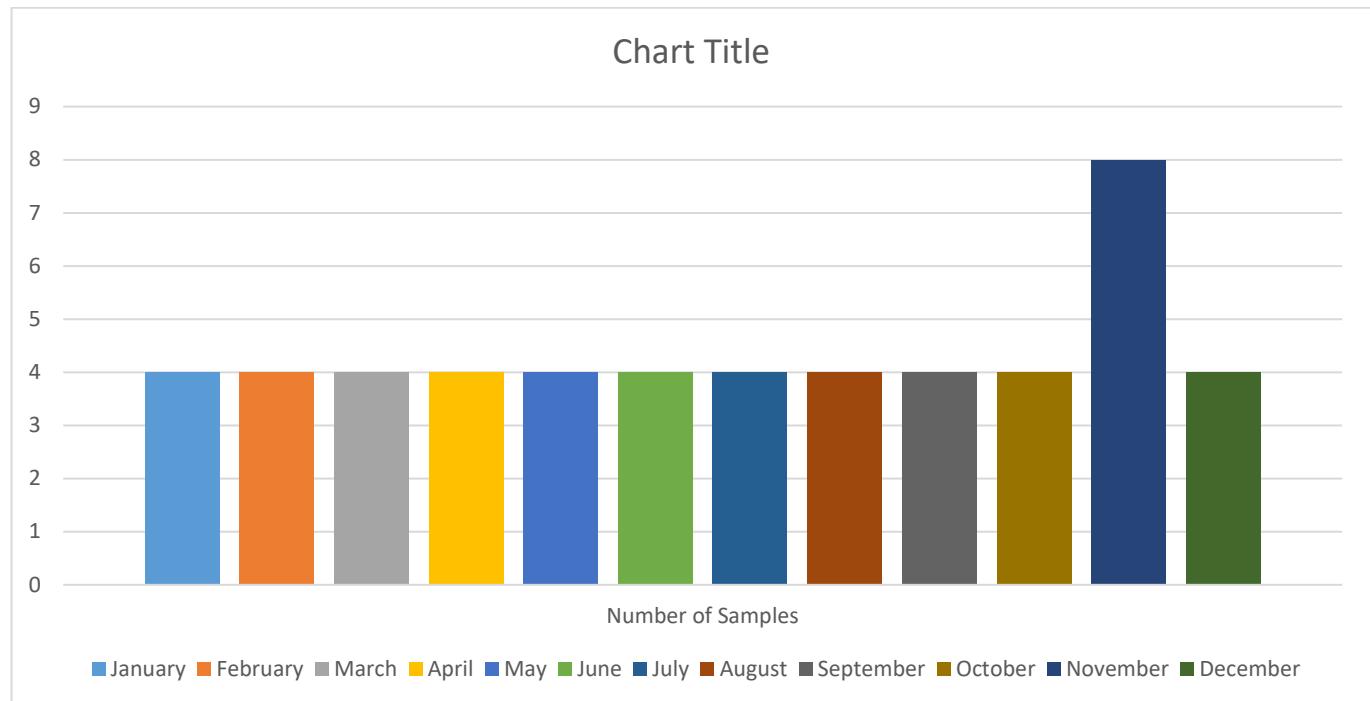
Figure #1: Number of Bacterial Samples Analysed / Month

All bacterial samples collected from municipal distribution systems are analysed for total coliform and *E. coli* bacteria. These samples are also analysed for the presence of heterotrophic bacteria. HPC bacteria provide an indicator of microbial growth in the distribution system and are used as an early warning to predict where water quality concerns may arise. The Village collects a minimum of 8 bacteriological samples per month. Further samples are collected by Village personnel on an as needed basis in response to water main breaks, operational adjustments, water quality complaints, or where cross-connections are suspected.

The quantity of bacterial samples collected from municipal water distribution systems is based on the population served. Under the BCDWPR the Village is required to collect a minimum of 4 bacteriological samples from the water distribution system per month based on population (under 5000). Figures #1 and #2 display the number of bacteriological samples collected from the Village's water distribution system and the percentage of samples collected that returned HPC results greater than 500 CFU/ml each month. It should be noted that the statistical analysis of a small number of samples per month is subject to skewing of results due to the limited number of samples. For example, if less than 10 samples were submitted in a month and one sample was positive, the percentage of samples containing coliforms would exceed the standard of 10%.

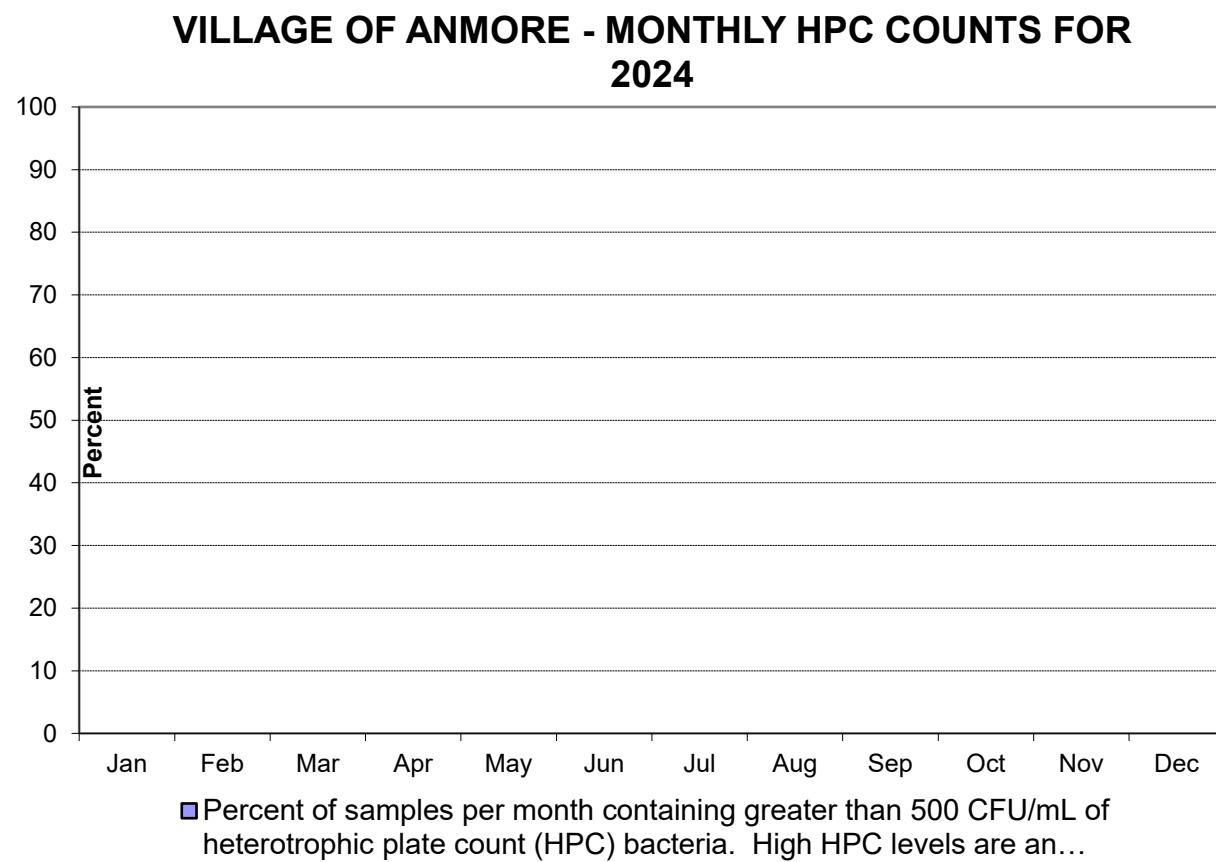
Figure #2: 2024 Monthly Heterotrophic Plate Count

A complete record of 2024 bacteriological water quality sampling results can be found in Appendix #1. The Village of Anmore's results were all within regulatory limits for 2024.

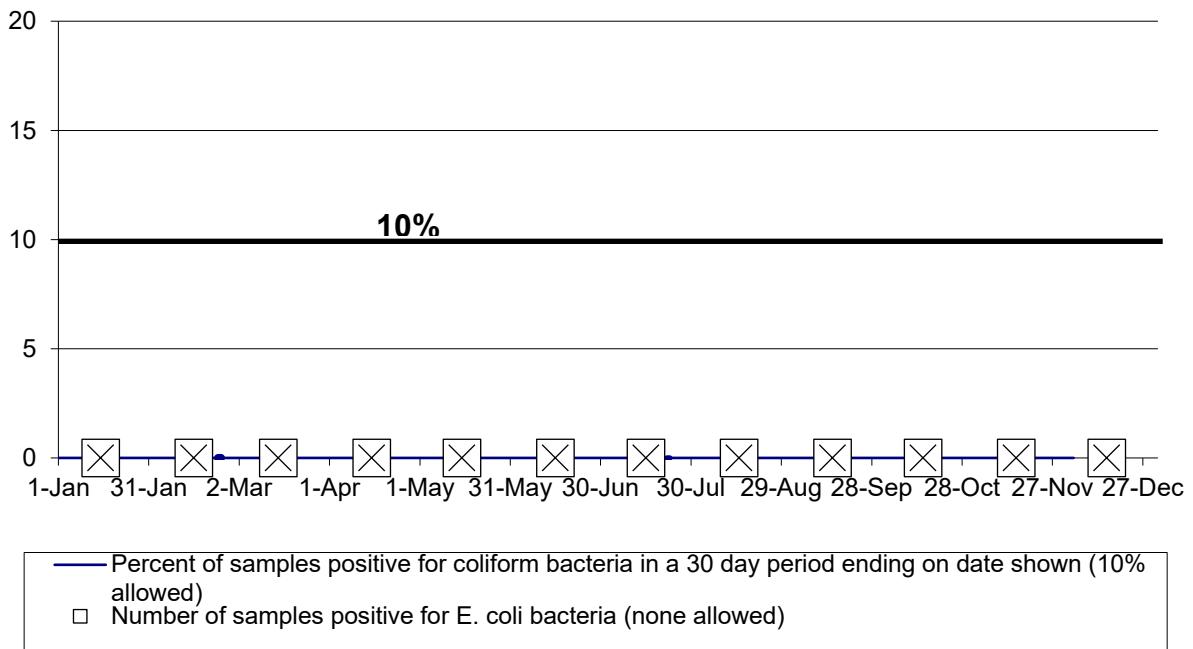
Figure #3: Results of Bacteriological Analysis of Potable Water Samples and Compliance with BCDWPR

Results of Bacteriological Analyses of Potable Water Samples Compliance With BC Drinking Water Protection Regulation

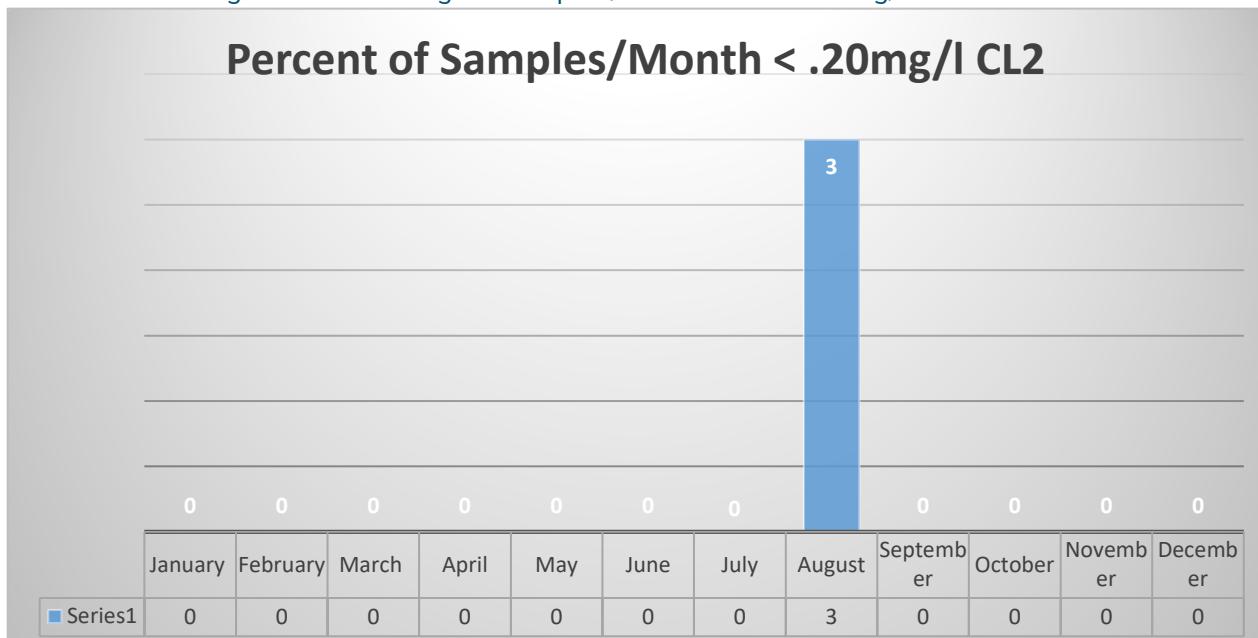
Figure #4: Percentage of Samples / Month with < 0.20 mg/l Free Chlorine

Free residual chlorine concentrations in water received by the Village from Port Moody generally varies and is not at concentrations high enough to provide adequate disinfection throughout the Village. Reduced concentrations of disinfectant have historically been a challenge for the Village's water system. Prior to the commissioning of the permanent Chlorine Booster Station in December of 2013, Anmore's Water System had little to no chlorine residual.

Tables #11, #12 and Figure #4 provide a summary of the number of samples collected from each sample station that were found to have free chlorine concentrations less than 0.20 mg/l. A map of all water quality sample collection points regularly sampled by the Village can be found in Appendix #4.

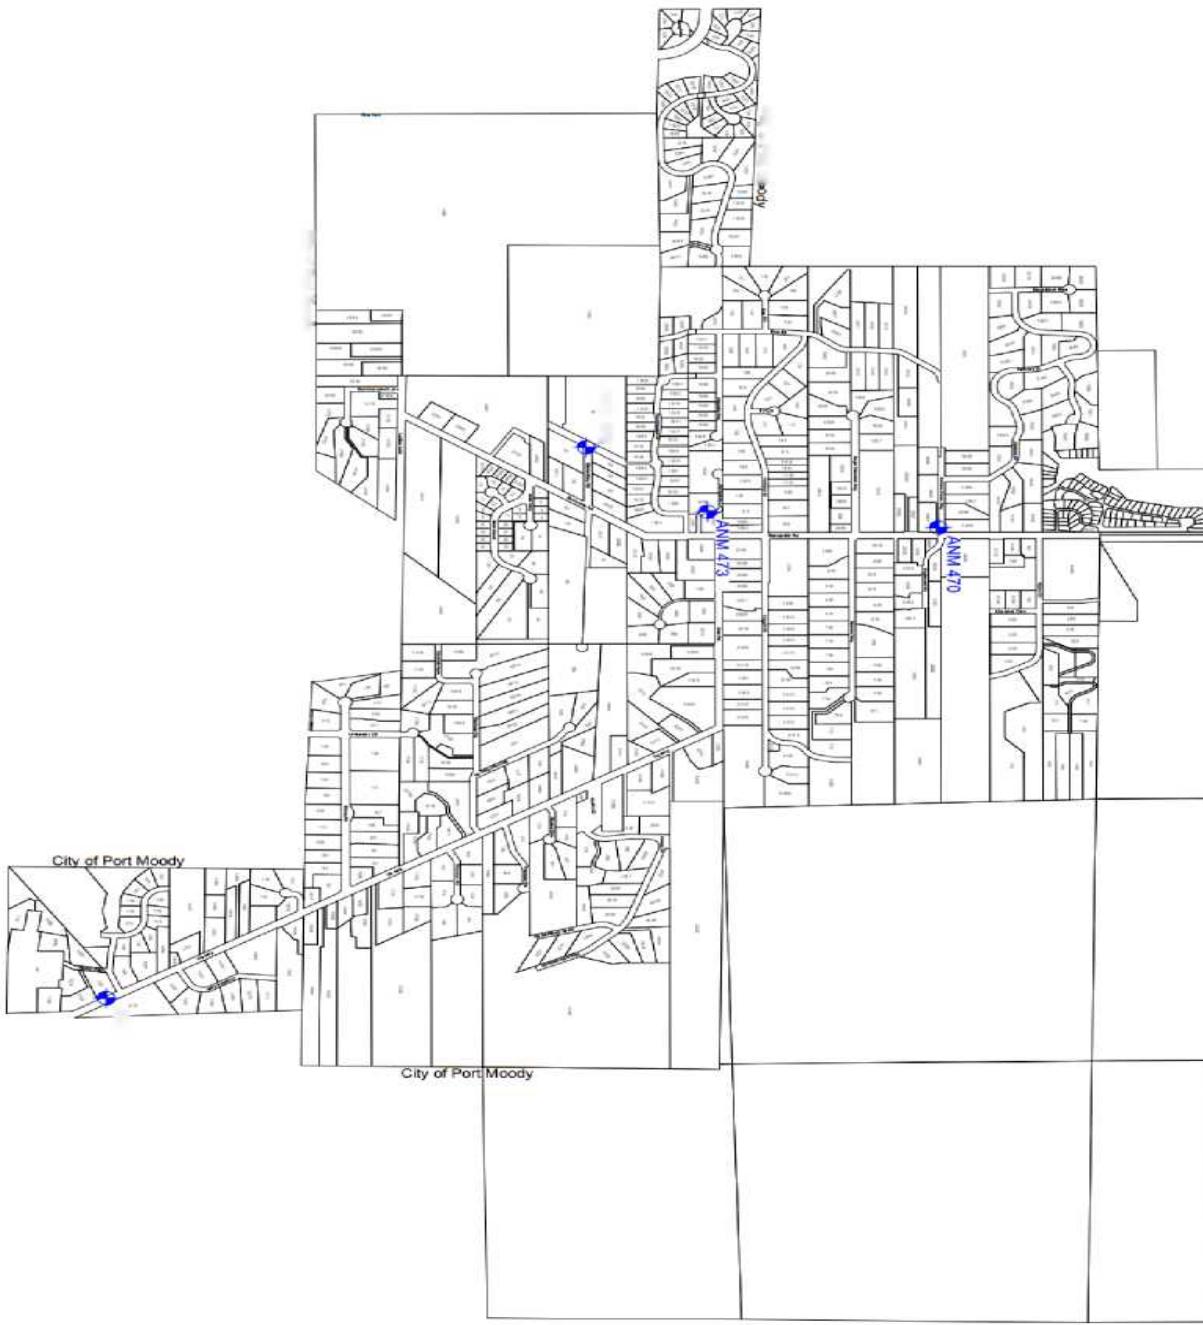
Anmore Water Quality Sampling Station Map

In 2024 a total of 53 bacteriological samples were collected from the Village's distribution system. Table #6 presents the locations and descriptions for the four sample stations where Metro Vancouver staff collect water quality samples on a bi-weekly basis.

SAMPLE STATION	LOCATION	SOURCE WATER
ANM-474	1009 Ravenswood Dr.	Coquitlam (Via Port Moody)
ANM-471	1175 East Rd.	Coquitlam (Via Port Moody)
ANM-472	3007 Sunnyside Rd.	Coquitlam (Via Port Moody)
ANM-473	76 Elementary Rd.	Coquitlam (Via Port Moody)
